LESSONS LEARNED FROM EARLY CRITICALITY ACCIDENTS

Richard E. Malenfant
Los Alamos National Laboratory

Nuclear Criticality Technology Safety Project Workshop
Gaithersburg, Maryland
May 14-15, 1996

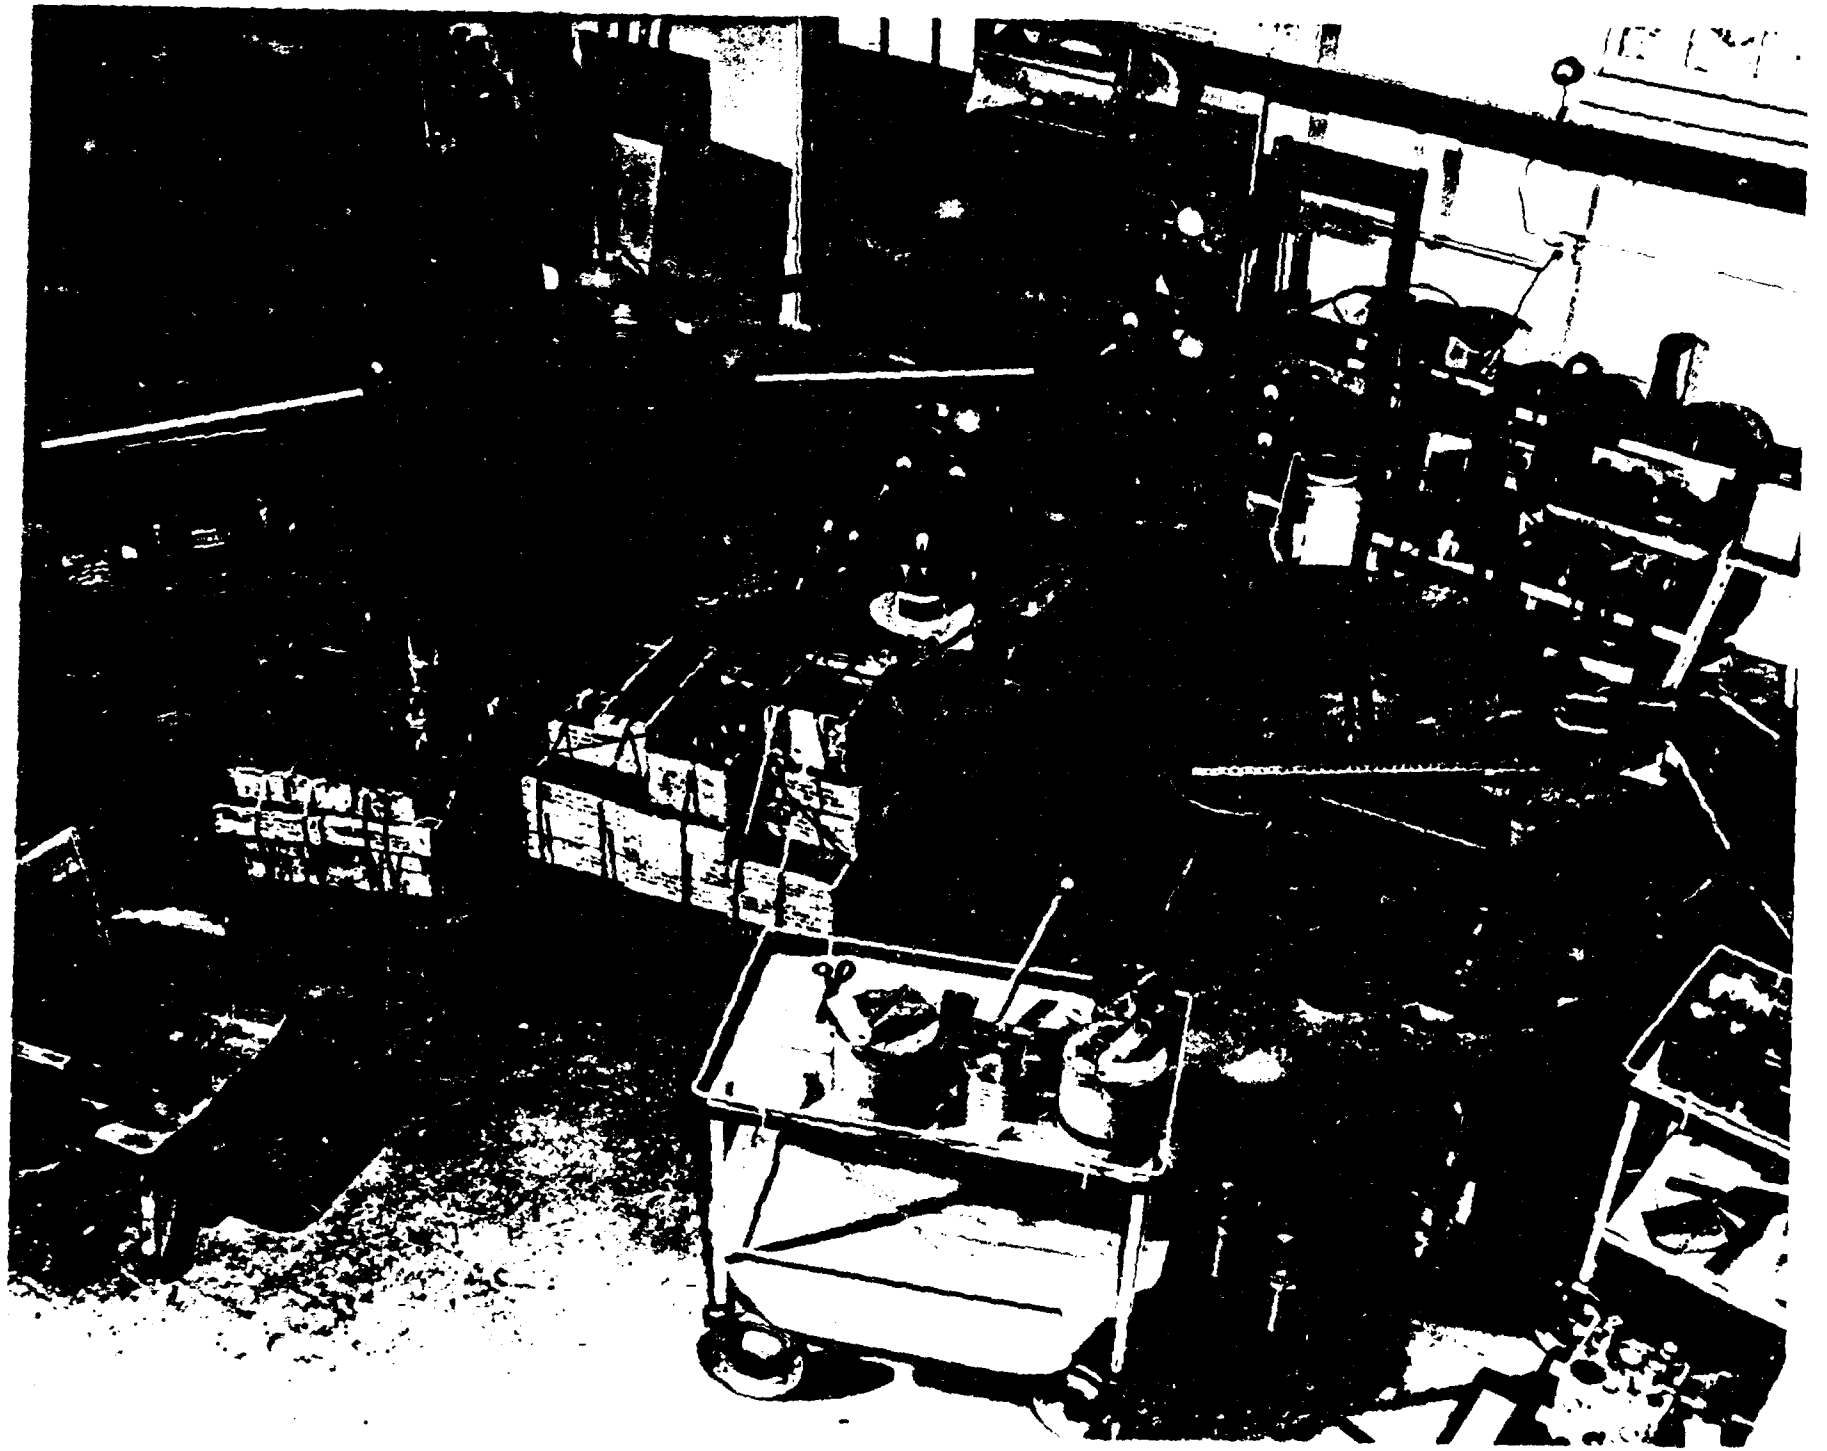
The area in which the experiment was conducted was cluttered and non essential equipment and personnel hampered the operation (Fig. 1).

Although it is argued (see attachment) that the experiment was not done carelessly, the condition of the experimental area and presence of non participants indicate a cavalier disregard for all but the most rudimentary safety features.

3. Only those persons actually concerned with the assembly should have remained in the room.
