LA-13638

A Review of Criticality Accidents

2000 Revision

Issued: May 2000

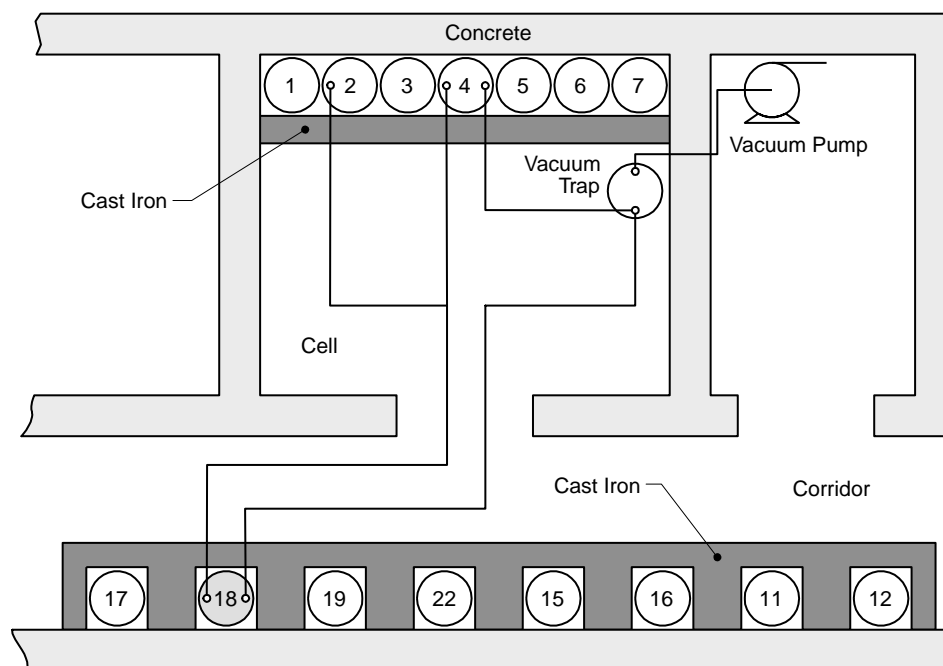
Figure 6. Layout of vessels and equipment in the staging area.

with the concrete floor and wall on the remaining 2 sides of the vessel. The criticality accident occurred in vessel 18.

As part of the investigation, both experiments and calculations were performed to estimate the conditions for criticality in vessel 18. The results determined that 30 ℓ of solution containing 825 g of plutonium (27.5 g/ℓ) would be required for criticality. These values agree closely with the best estimate of the contents of vessel 18 at the time of the accident, 31 ℓ of solution with 848 ± 45 g of plutonium (27.4 g/ℓ). One contributing cause of the accident was the unrecorded transfer of 5 ℓ of solution from vessel 1 to vessel 18.

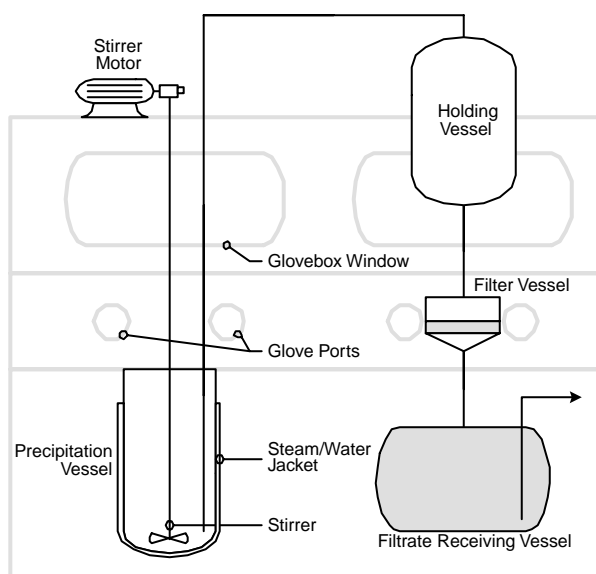
Figure 7. Equipment layout for the oxalate precipitation and filtration process.

- While not known for sure, it was suspected that minor defects in the filter fabric might also have contributed to an increased rate of precipitate accumulation in the filtrate vessel. Procedures called for the filter fabric to be replaced based on either visual evidence of defects or unusually high flow rates through the filter.

After dismantling the glovebox and cleaning the various pieces of equipment, a total of 3.06 kg of ^{235}U was discovered in the filtrate receiving vessel. This material was primarily in two forms: a thin, hard crust, due to long-term buildup, and a flocculent precipitate, the concentration of which decreased with height in the vessel. The accident caused no mechanical damage to this vessel, and the room was not contaminated. The glovebox was taken apart, cleaned, and reassembled with essentially the original equipment. The operation was resumed after just a few days. During the downtime, a radiation meter was installed on the glovebox, operating instructions were revised, and enhanced operator training was implemented.

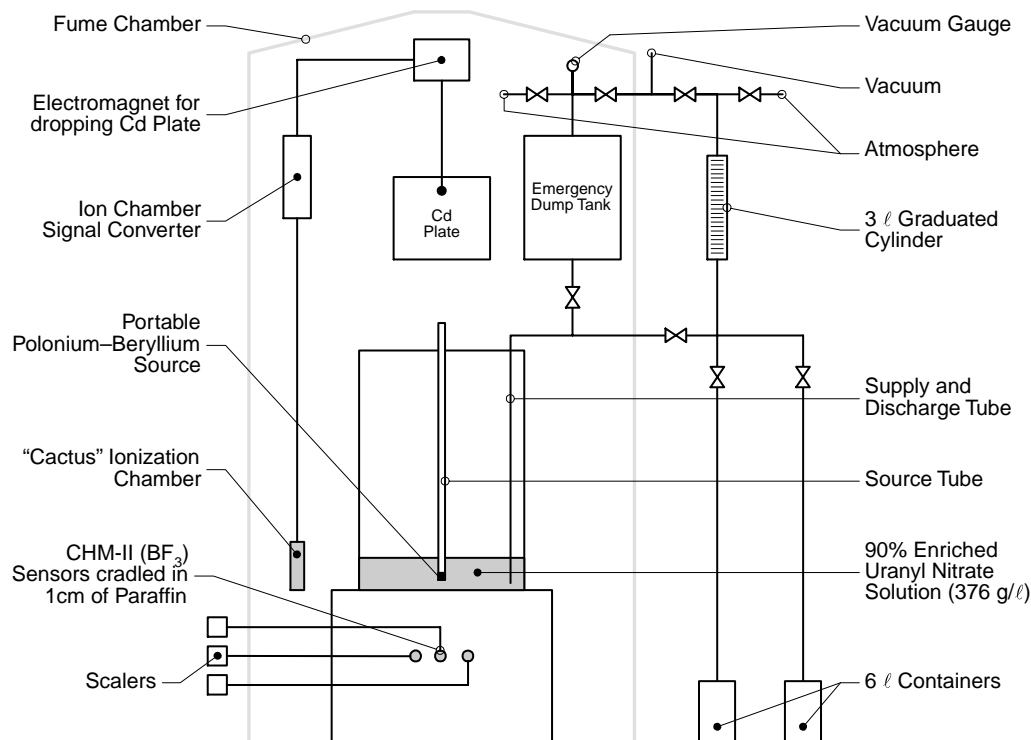
Figure 8. Layout of the experimental equipment.

They immediately noticed a flash (due to Cherenkov radiation), and simultaneously, fissile solution was violently ejected, reaching the ceiling about 5 m above. The three experimenters dropped the vessel and, along with a fourth experimenter who was located about 2.5 m away from the excursion, went immediately to the change room, showered, and were transported to the hospital. The combination of additional reflection from the three experimenters and the change in the geometry of the solution volume was sufficient to cause the system to exceed prompt critical. The small neutron background, estimated at only 100 neutrons per second, apparently also contributed to delayed initiation and thus to increased excursion energetics.

- Violation of the procedure that stipulated the complete draining of the experiment solution into 6 liter bottles.
- Unbolting and removing the experiment vessel when it contained solution. This was not specifically permitted in the operating procedure.

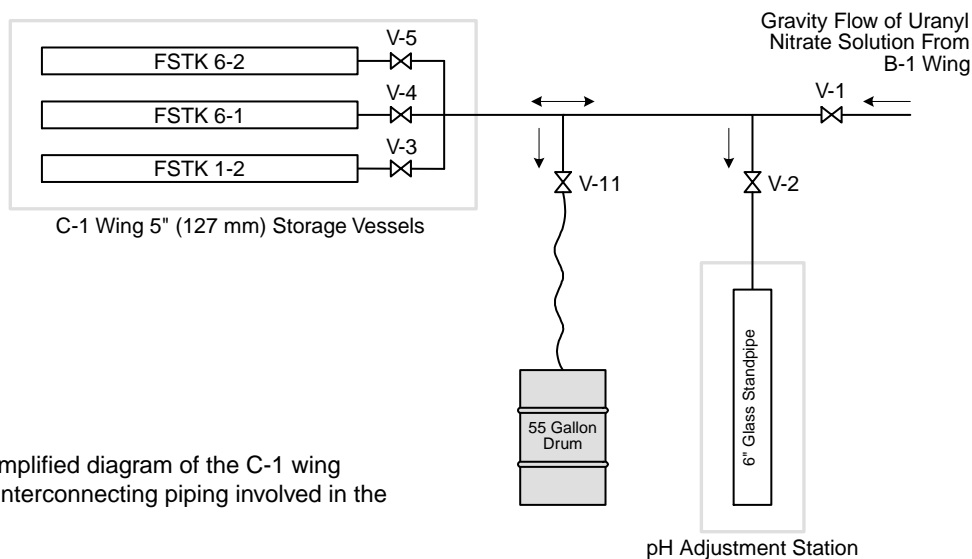
investigation, they determined that solution was leaking into the standpipe through valve V-2. The valve was closed, and the standpipe was again drained.

Unknown to anyone at the time, uranyl nitrate had been leaking from the B-1 Wing through valve V-1 from the early hours of the previous shift until about 13:30, when one of the operators checked it (and by applying pressure completely closed the valve), as instructed by the supervisor. Before this, the uranyl nitrate had been collecting in vessel FSTK 1-2, because valve V-3 had also been open.

Figure 9. Simplified diagram of the C-1 wing vessels and interconnecting piping involved in the accident.

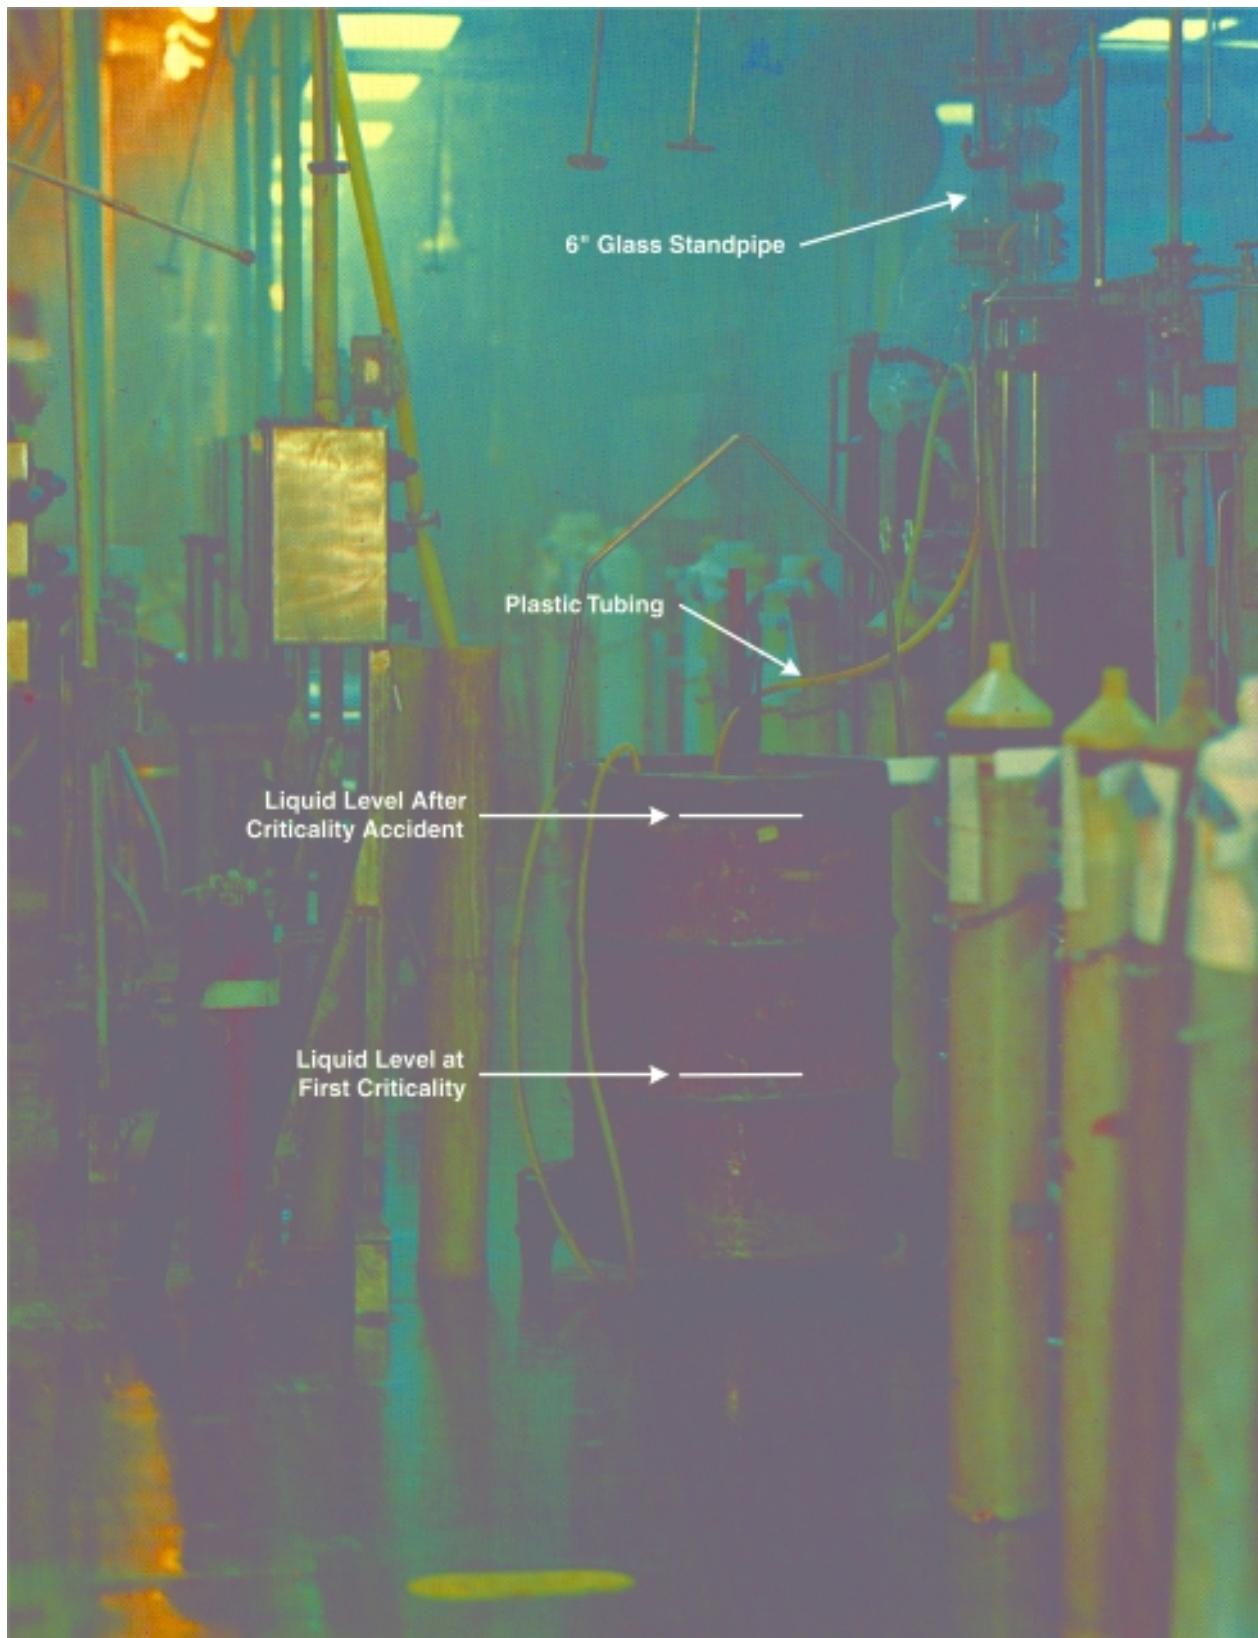
Figure 10. Drum in which the 1958 Y-12 process criticality accident occurred.

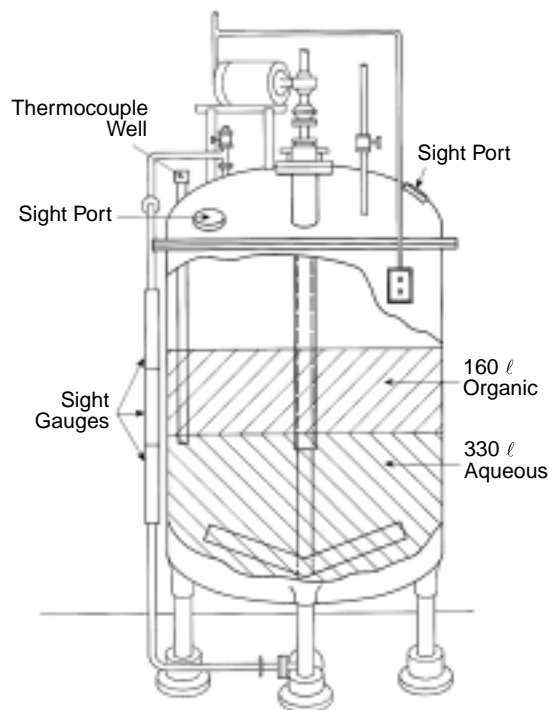
From these time intervals and the estimate that initially the system was 5 \$ subcritical, the reactivity insertion rate would have been about 5 \$/s. Using coefficients appropriate for the solution, this insertion rate leads to a spike yield of 2.2×10^{17} fissions with the spike completed in 1.65 seconds, that is, 0.45 seconds after prompt criticality was reached. To obtain the observed yield (1.5×10^{17} fissions) in a single spike, the reactivity insertion rate would have to be reduced to about 2 \$/s. Because this is inconsistent with the time involved (about 3 seconds before complete mixing), the only alternative is to assume that the rate was somewhat less than 5 \$/s and that the excursion was terminated in about 3 seconds by the stirring action. One can surmise that the initial action was thickening of the upper layer at the same time reflection was added by the aqueous liquid. This was followed almost immediately by distortion into a less critical, vortex-like shape by the action of the stirring blades and then permanent shutdown due to a uniform concentration of less than 7 g/ℓ.

Figure 11. Configuration of solutions (aqueous and organic) in the vessel before the accident.

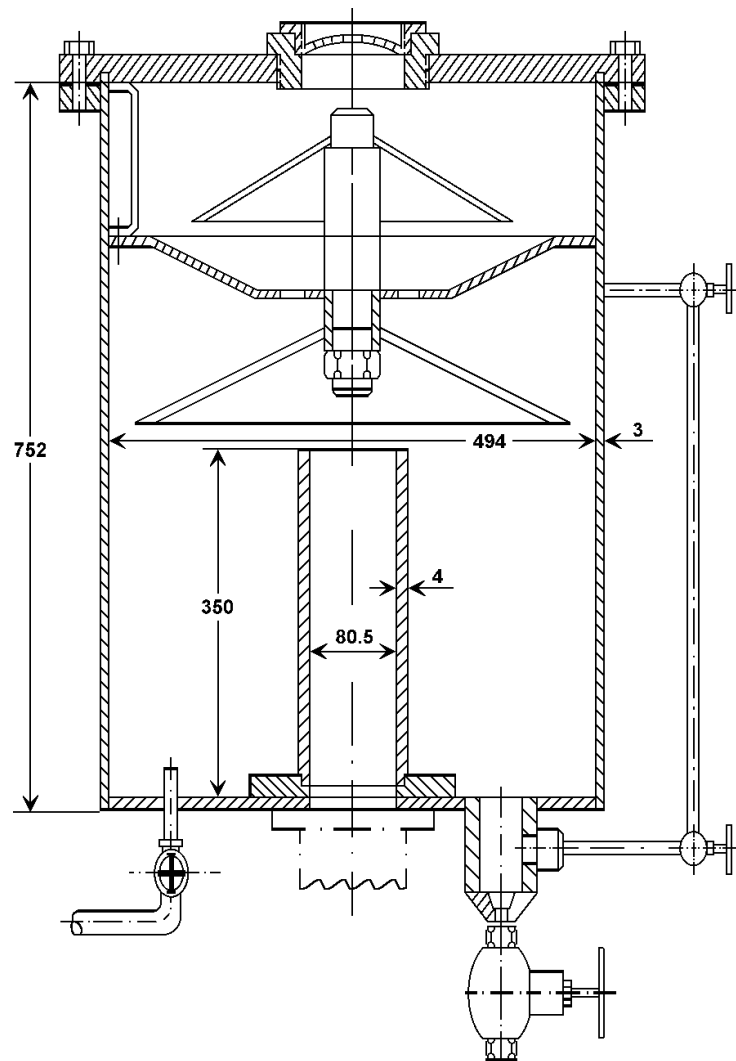
When the pump was turned on at 07:30, the oil in the pump's cavities was forced out into the central pipe of the oil reservoir. This sudden injection of oil containing uranium led to the second and much larger excursion. The shutdown of this excursion was due to a combination of temperature rise and radiolytic gas generation, which caused ejection of the oil from this central pipe back into the pump's cavities and the gas purification equipment. As with the first excursion, the

Figure 16. Oil reservoir (Dimensions are in mm).

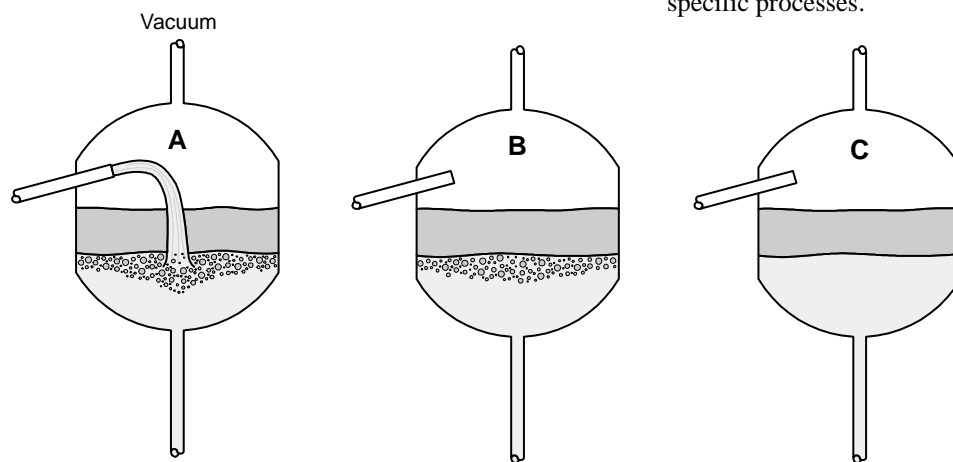
This excursion illustrates the subtle ways in which accidents can occur during solution processing. Although the deep trap was considered a safety feature for the control of contamination, it contributed directly to the criticality accident. The difficulty of understanding what had happened, even after it was known in which vessel the excursion occurred, is an excellent example of the impracticability inherent in attempting to calculate criticality accident probabilities for specific processes.

Figure 26. Solution transfer as reconstructed from the transparent plastic mockup of the transfer vessel. Configuration (B) is the postulated state at the time of the accident.

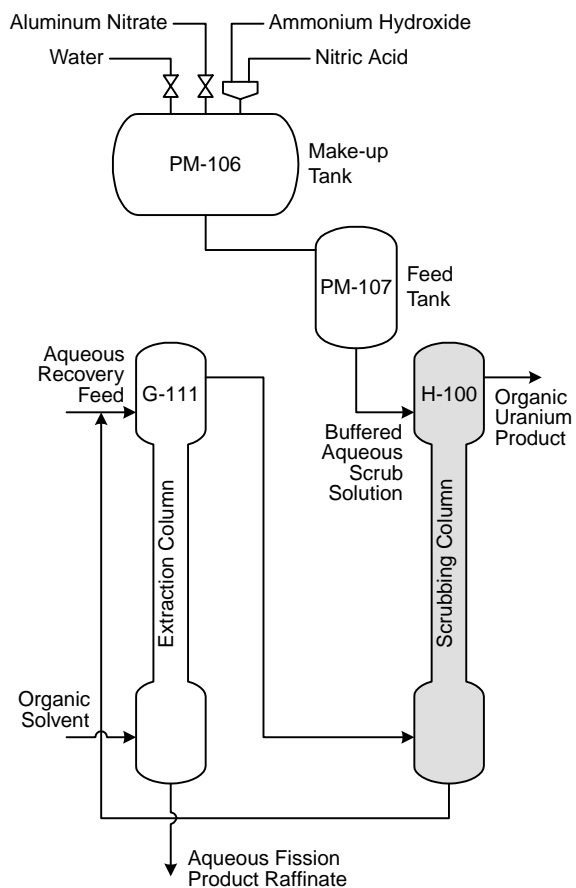
for the scrubbing column, H-100, had been leaking for about a month prior to the accident. Over time, this leak caused a dilution of the feed solution from 0.75 M to 0.08 M. The 13,400 ℓ make-up tank was equipped with a density alarm that would have indicated the discrepancy, but the alarm was inoperable. A density alarm was scheduled to be installed on the 3,000 ℓ process feed tank (PM-107) that was filled, as necessary, from the make-up tank, but this had not been done. The make-up tank was instrumented with a strip-chart recorder showing the solution level in the tank. However, the leak into the tank was so slow that the change in level would have not have been discernible unless several days worth of the chart was analyzed. To complicate matters, the chart recorder had run out of paper on 29 September and it was not replaced until after the accident. Furthermore, procedures that required the taking of samples from the feed tank, PM-107, to confirm the density, were not being followed.

Figure 27. First cycle extraction line equipment. The accident occurred in the lower disengagement section of the H-100 column.

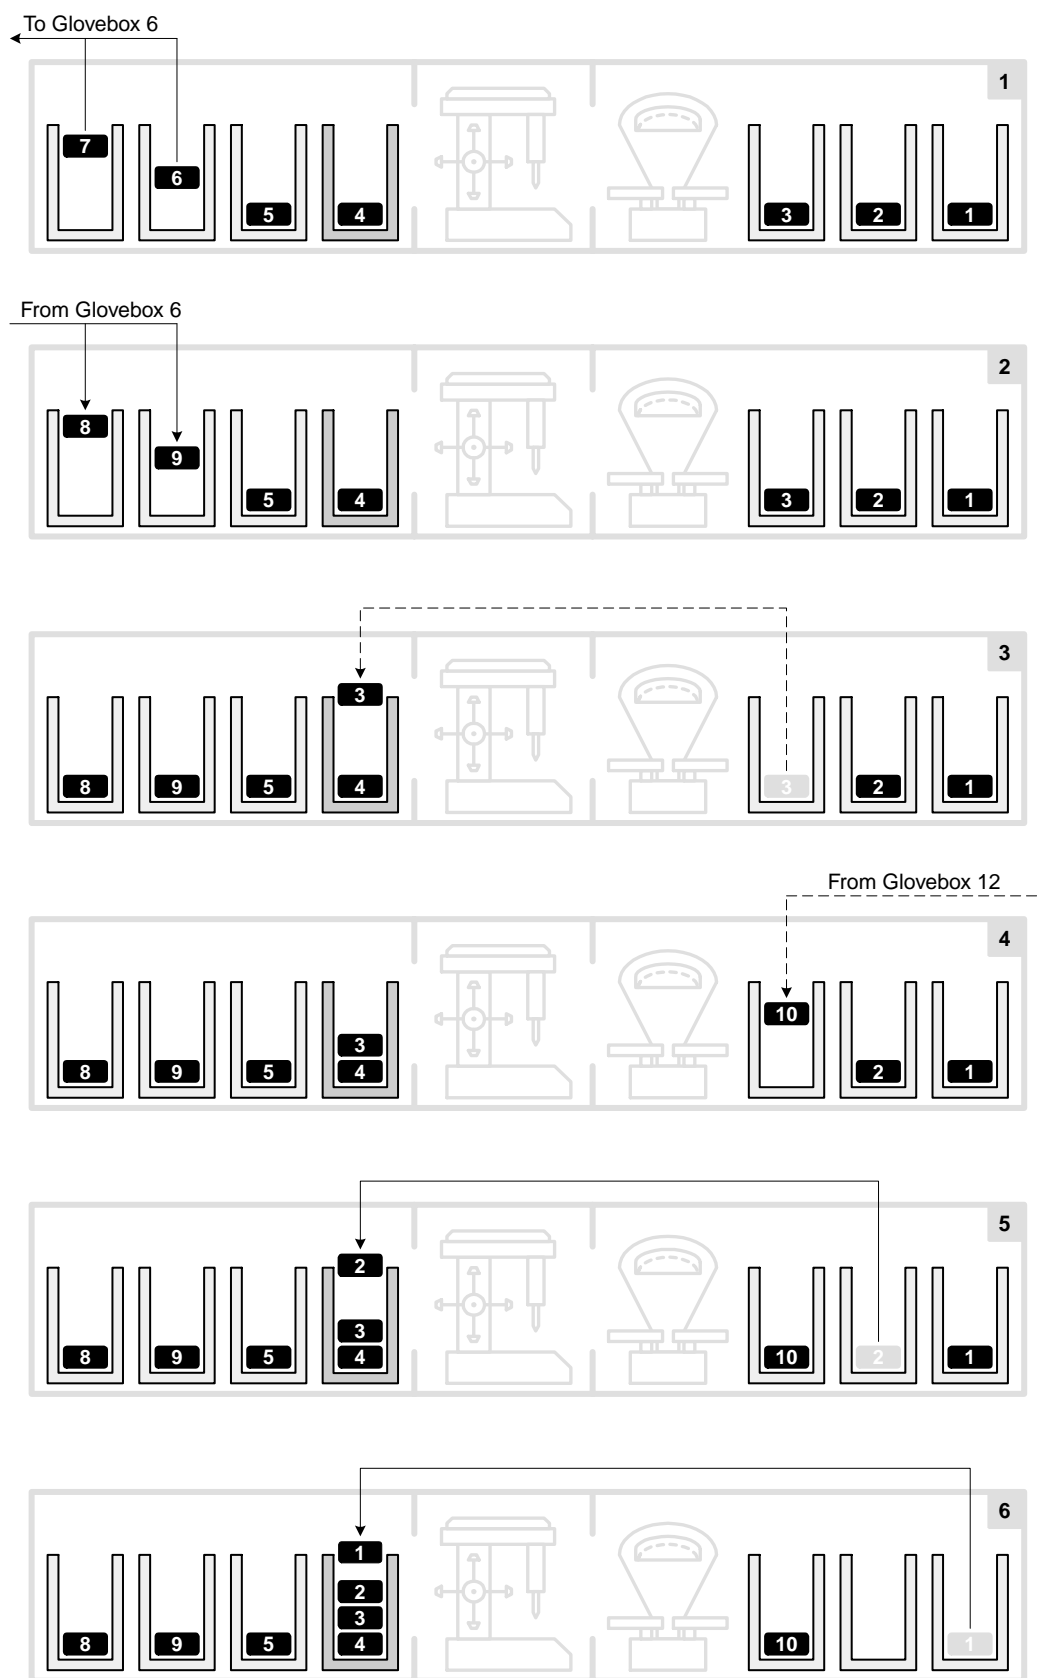
Figure 31. Actual order of ingot transfers from and to Glovebox 13. The solid lines represent the actions of operator A and the dotted lines the actions of operator B.

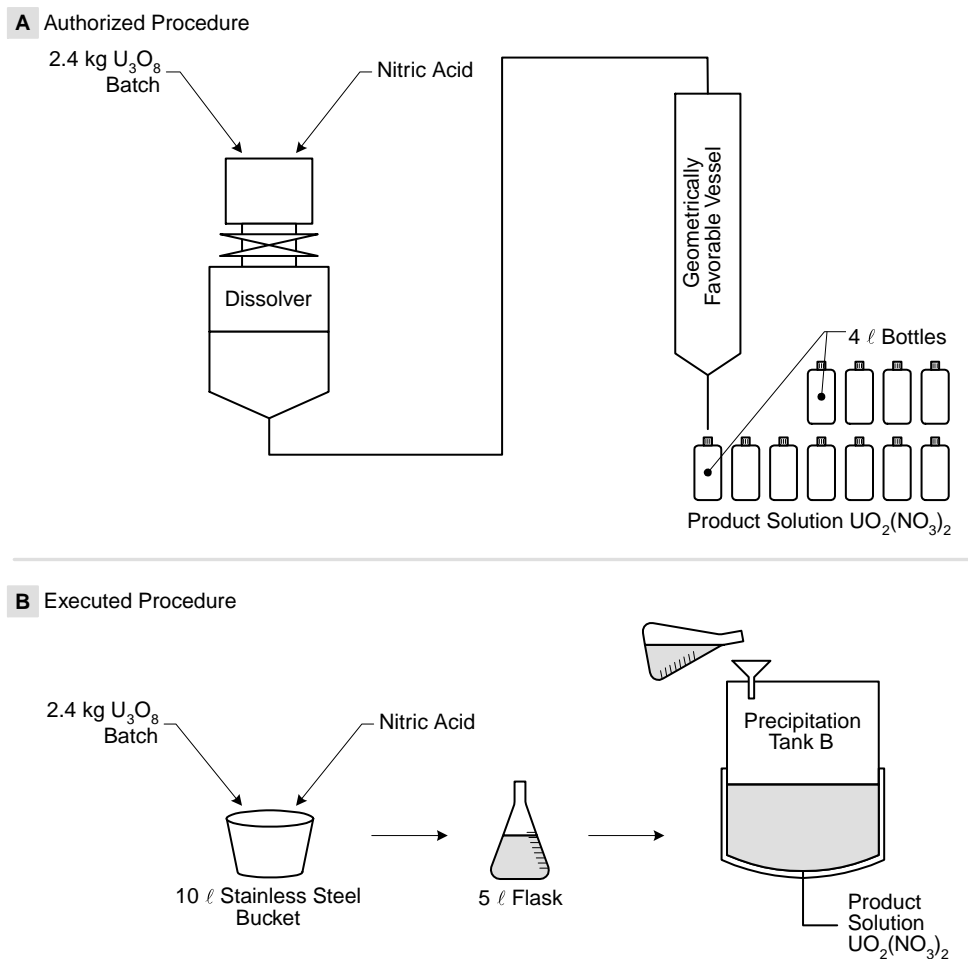
Figure 34. Authorized and executed procedures.

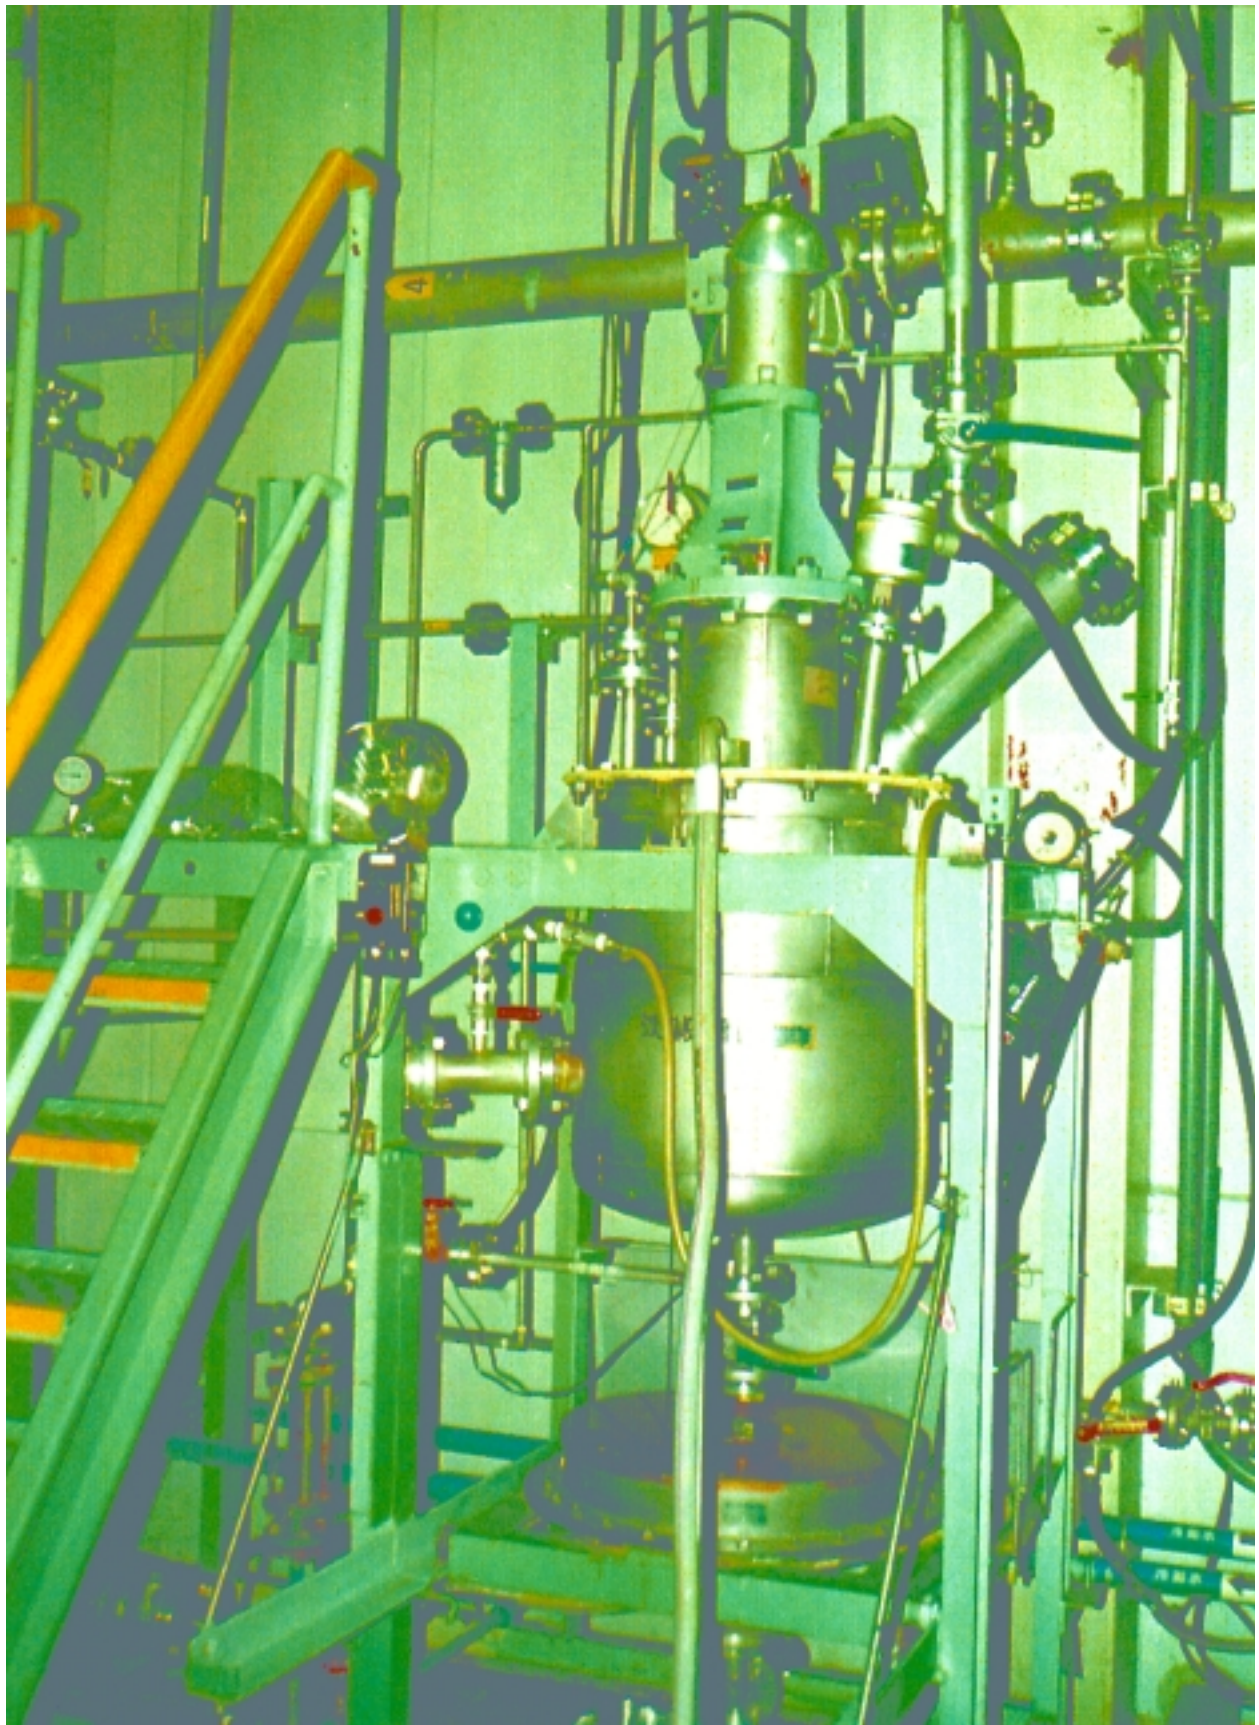
Figure 35. The precipitation vessel in which the process criticality accident occurred.
