# Argonne National Laboratory

## THE EBR-I MELTDOWN - PHYSICAL AND METALLURGICAL CHANGES IN THE CORE

Final Report - Metallurgy Program 7.2.18

November 1957

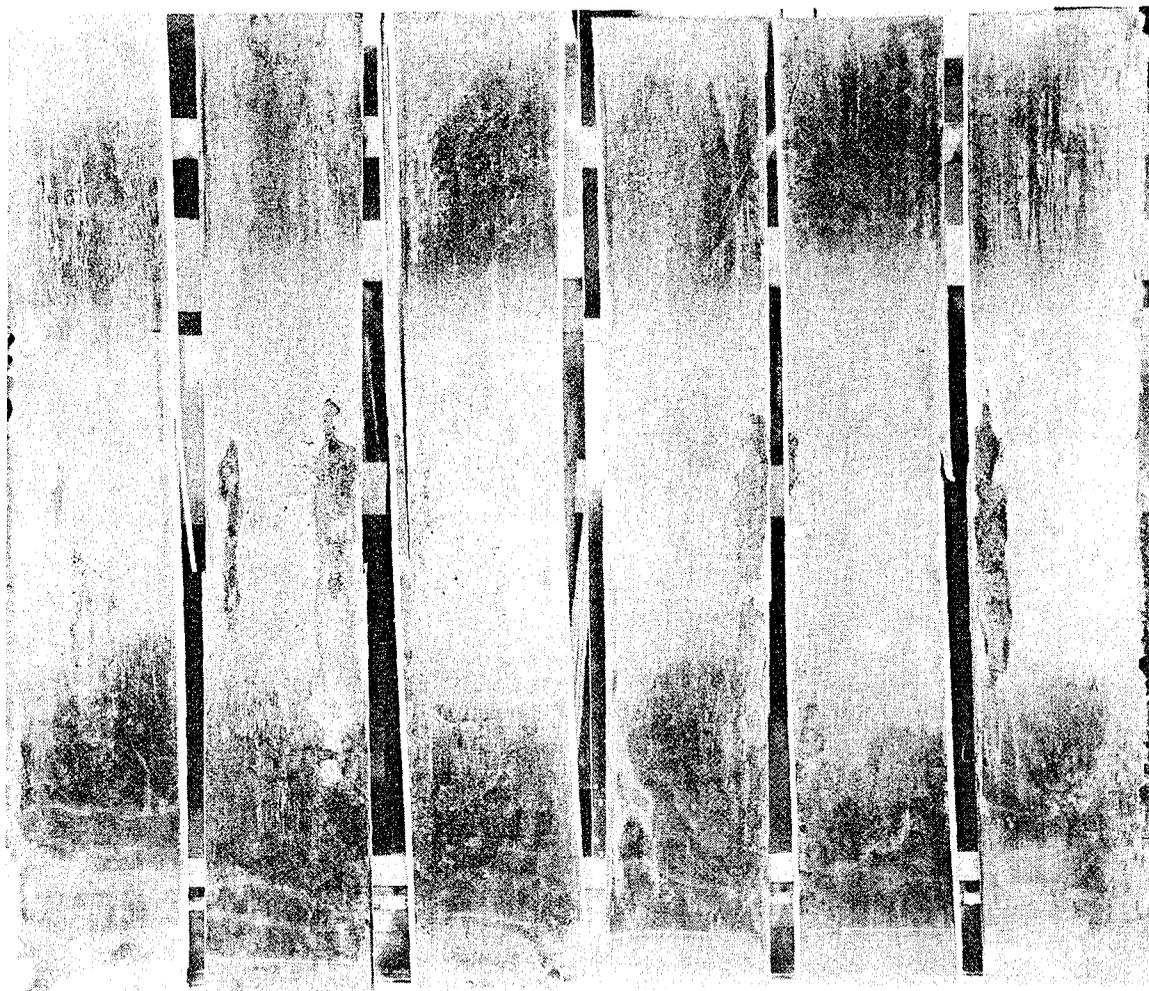
Subsequently, at the Lemont site of the Laboratory, the hexagonal separator was split down each corner to provide specimen material for determination of the effects of irradiation on the mechanical properties of the stainless steel. Figure 9 shows a photograph of the six interior faces of the separator, and it can be noted that the material formed during the temperature excursion had alloyed superficially with the separator in certain areas, particularly on sides 2, 4, and 6.

Figure 9. Interior surfaces of hexagonal separator, showing superficial alloying of molten phase with separator, particularly on sides 2, 4, and 6.

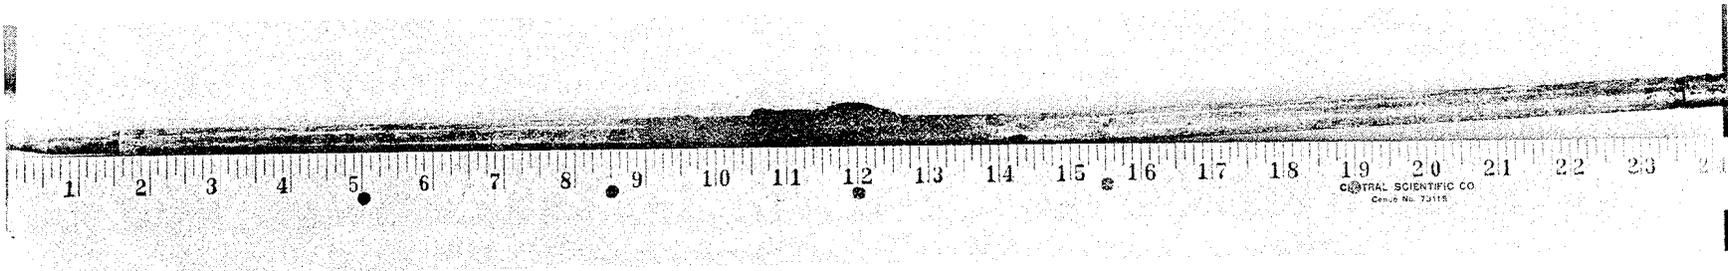
Typical fuel rods from this group are shown in Figures 11 and 12. Although the outer jackets were damaged on most of the fuel elements in the outer row, as shown in Figure 11, it was evident that any jacket melting resulted from external causes, rather than from the fuel slugs which they contained. This is clearly shown in Figure 13, in which can be seen an undamaged stainless steel spacer between fuel slugs contained in an outer jacket which had been subjected to melting damage. Had these particular slugs overheated, the spacer, being at the center of the fuel section, would have formed a eutectic before any jacket damage occurred.

Figure 11. Typical fuel element from the first (outer) row of the damaged EBR-I core.

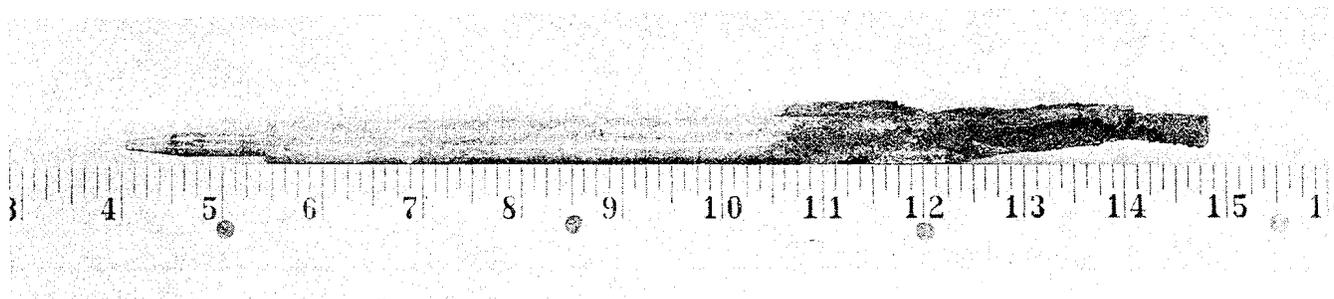
Figure 12. Typical fuel element from the second row of the damaged EBR-I core.

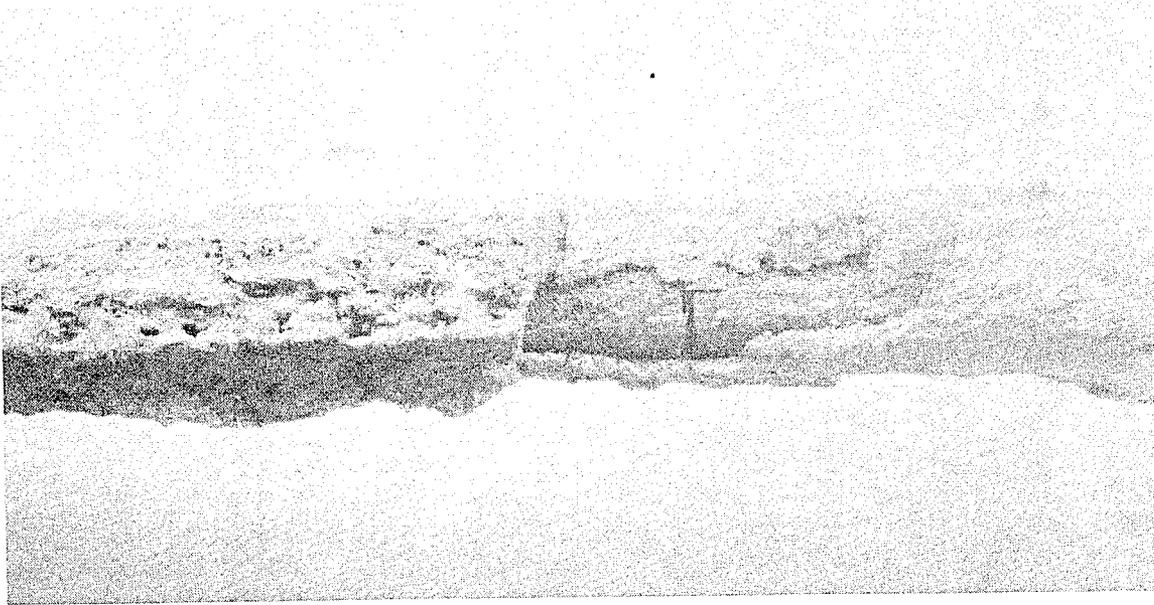
Figure 13. Fuel element from outer row of damaged EBR-I core assembly, showing that although the outer jacket has been severely damaged by melting, the stainless steel spacer between adjacent fuel slugs is undamaged.

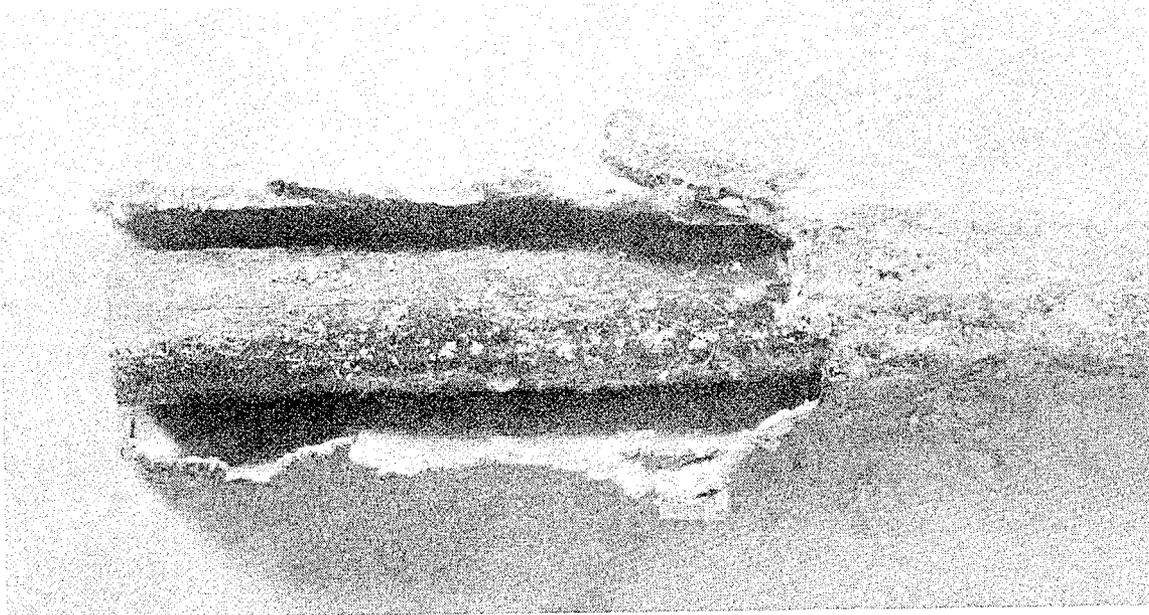
Additional evidence that the fuel in the outer row of elements did not participate in the molten phase is shown in Figure 14. Here, the damaged jacket shown in Figure 13 has been peeled back to expose one of the fuel slugs, and it can be noted that the surface of the slug and the interior surface of the stainless steel jacket have not been affected by the meltdown. For the outer row of fuel elements, therefore, it appears that the fuel temperature did not exceed about 850° to 950°C, which have been reported<sup>(10)</sup> to be the lowest temperatures at which uranium and stainless steel form a liquid phase for short heating periods.

Figure 14. The stainless steel jacket shown above in Figure 13 has been peeled back, and it can be noted that the surface of the fuel slug and the interior surface of the jacket were unaffected by the meltdown.

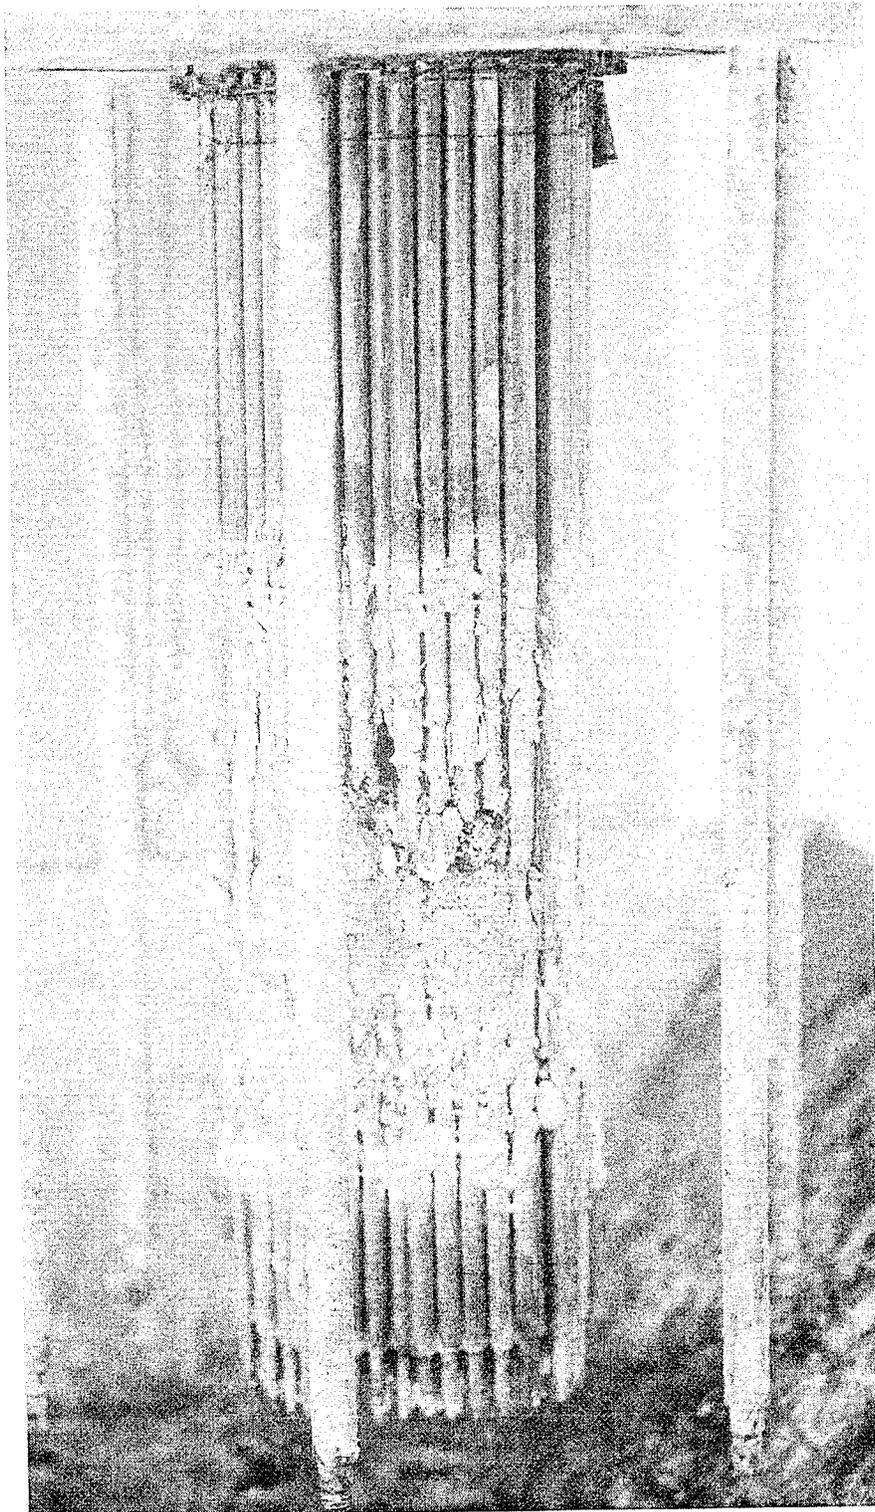
The appearance of the core assembly after removal of the outer fuel elements is shown in Figure 15. It is evident that severe melting damage had occurred in the fuel section, which had slumped somewhat so that the lower half was tightly packed with solidified material. The upper half, on the other hand, contained numerous cavities. Evidently many of the jackets, after forming a molten phase with the fuel slugs they contained, sloughed off and left the partially dissolved fuel still more or less in place. It was subsequently learned during final disassembly that the partially dissolved fuel still in position was confined generally to the second row of fuel elements, i.e., the row next to the outermost row. Moving inwardly from the second row, damage was more extensive.

Figure 15. Damaged EBR-I core after removal of outer fuel elements.

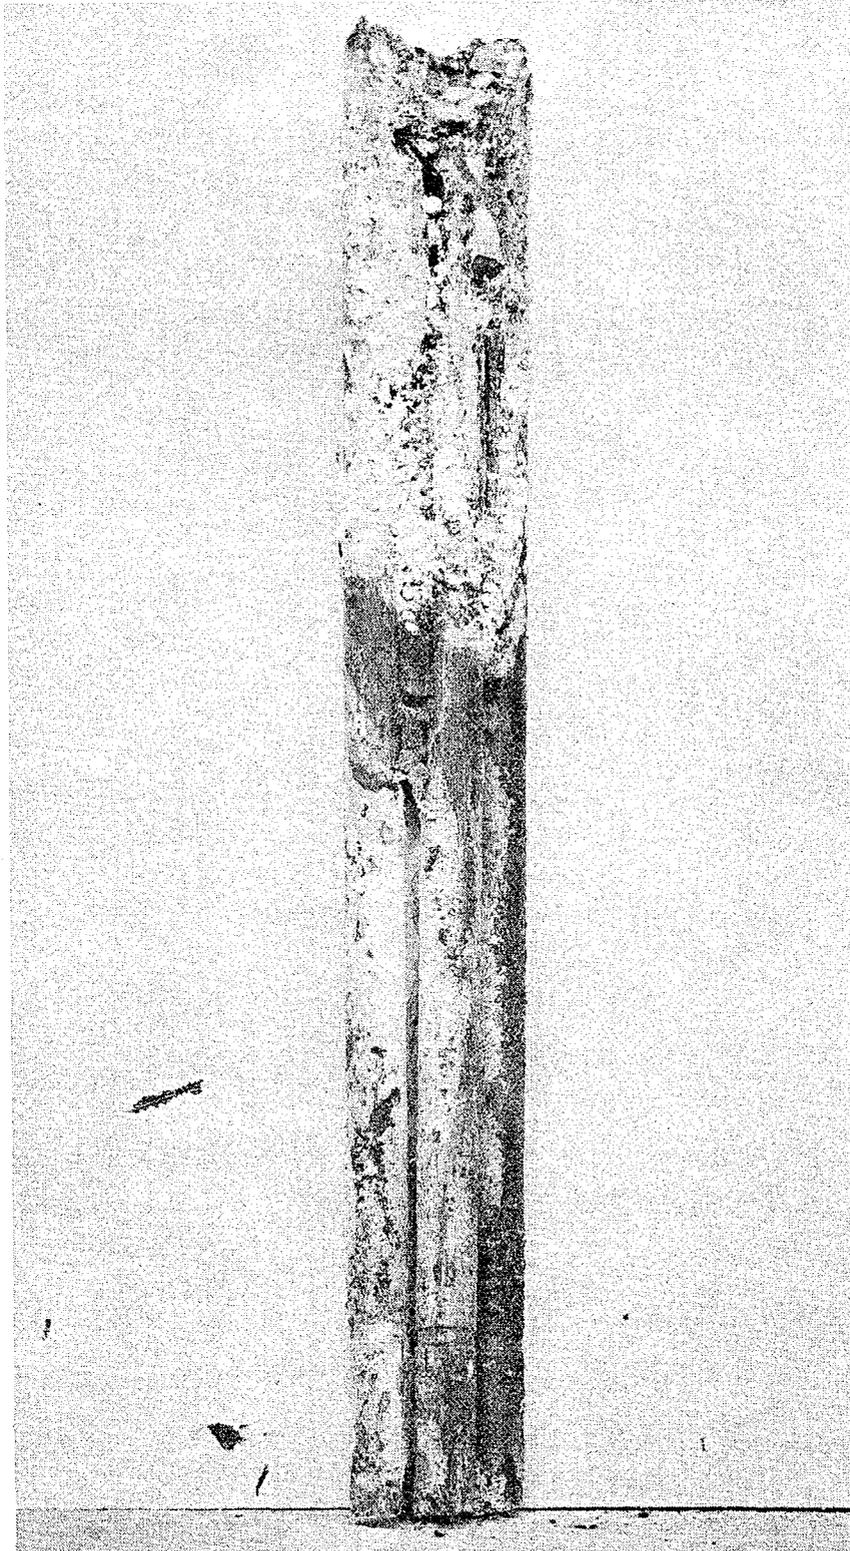
Figure 28. Clump of upper blanket rods from near the center of the core assembly. The blanket section begins about one-half in. above the lower end, and it can be noted that the molten fuel alloy has moved upward between the rods for approximately 5 in.

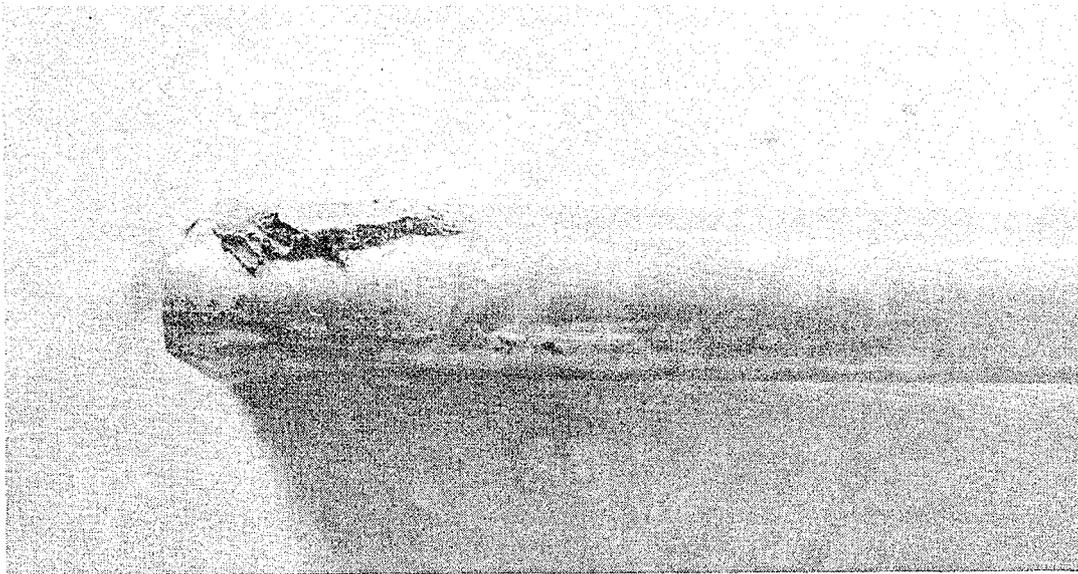
Figure 29. Stainless steel outer jacket from the upper blanket. The left end originally was attached to the fuel section. Most of the adhering fuel alloy has been removed, and it can be noted that the jacket does not appear to have been damaged by melting.

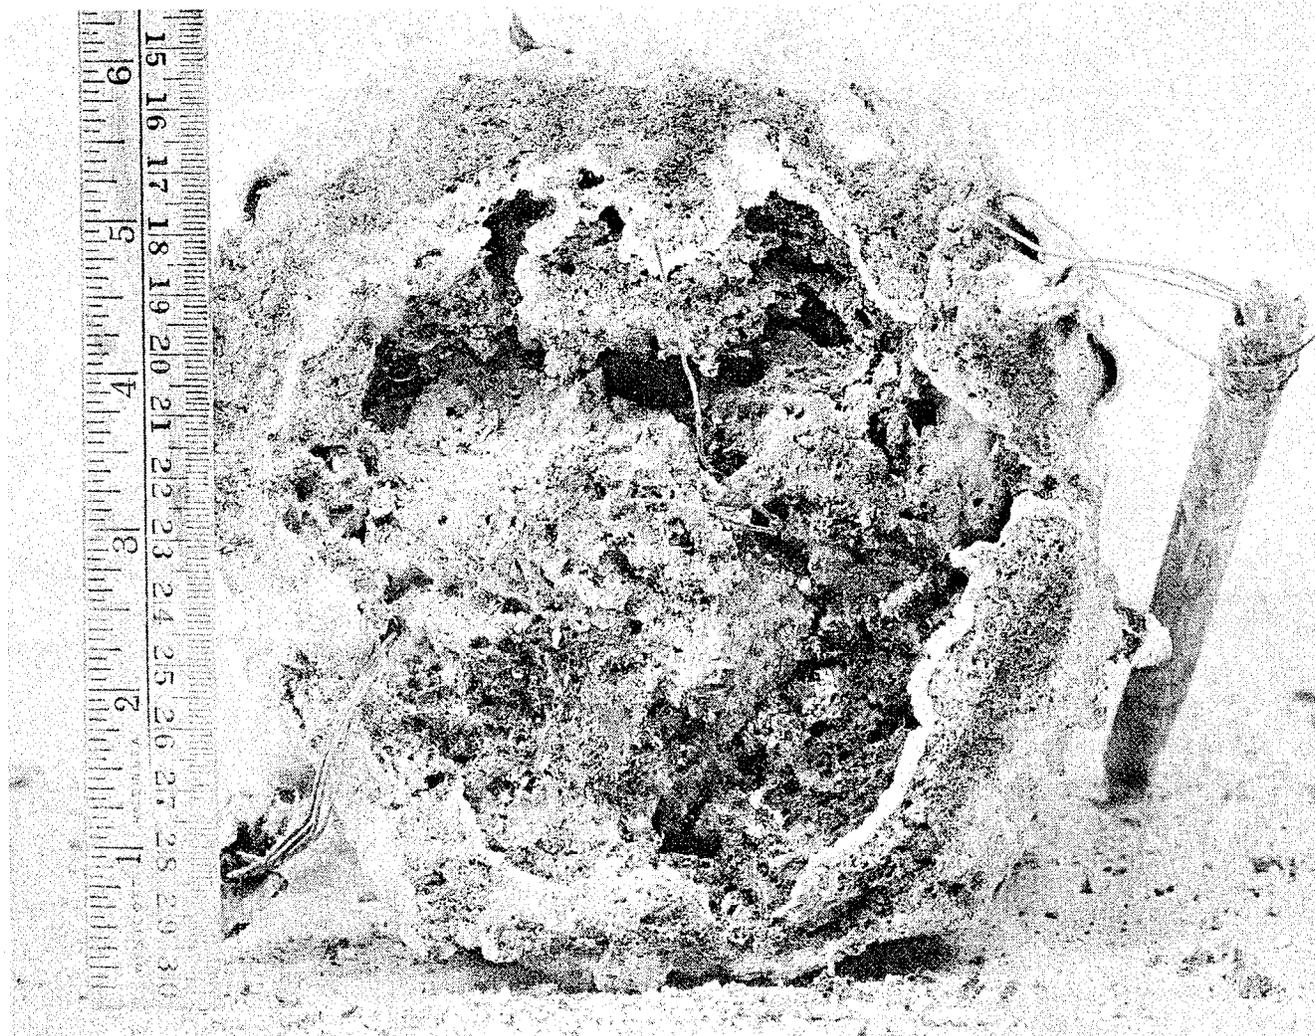
Figure 32. Cross section of damaged EBR-I core at the midplane of the fuel section. Two distinct sponge-like zones are present. Thermocouple wires in the fused mass are undamaged.

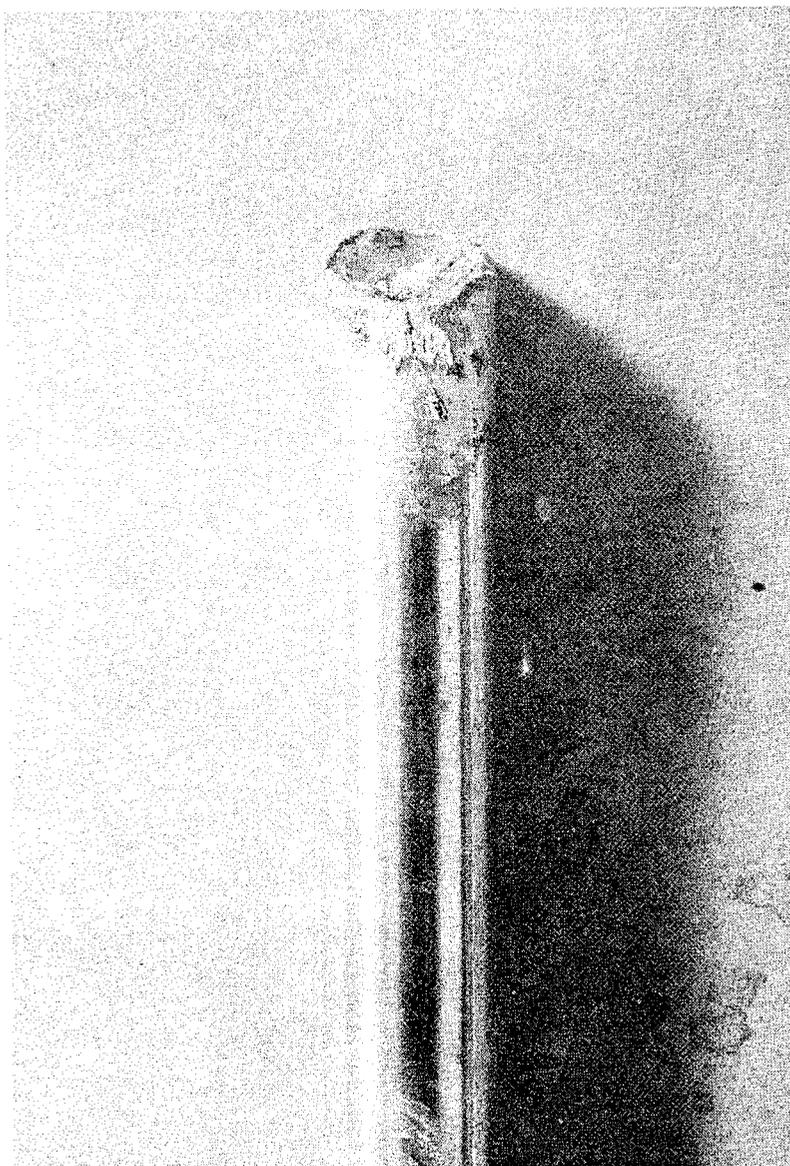
Figure 35. Stainless steel outer jacket from the lower blanket. The upper end was originally attached to the fuel section. Most of the adhering fuel alloy has been removed, and it can be noted that the jacket does not appear to have been damaged by melting.

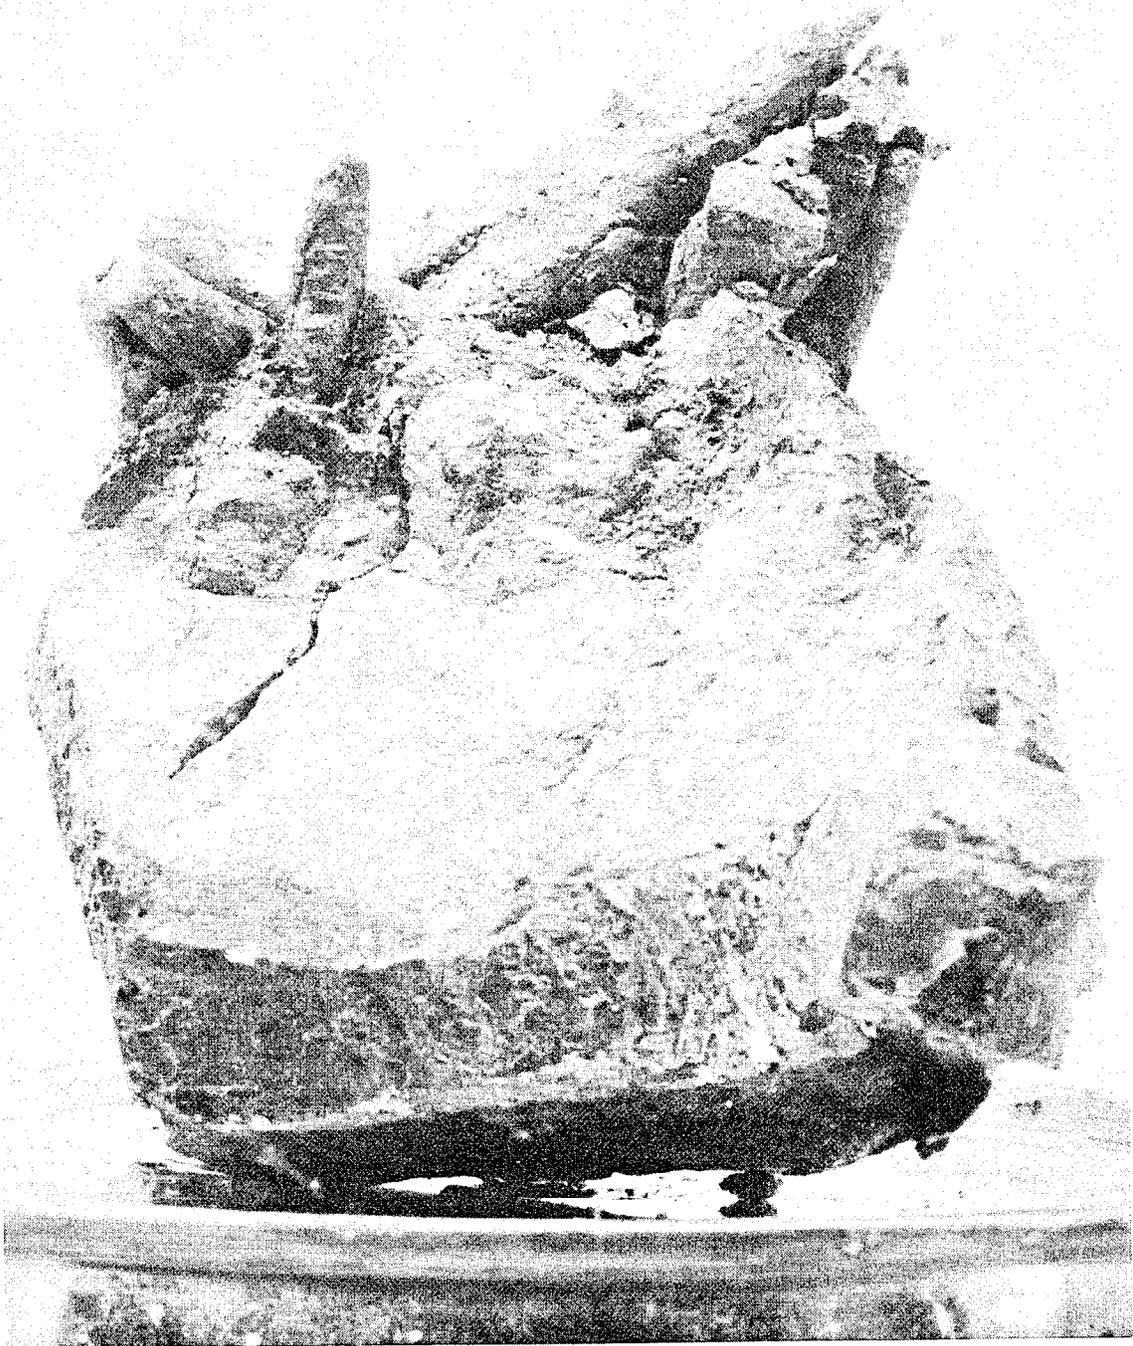
Figure 37. Partially dissolved fuel slugs embedded in dense material from near bottom of fuel section.

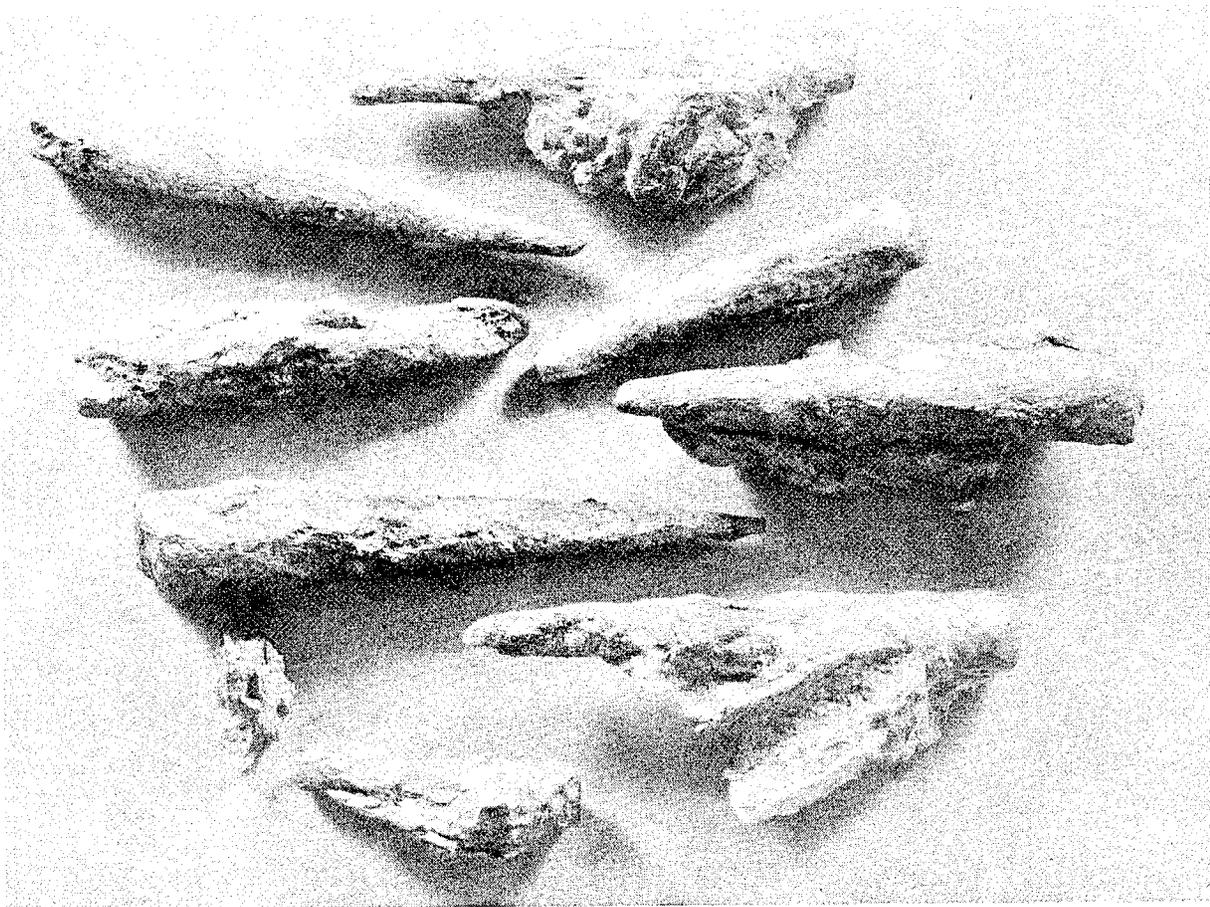
Figure 38. Partially dissolved fuel slugs separated from adjoining material.

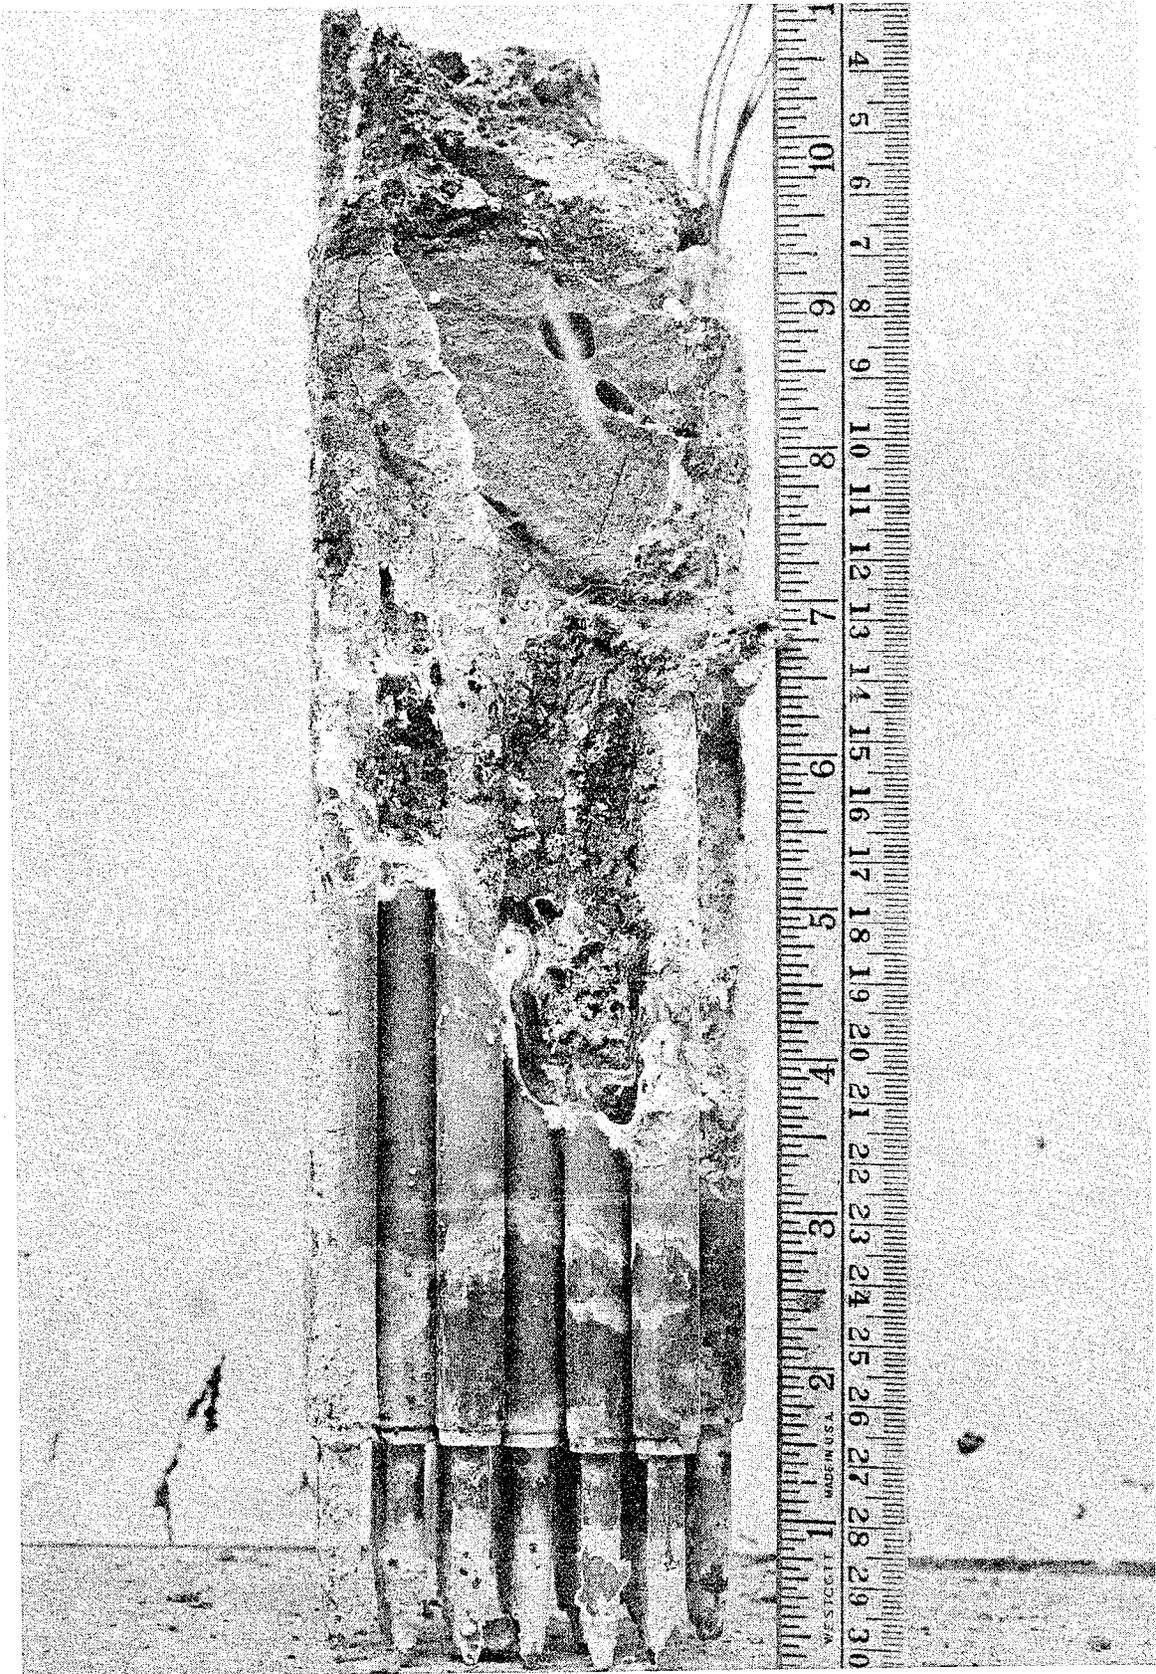
Figure 39. Illustration of voids which were found in the dense zone in the lower fuel section.

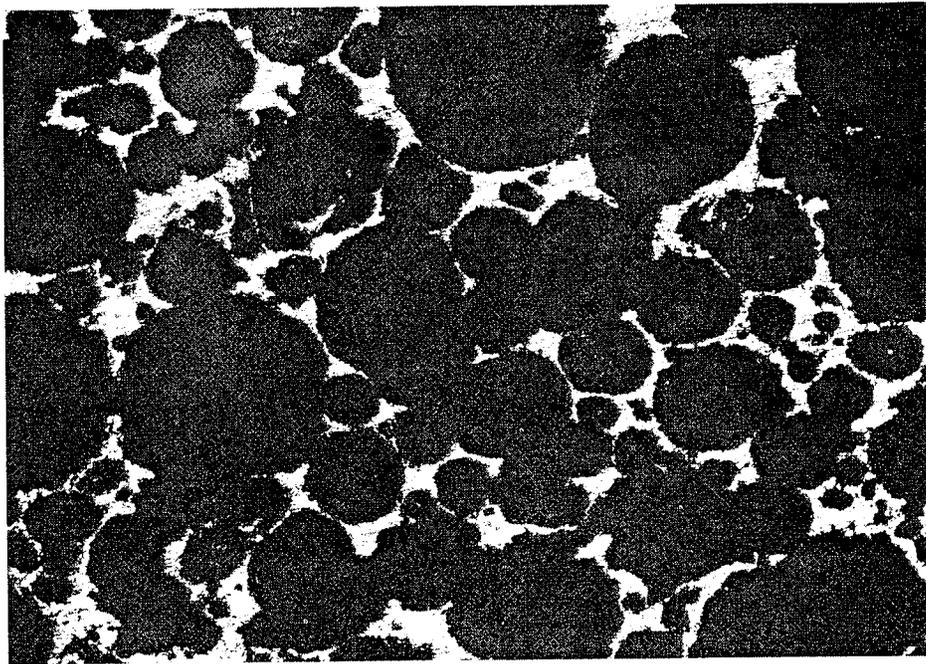
Figure 44. Typical porosity in sample No. 29, from coarse sponge zone.

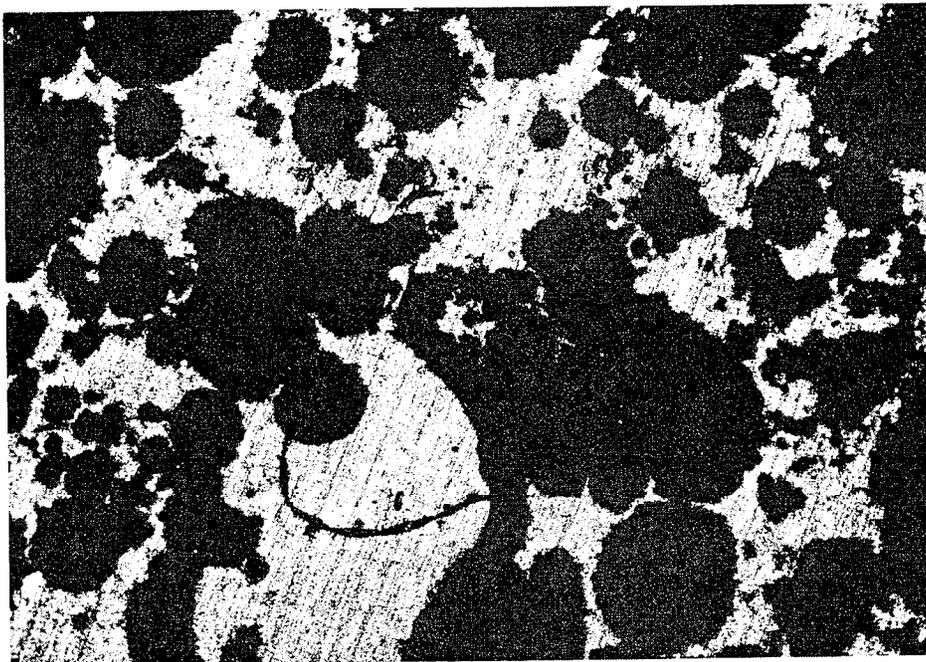
Figure 45. Typical porosity in sample No. 30, from fine sponge zone.

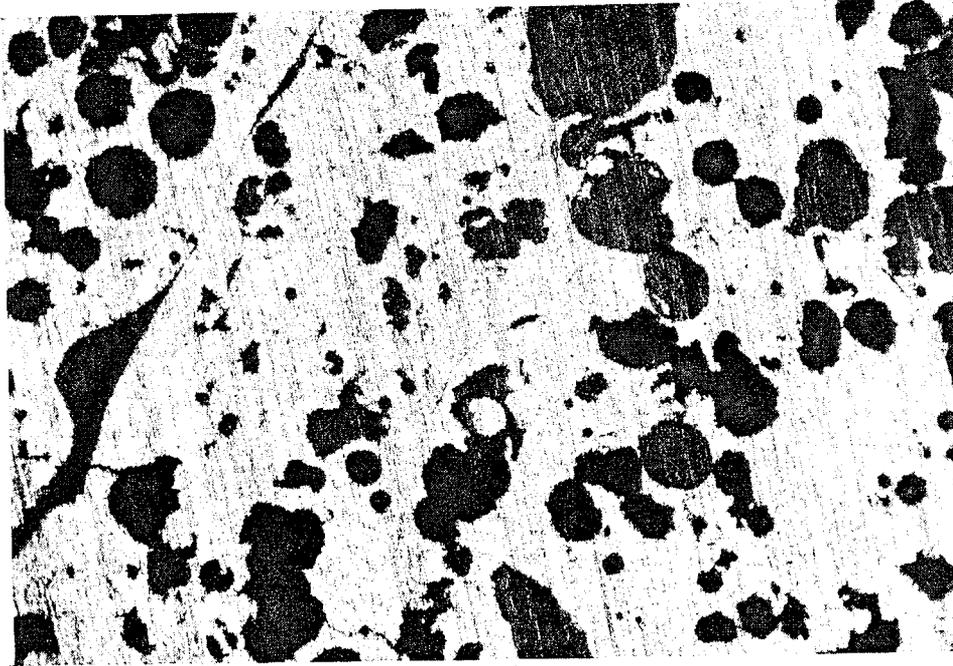
Figure 46. Typical porosity in sample No. 31, from material between blanket rods.

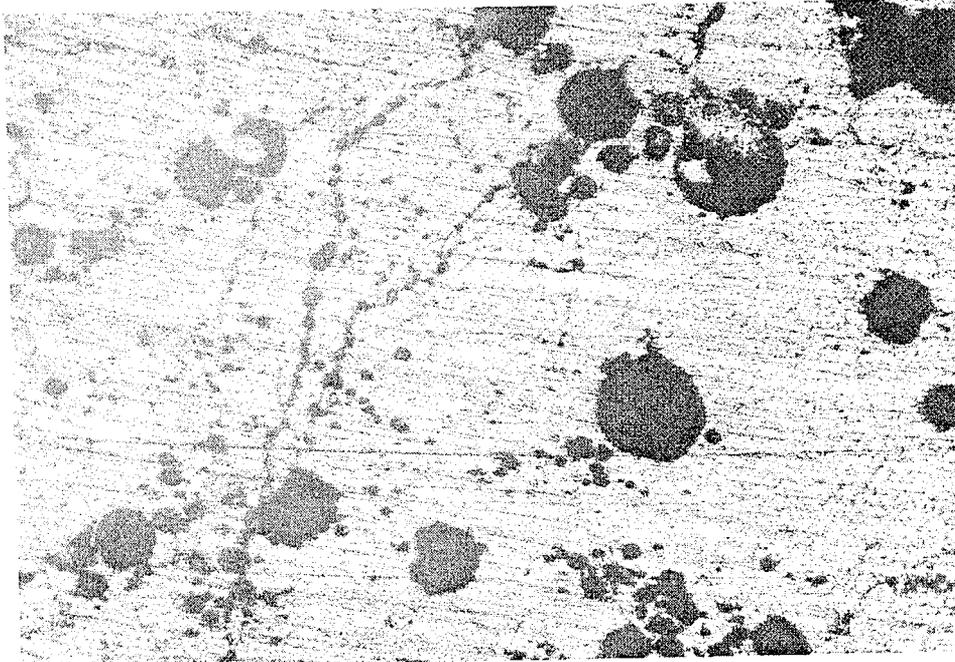
Figure 47. Porosity in material adhering to partially dissolved fuel slug, in sample No. 32.

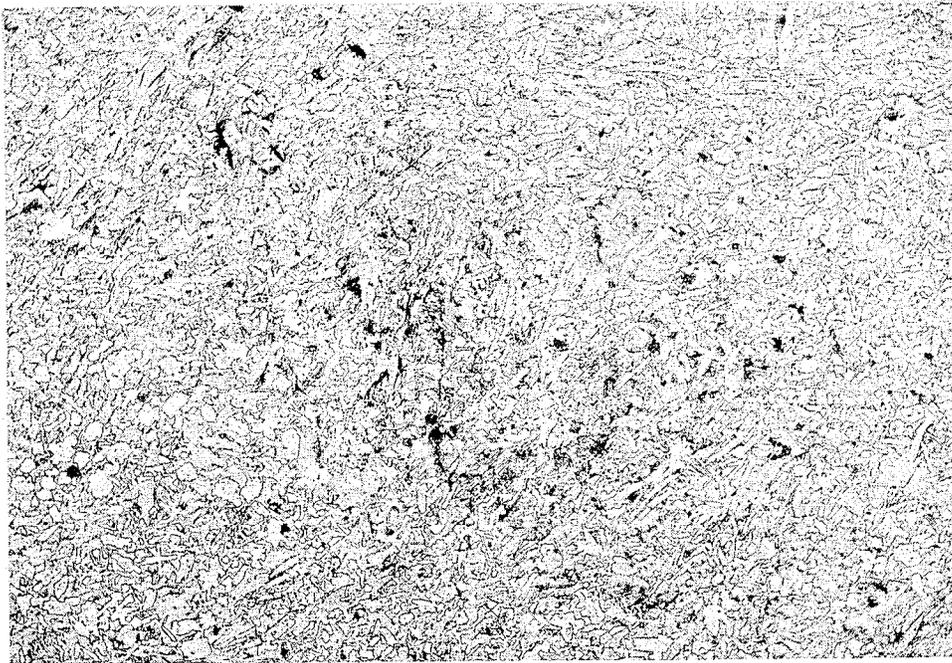
Figure 48. Typical porosity in sample No. 33, from high-density zone.

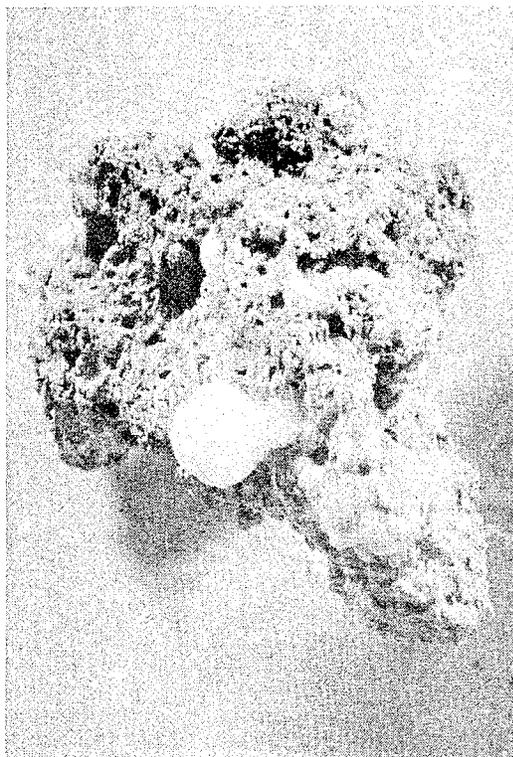
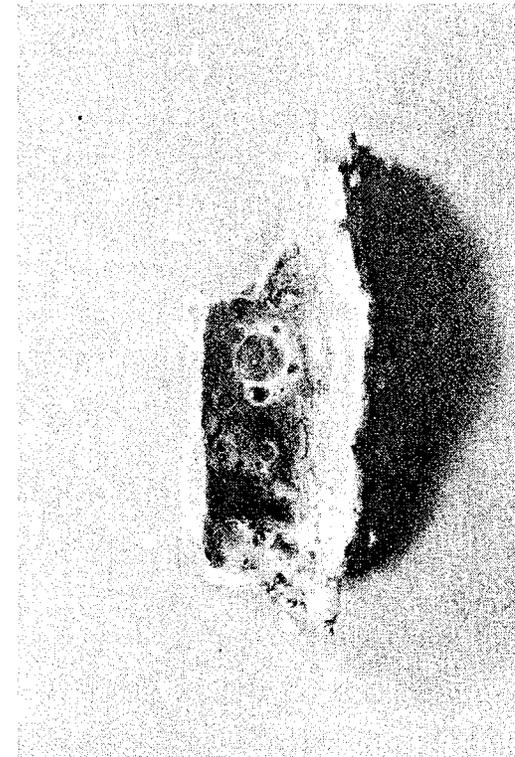
Figure 49. Exudation of NaK oxide and resulting deliquescence in porous samples removed from damaged core. From left to right, the samples are from the coarse sponge zone, the fine sponge zone, and material solidified between lower blanket rods.
