FINAL REPORT
OF
ACCIDENTAL NUCLEAR EXCURSION
RECUPLEX OPERATION
234-5 FACILITY

DATE OF INCIDENT: APRIL 7, 1962

HW-74723

August 1962

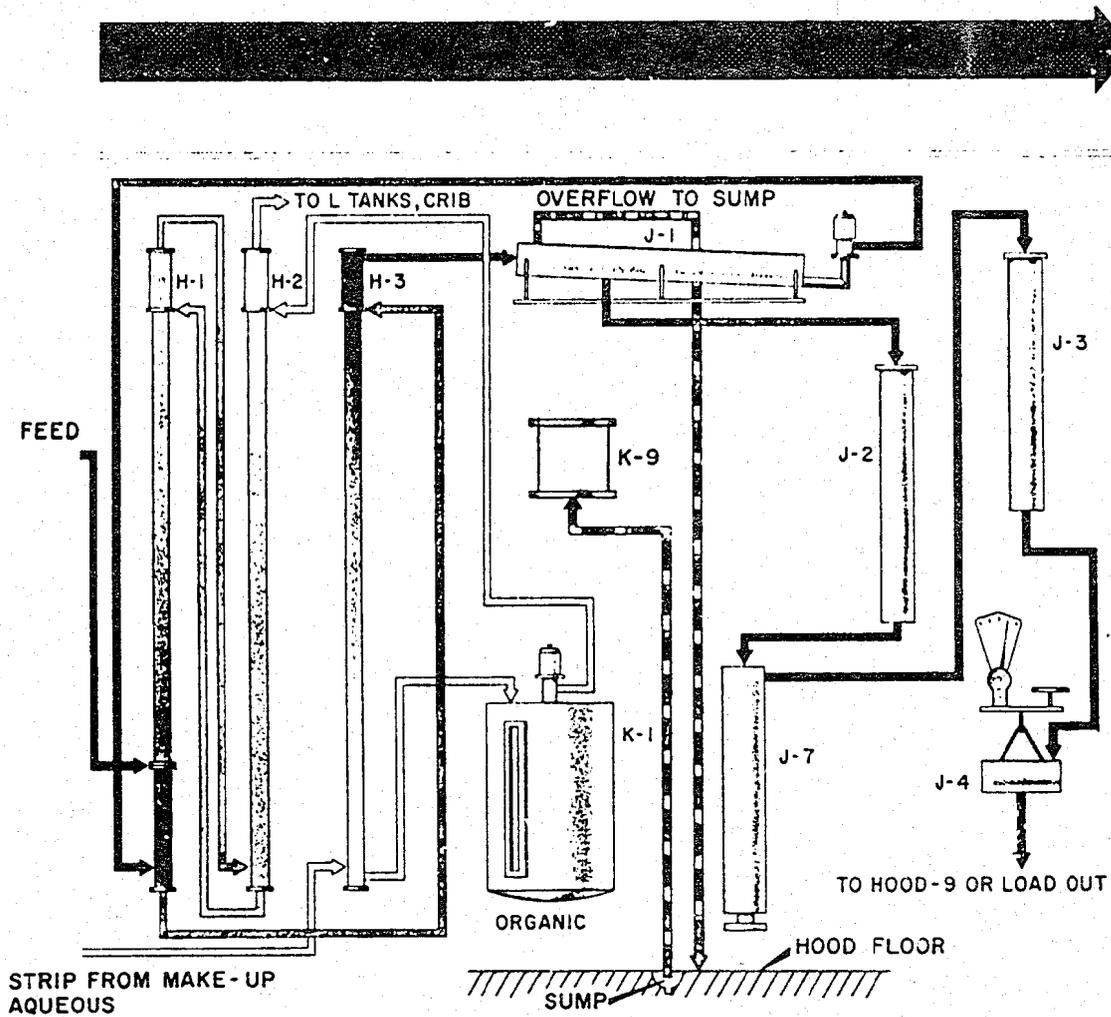
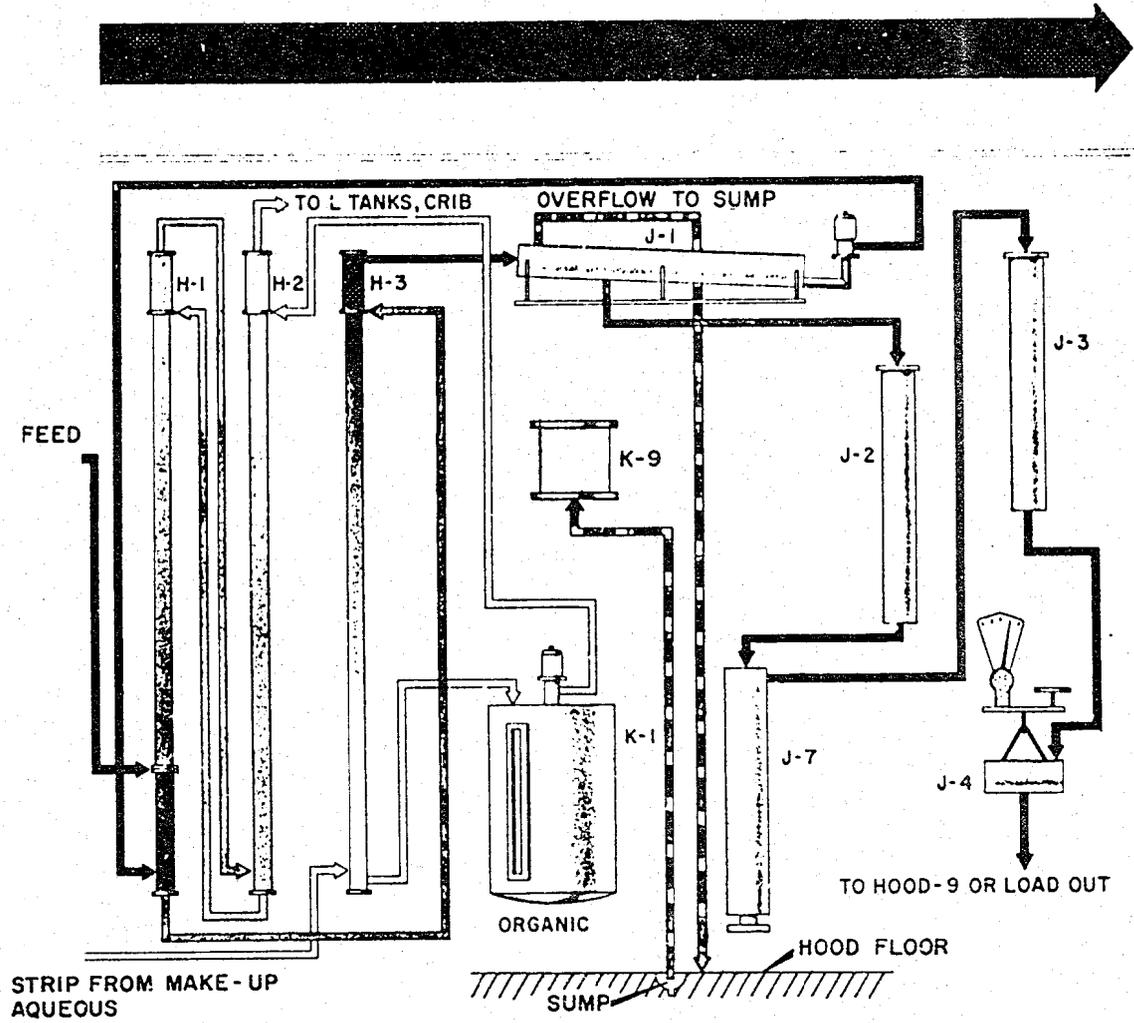
FIGURE IV-5
Pictorial Flow Diagram of SE Process

Fig. IV-5 is a pictorial flow diagram of the SE process. This figure concerns itself mainly with the route by which product solution entered the K-9 tank, viz., from the J-1 tank via the J-1 overflow to the sump, and from the sump via the 1" temporary plastic line to the K-9 tank.

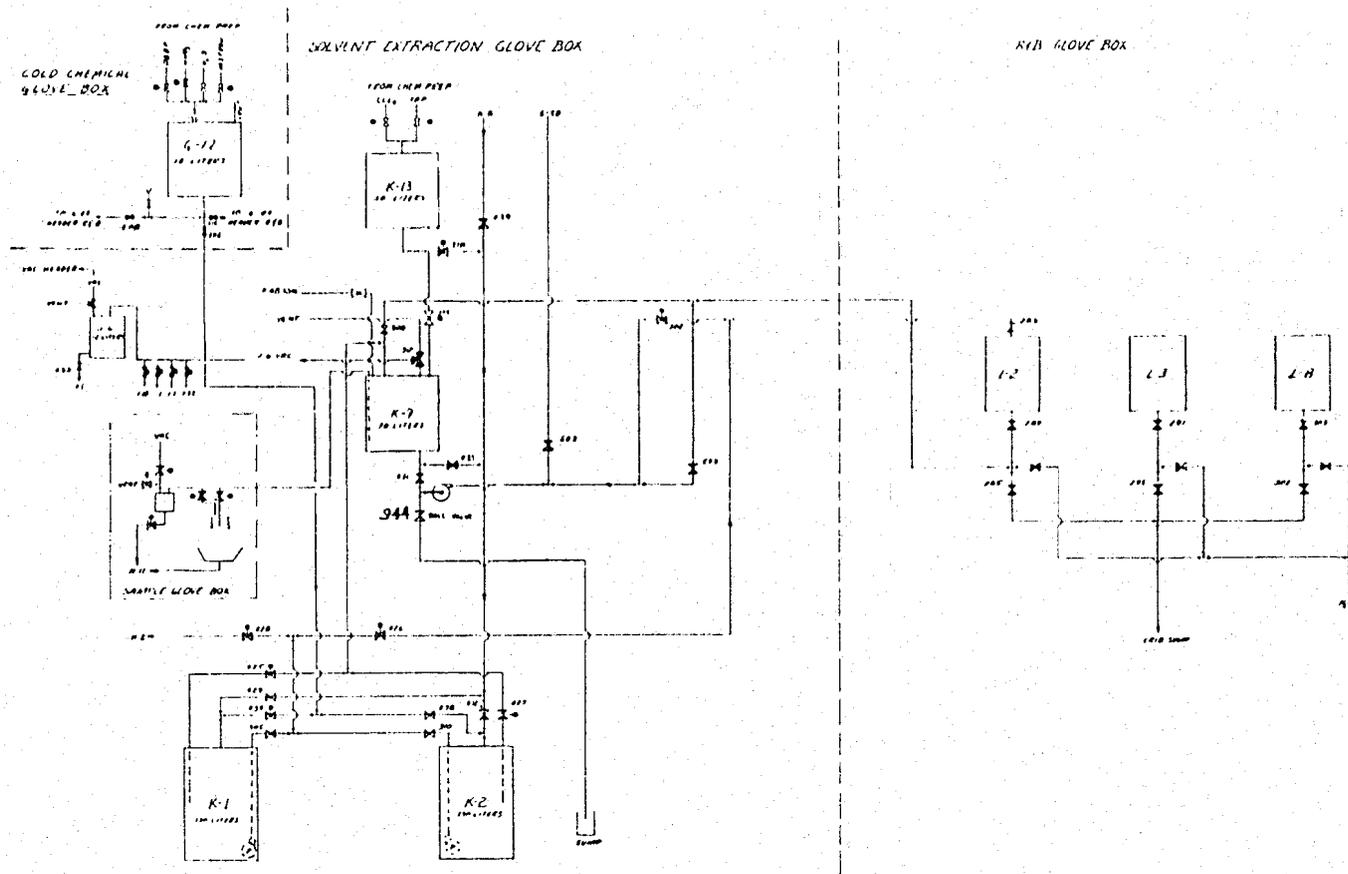
FIGURE VI-1
Solvent Extraction Partial Flow Diagram

The 8-4 shift continued the transfer of contact organic from L-2 through K-9 to K-2 by opening valve 506, which is the normal route from L-2 to K-9. The operator who continued these transfers (Employee No. 1) does not remember closing the 543 and 431 valves (found open subsequently) which were used on the previous shift and were reportedly left open by the 12-8 shift operator, which allowed the material to be moved into K-9 from L-2 by two routes simultaneously. This transfer continued intermittently during the morning of April 7, 1962 until a total of 3 or 4 batches of approximately 50-55 liters each had been transferred into K-2 tank. (Operator recollection is hazy as to whether 3 or 4 batches were transferred.) The intermittent operation occurred due to interruptions caused by a flooding condition in the solvent extraction columns which required the operator's attention.

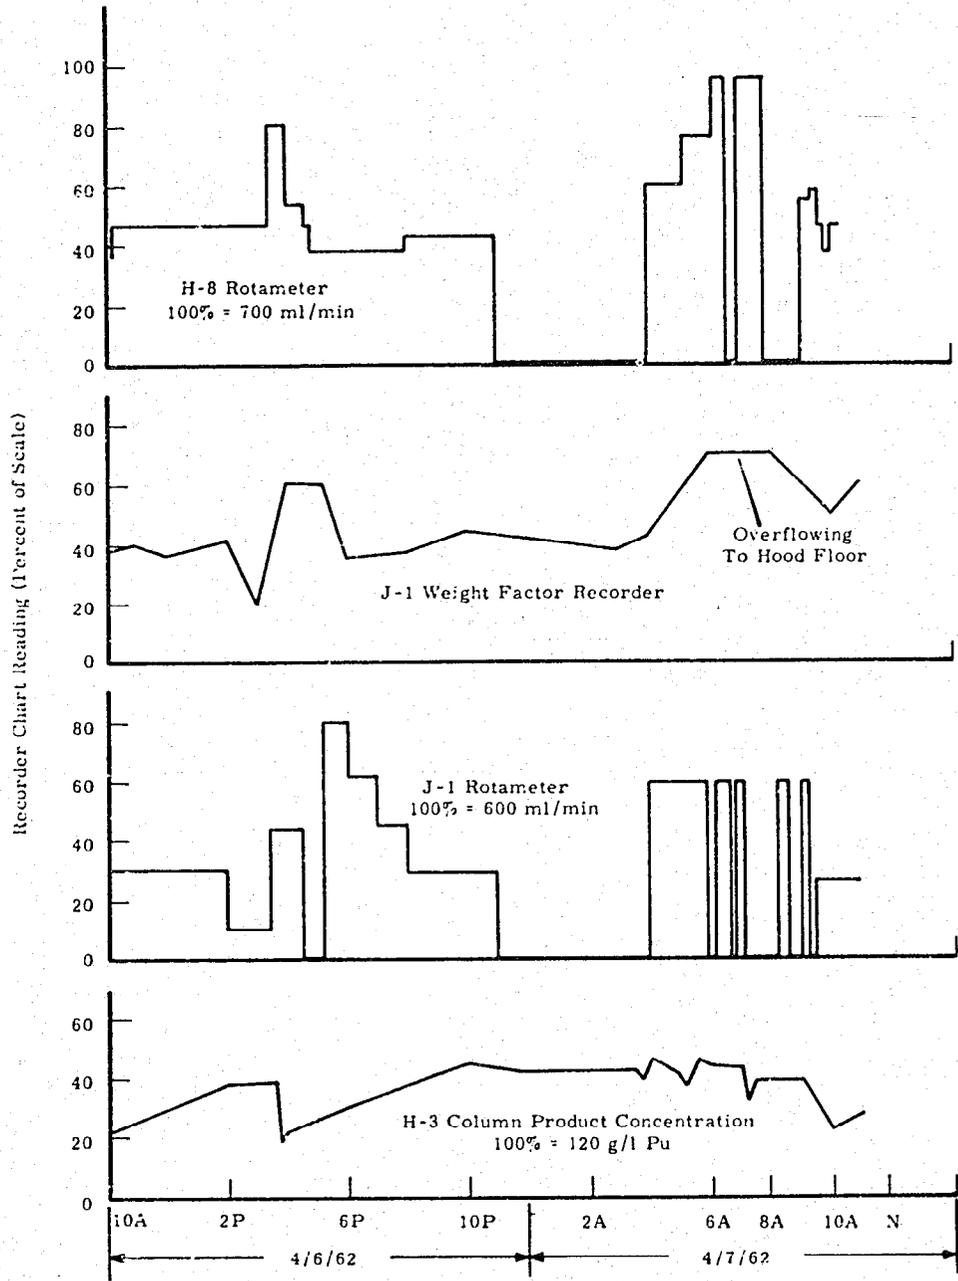
FIGURE VIII-1

The evidence for this statement is summarized on Fig. VIII-1, which is a record of inflow to J-1, outflow from J-1, and weight factor (i.e., depth x density) in J-1. This figure is drawn from charts taken from recorders after the accident. The traces on the original charts were not as sharp as these drawings might imply, because of instrument noise and sticking of the tracing stylus in places. However, the uncertainties thus introduced are not enough to invalidate the conclusion above-stated. It will be observed that for considerable periods between 0600 and 0800, the weight factor indicated J-1 to be full while input was occurring at rates greater than output. During these periods, J-1 must have been overflowing.

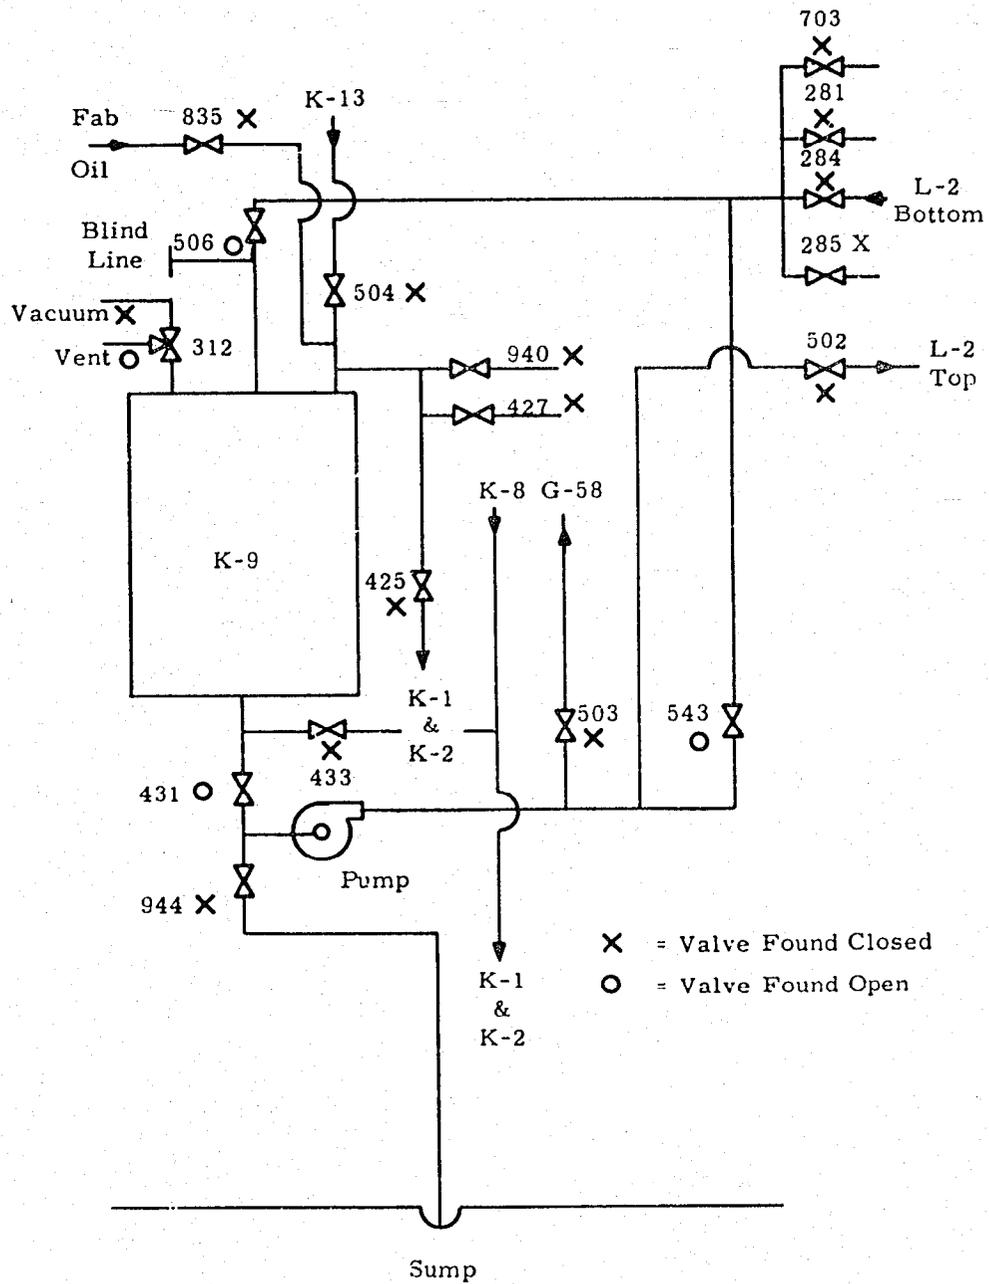
FIGURE VIII-2
 K-9 Piping and Post-Accident Valve Status

4. The process vacuum (line vacuum possibly as high as 26" mercury) was apparently on the K-9 tank at the time of the incident.
5. The temporary plastic line from the bottom of K-9 tank was in place with one end lying in the bottom of the sump. The temporary ball valve installed in this line was found to be in the closed position and the permanent valve (431) in the line to the bottom of K-9 tank, to which this line is attached, was found open.

6. The valve (433) between K-9 and the chemical addition line from K-8 to K-2 was found closed.
7. The material which went critical in K-9 vessel was analyzed subsequent to the incident and found to have the following analysis:

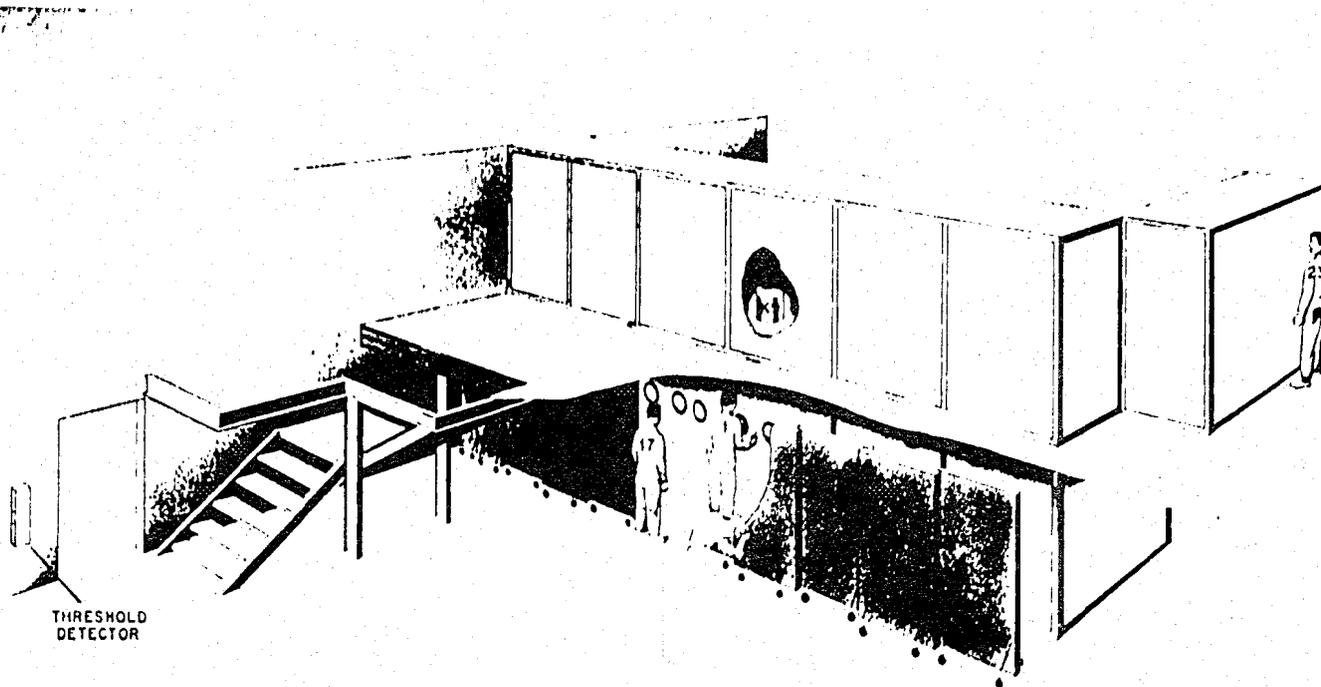
FIGURE 3

Information for the three most highly exposed persons was made as detailed as their recollections would allow. Figure 3 shows where these people were standing at the time they saw the Cerenkov radiation flash. Employee #1 was standing immediately below the critical vessel, the K-9 Tank, manipulating a valve at the face of the hood containing the tank. His body was very close to the hood wall. His eyes were about 5 feet from the center of the K-9 Tank; the parts of the trunk of his body were between 6 and 8 feet away. Employee #17 was standing about 2 feet to the side and about 5 feet behind Employee #1. There was a movable lead shield behind #1, but #17 was in full view of #1 and of the K-9 Tank. #17's eyes were about 10 feet from the center of K-9 and the trunk of his body was 10 to 11 feet away. The K-9 Tank is cylindrical with a capacity of 69 liters; it contained about 45 liters when the excursion occurred. The tank has a Pyrex wall about $3/8$ inch thick and a steel bottom plate about one inch thick. #1 and #17 were exposed to radiations coming through both the wall and the bottom. The only other materials between them and the tank were the half inch thick lucite hood walls and some plumbing inside the hood. Employee #23 was standing in front of another hood about 26 feet from the center of K-9. Most of the radiation reaching him probably came through the sides of the tank. The only materials between him and K-9 were the lucite walls of

A threshold detector²⁾ was located about 26 feet from the critical vessel. Its position is shown in Figure 3. At least one of the steel beams of the stairway shown in the figure was on the line-of-sight between the
