## ICPP Criticality Event of October 17, 1978

By Nuclear Safety Staff

## IDAHO CHEMICAL PROCESSING PLANT

October 17, 1978

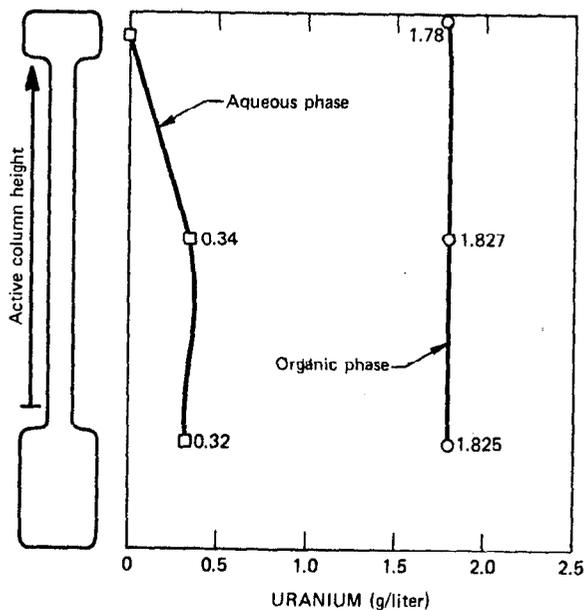
Figure 2 shows that a small increase in uranium concentration exists in both the aqueous and organic phases at about the midpoint of the column during normal operation. The increase is due to internal circulation (reflux) of uranium between the two phases. This occurs frequently in solvent extraction columns and is an accepted and sometimes desirable phenomenon.

Fig. 2 Uranium concentration profiles in column H-100 under normal operating conditions.

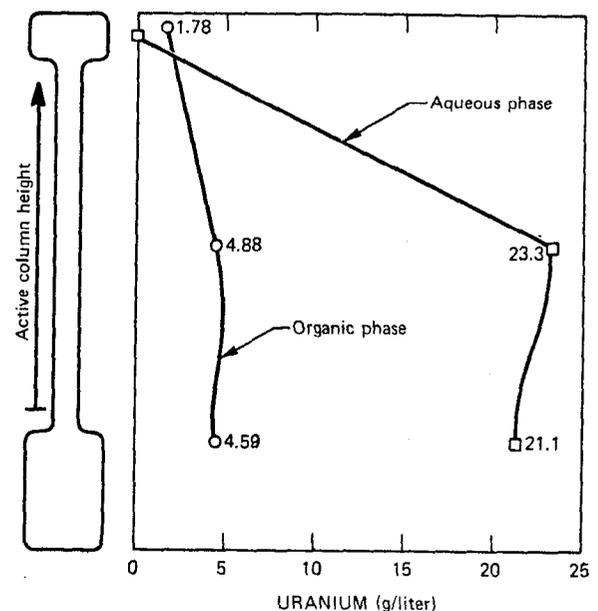
Under abnormal conditions (Fig. 3), the uranium concentrations associated with this internal recirculation are quite high, representing a substantial mass of uranium at relatively high concentration literally suspended in the small-diameter (203.2-mm) section of the column. We believe that at 8:40 p.m. on October 17 the solution in the base of H-100 had been in a delayed critical condition at ~22.2 g of uranium (82)\* per liter (at 20°C). The power production rate can be expected as  $21 \exp(1.67 t)$  kW, with  $t$  in hours.

Fig. 3 Uranium concentration profiles in column H-100 with low scrub solution concentration.

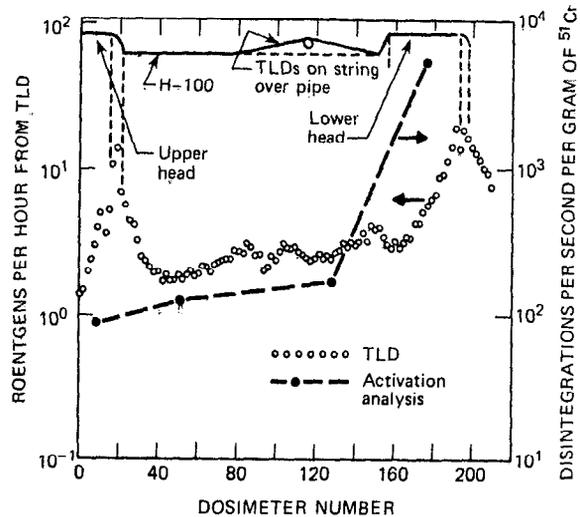
Fig. 4 Thermoluminescent dosimeter (TLD) measurements of radioactivity of washed  $^{51}\text{Cr}$  filings from various elevations in column H-100.

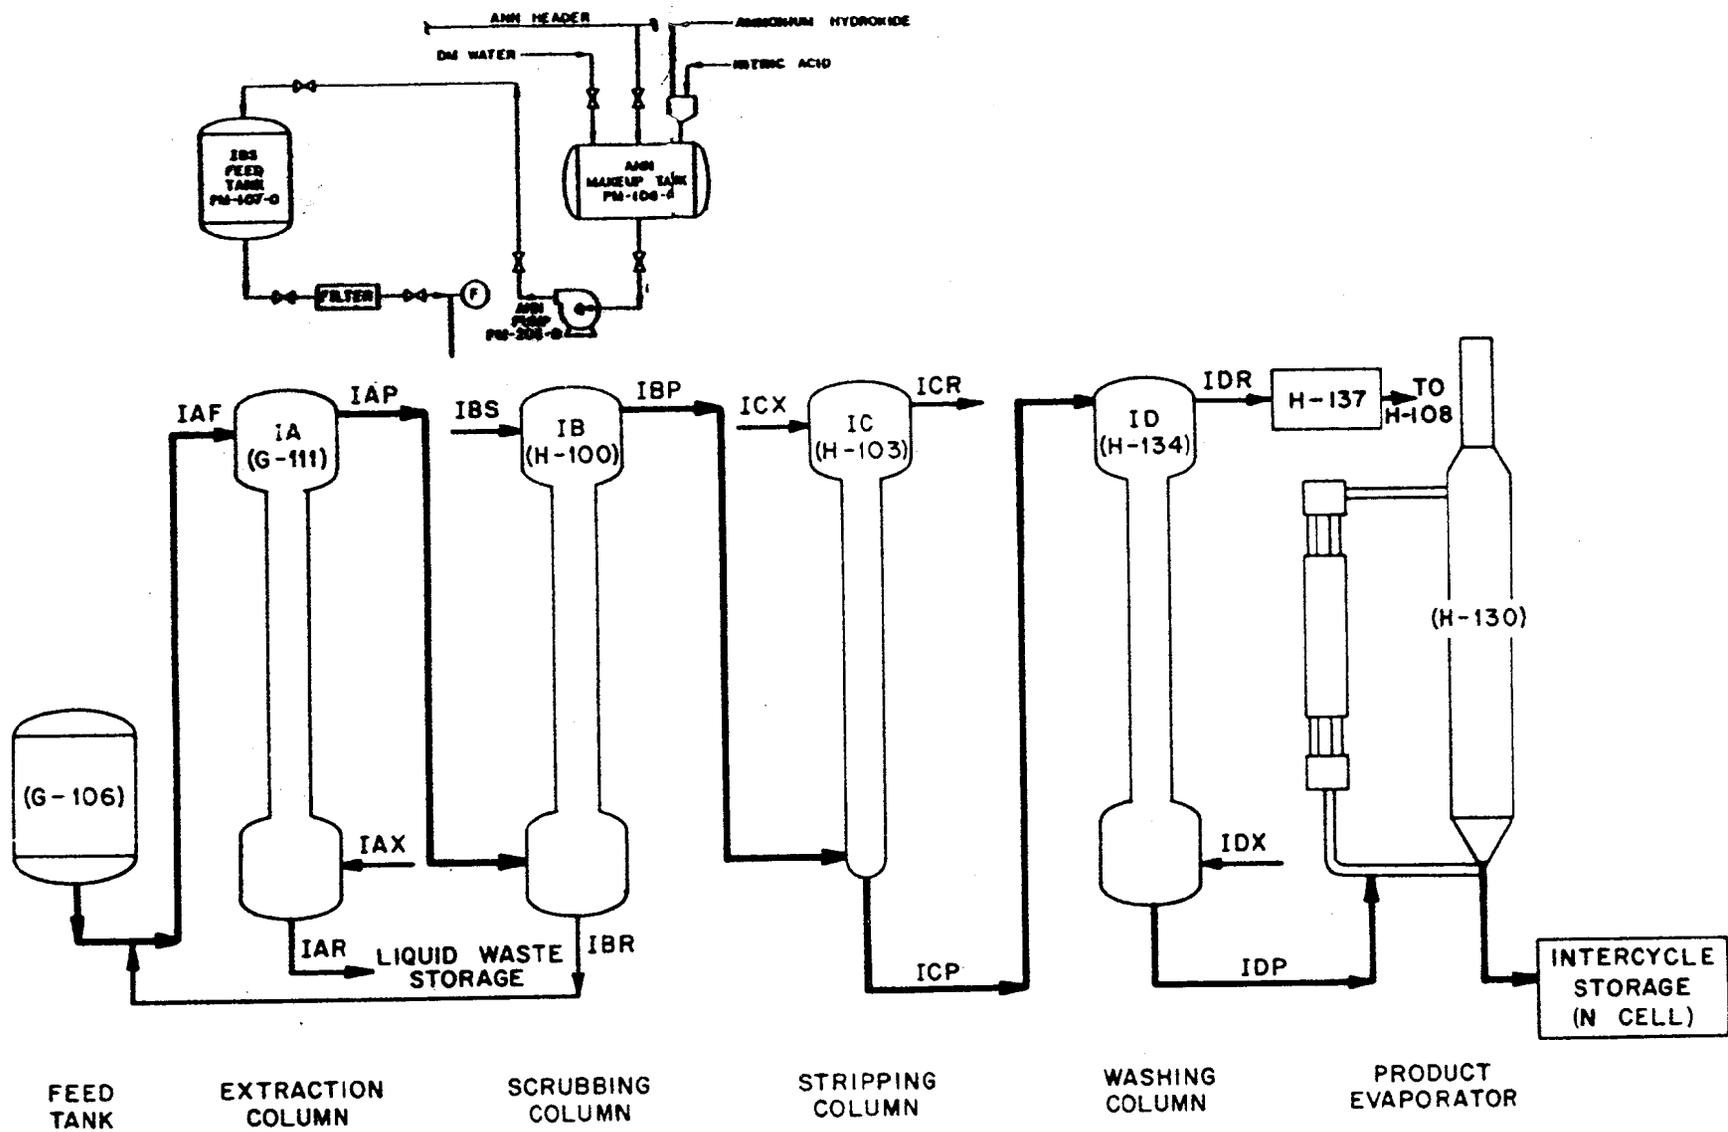
Fig. 1 Simplified flowsheet for first-cycle extraction.

The out-of-specification aqueous feed to the scrubber column caused it to operate as a stripper rather than as a scrubber. <sup>Some?</sup> Much of the enriched uranium was removed from the 1B organic and recycled into the input of 1A. This partially closed loop resulted in a steady increase in the uranium inventory in these two columns.

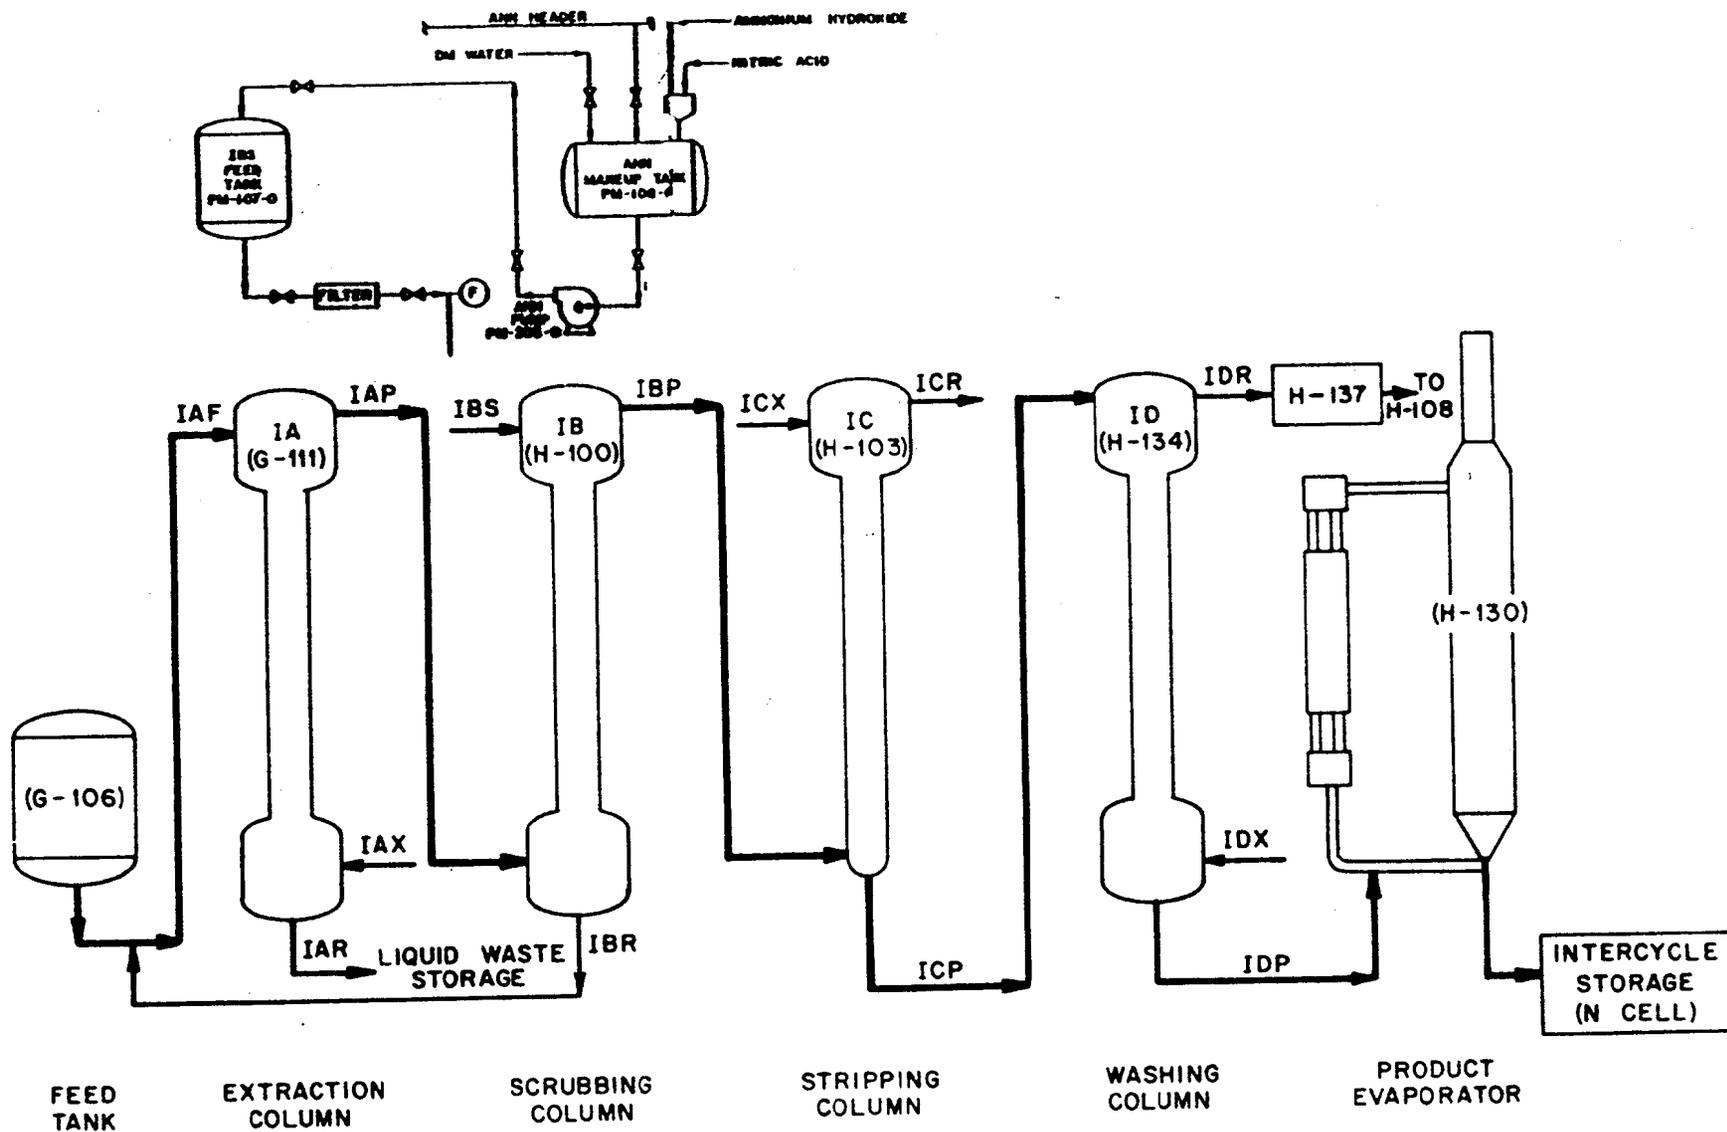
Fig. 1 Simplified flowsheet for first-cycle extraction.

The out-of-specification aqueous feed to the scrubber column caused it to operate as a stripper rather than as a scrubber. Much of the enriched uranium was removed from the 1B organic and recycled into the input of 1A. This partially closed loop resulted in a steady increase in the uranium inventory in these two columns.
