# Los Alamos Criticality Accident, December 30, 1958

By HUGH C. PAXTON, R. D. BAKER, W. J. MARAMAN, and ROY REIDER  
 Los Alamos Scientific Laboratory, Los Alamos, New Mexico

### LOS ALAMOS SCIENTIFIC LABORATORY CRITICALITY ACCIDENT

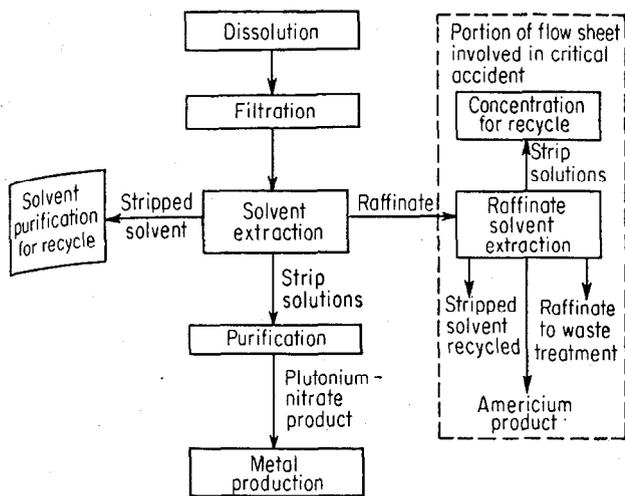
FIG. 1. FLOW SHEET for plant in which accidental criticality occurred. Portion involved is at right

At the time of the accident a physical inventory was in progress in the TBP-solvent-extraction plant. The normal inflow to this area was interrupted, and residual materials in all process vessels were to be evaluated for plutonium content. This requires filtration of solutions supplemented by thorough cleaning of vessels and analyses of clarified solutions and removed solids.

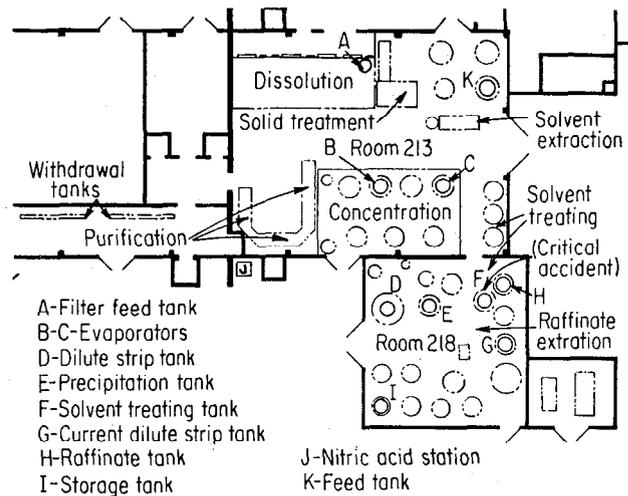
FIG. 2. PLANT LAYOUT shows relation of different processing areas and tanks set to receive near-critical liquids

Immediately after the incident, a bank of ten 6- and 5-in.-diameter withdrawal cylinders was fabricated and set up about 100 feet from the point of the accident (Figs. 2 and 6). This storage array was connected to a transfer line that leads from the bottom outlet of the solvent-treating tank.

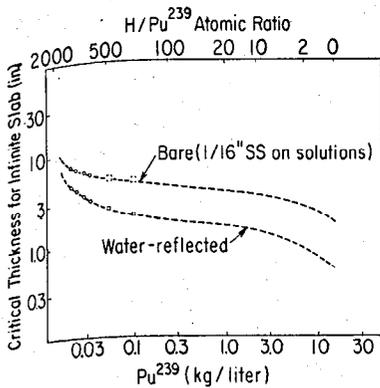
The resulting situation in the 225-gal, 38-in.-diameter, solvent-treating tank immediately before the accident is now believed to be as illustrated in Fig. 4: 87.4 gal of aqueous solution contained 40 gm of plutonium, and on top, a 42.2-gal layer of solvent contained 3.27 kg of plutonium. Solids (containing 60 gm of plutonium) were suspended in both the aqueous and organic phases and at the interface; few solids settled to the bottom of the tank. Estimates based on Fig. 5, taking into account the tank diameter and effects of neutron poisons, indicate that the 8-in.-thick solvent layer was barely subcritical at the plutonium concentration of 20 gm/liter (the estimated critical thickness is 8 1/4 inches, and the actual configuration was roughly 5 dollars subcritical).

FIG. 5. CRITICAL THICKNESSES of infinite slabs can be used to estimate amount by which tank was subcritical before stirring

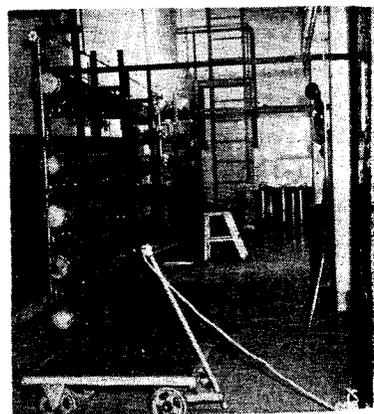
As the disposition of plutonium in the tank was then unknown, opening of the bottom outlet valve was a suspect operation, and therefore it was accomplished from behind a temporary shield with a 10-ft extension handle. The solution was vacuum-transferred into the bank of cylinders without complication on January 1. The solution level within the cylinders was followed by gamma-sensing instruments (maximum reading at contact was about 1 r/hr, and indications along the wall of the solvent-treating tank immediately after emptying were less than 50 mr/hr).

FIG. 6. TEN WITHDRAWAL TANKS established safe geometry for vacuum removal of solutions after accident occurred

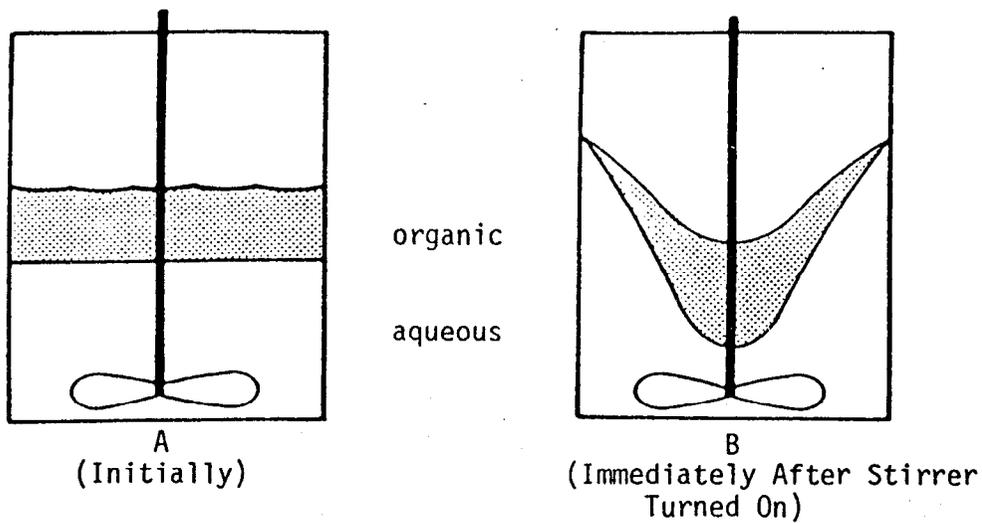
After transfer, the organic and aqueous phases separated resulting in the extraction of 3.27 kg of plutonium in the organic phase at a concentration of 20.5 g per liter. The organic phase floated like oil on water on the aqueous phase which contained 60 g of plutonium at a concentration of 0.18 g per liter. The system was subcritical due to the low concentration in the aqueous phase and the slab or disk-like geometry of the organic phase. Only a slight change in the geometry of the organic phase was necessary to cause criticality, and this change occurred when the stirrer in the 850-liter tank was started (see Fig. 1).

Fig. 1. Solutions in the 850-Liter Tank

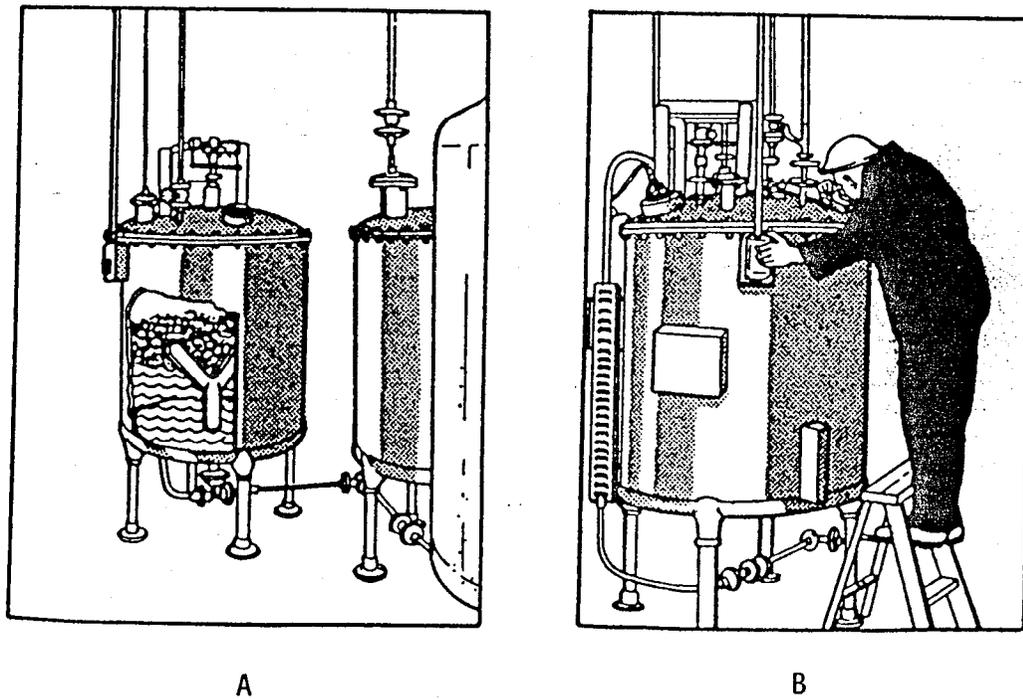
An operator looking into a sight glass on the tank (Fig. 2) was exposed to the radiation from  $1.5 \times 10^{17}$  fissions in the 2 seconds before continued stirrer action mixed the two phases diluting the plutonium to a subcritical concentration. This operator died 35 hours later, and two other operators nearby received significant doses of radiation.

Fig. 2. The plutonium-processing tank (A) cutaway and (B) with the operator in position at the time of the LASL criticality

The plutonium recovery plant had been scheduled to operate for six more months but was retired immediately. A new facility was constructed with equipment geometrically favorable for criticality safety. Large auxiliary vessels were filled with borosilicate glass Raschig ring neutron absorbers, and unnecessary solution transfer lines were blocked. Written procedures and the criticality safety training program were improved. Portable survey instruments were acquired to detect plutonium buildup in the process equipment, and improved gamma-ray-sensing radiation alarms were installed to ensure more complete coverage of process areas.
