TID-5360

**A SUMMARY OF ACCIDENTS AND INCIDENTS  
INVOLVING RADIATION IN ATOMIC ENERGY  
ACTIVITIES, JUNE 1945 THROUGH  
DECEMBER 1955**

By  
Daniel F. Hayes

August 1956

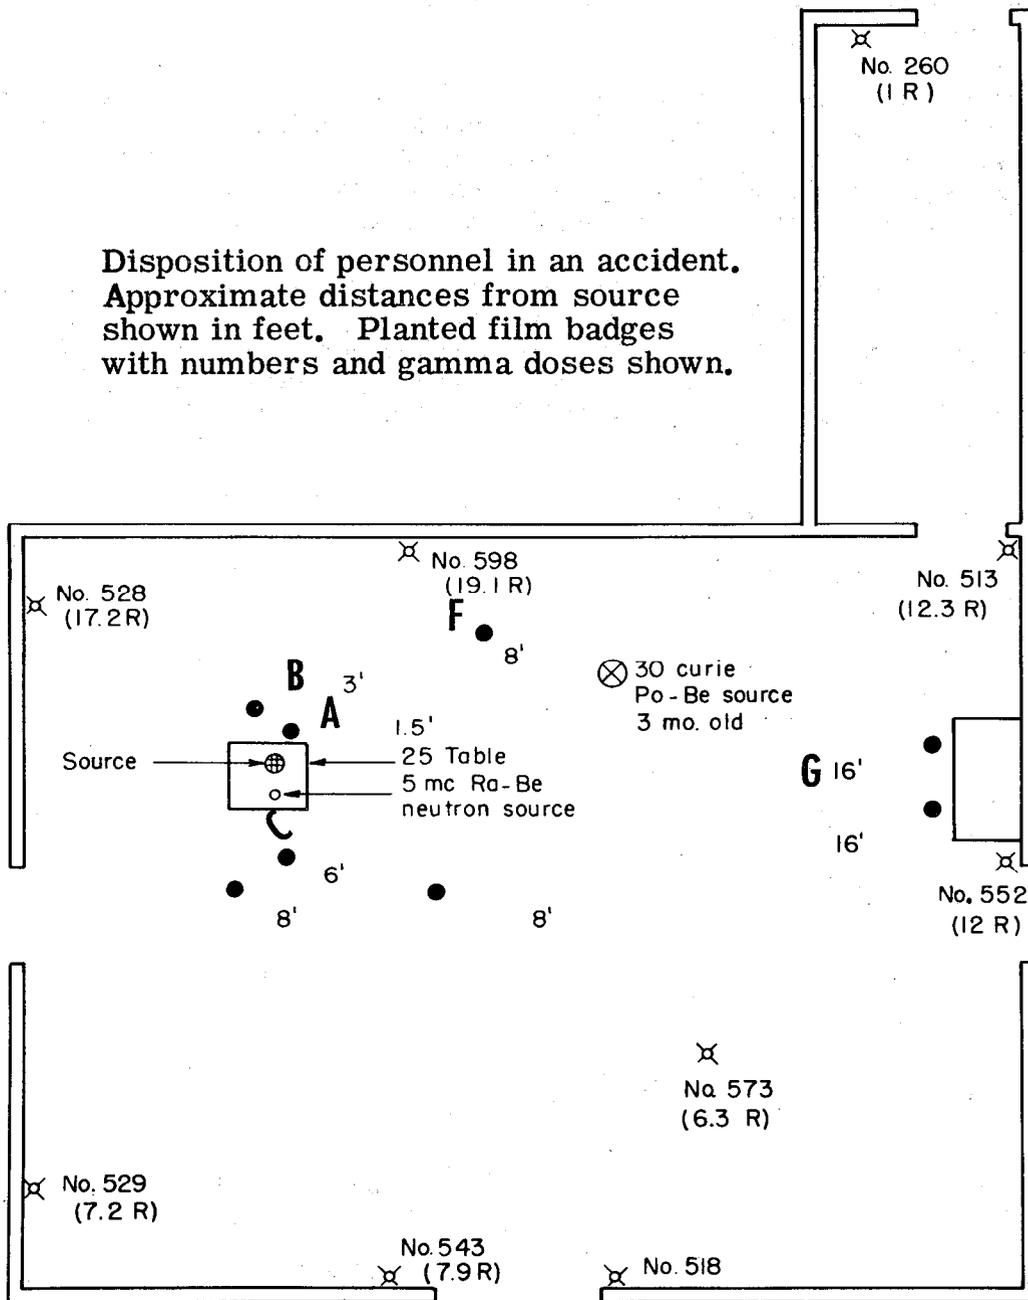
Scientist (A) who was demonstrating the experiment received radiation dosage sufficient to result in injuries from which he died 9 days later. The scientist (B) working with the deceased received radiation dosage sufficient to cause serious injuries and some permanent partial disability.

Disposition of personnel in an accident.  
 Approximate distances from source  
 shown in feet. Planted film badges  
 with numbers and gamma doses shown.

While some work had been done in fabricating mechanical remote controls previous to this incident, as a result of an earlier similar critical assembly accident, such devices had not been fully developed to the point where they were considered sufficiently reliable to perform the task of critical assembly studies.

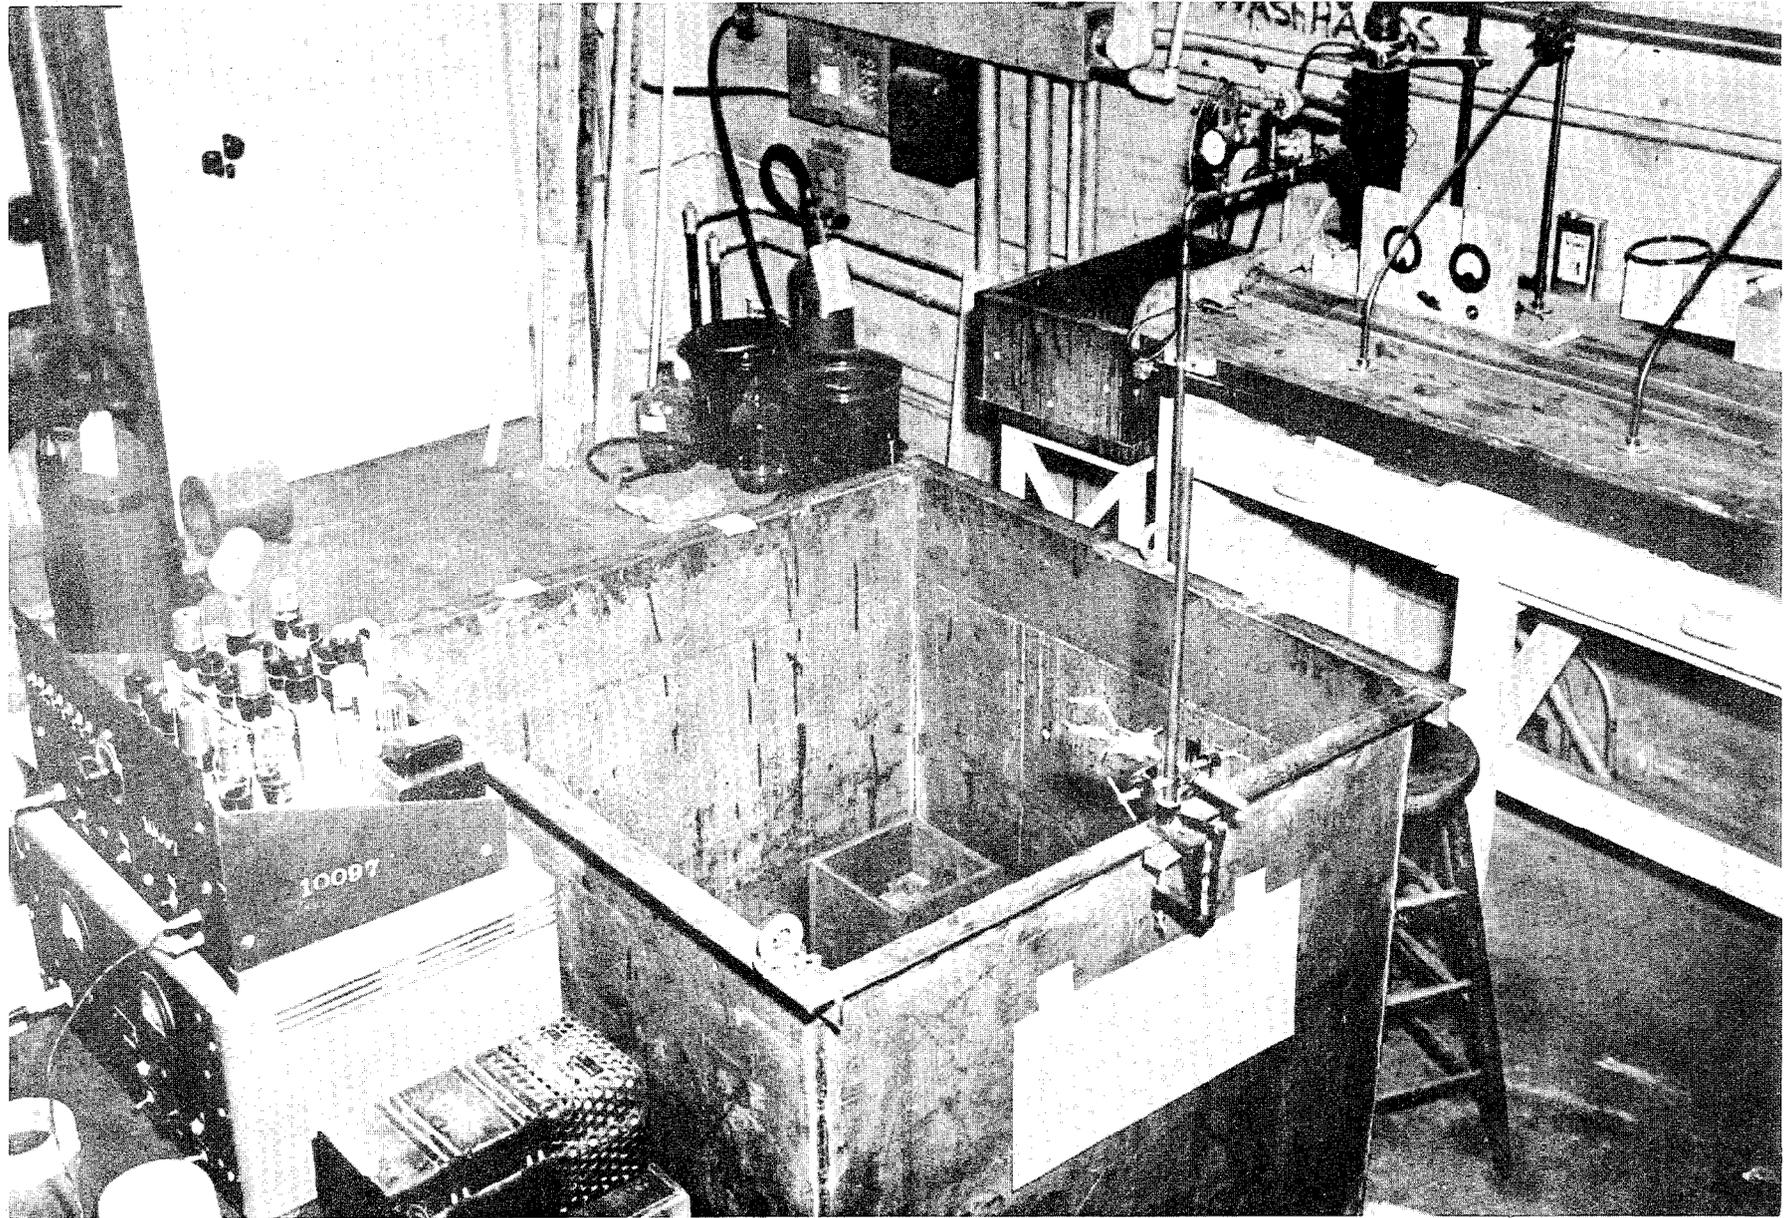
The three individuals involved received excessive radiation exposures, estimated in the case of two as about 66.5 rep, and in the third as 7.4 rep. The doses delivered to the head and neck of these individuals may have been considerably greater. The involved individuals were hospitalized for observation, but no untoward symptoms appeared. No significant changes in blood counts were observed, and sperm counts on one occasion some time after the incident were normal. It is not believed that the individuals concerned received any significant radiation damage. There was no damage to equipment, no loss of active material, and no local contamination problem.

It seems most probable that the unanticipated increase in reactivity

Test equipment for water shielded assembly.

occurred because of water seeping between the blocks of active material and increasing the internal moderation of the assembly. Sufficient heating occurred to melt and deform the plastic bottom of the assembly container, and the water between the blocks must have vaporized, thus stopping the reaction. More water would then seep in and the cycle would repeat. It was estimated that three such cycles occurred before the water level in the tank fell sufficiently low to prevent further reaction.

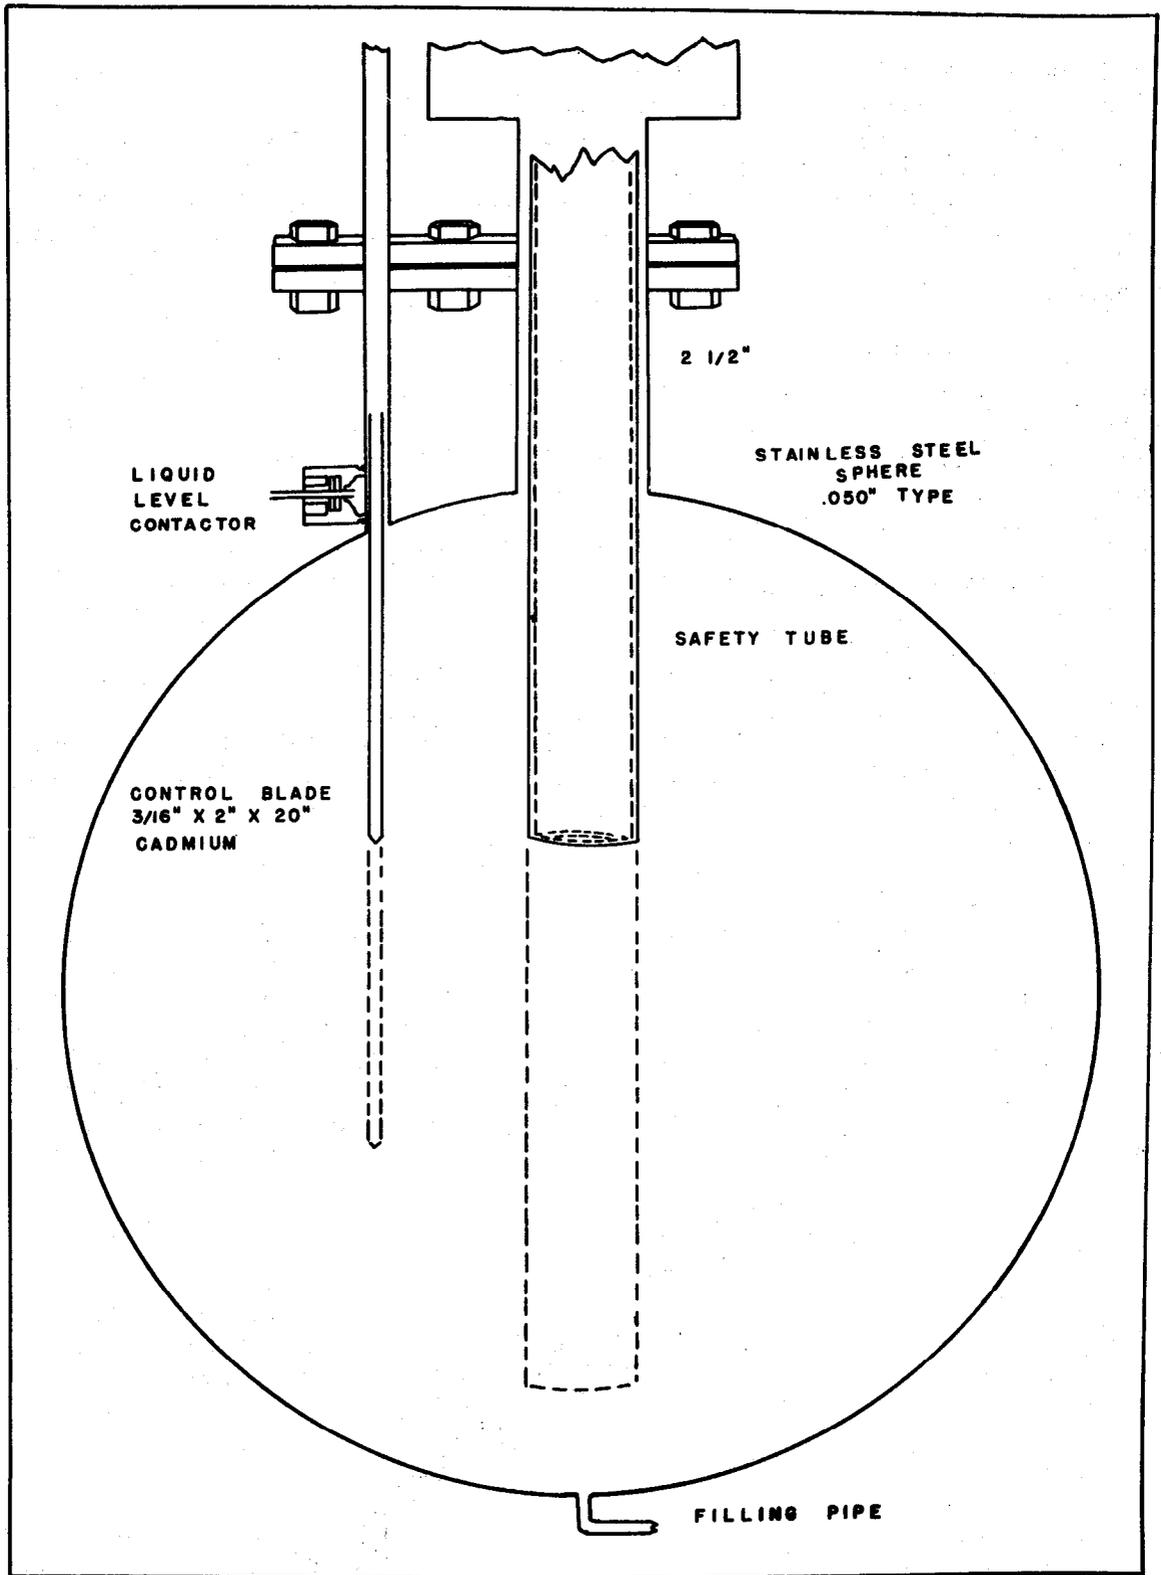
A SCHEMATIC DIAGRAM OF THE REACTOR ASSEMBLY.

(2.3 inches/second). A waiting period for the delayed neutron effect of about 15 seconds was made just prior to the incident. This was too short a time to determine whether or not the assembly was critical. The operators next heard the safety controls actuate, instrument indicators moved off scale, scalars jammed, and the most startling manifestation was that of the breakdown of "counters" playing back through the public address system. The portable "Juno" in the control room was off scale. Presumably, a further rod withdrawal had been made.

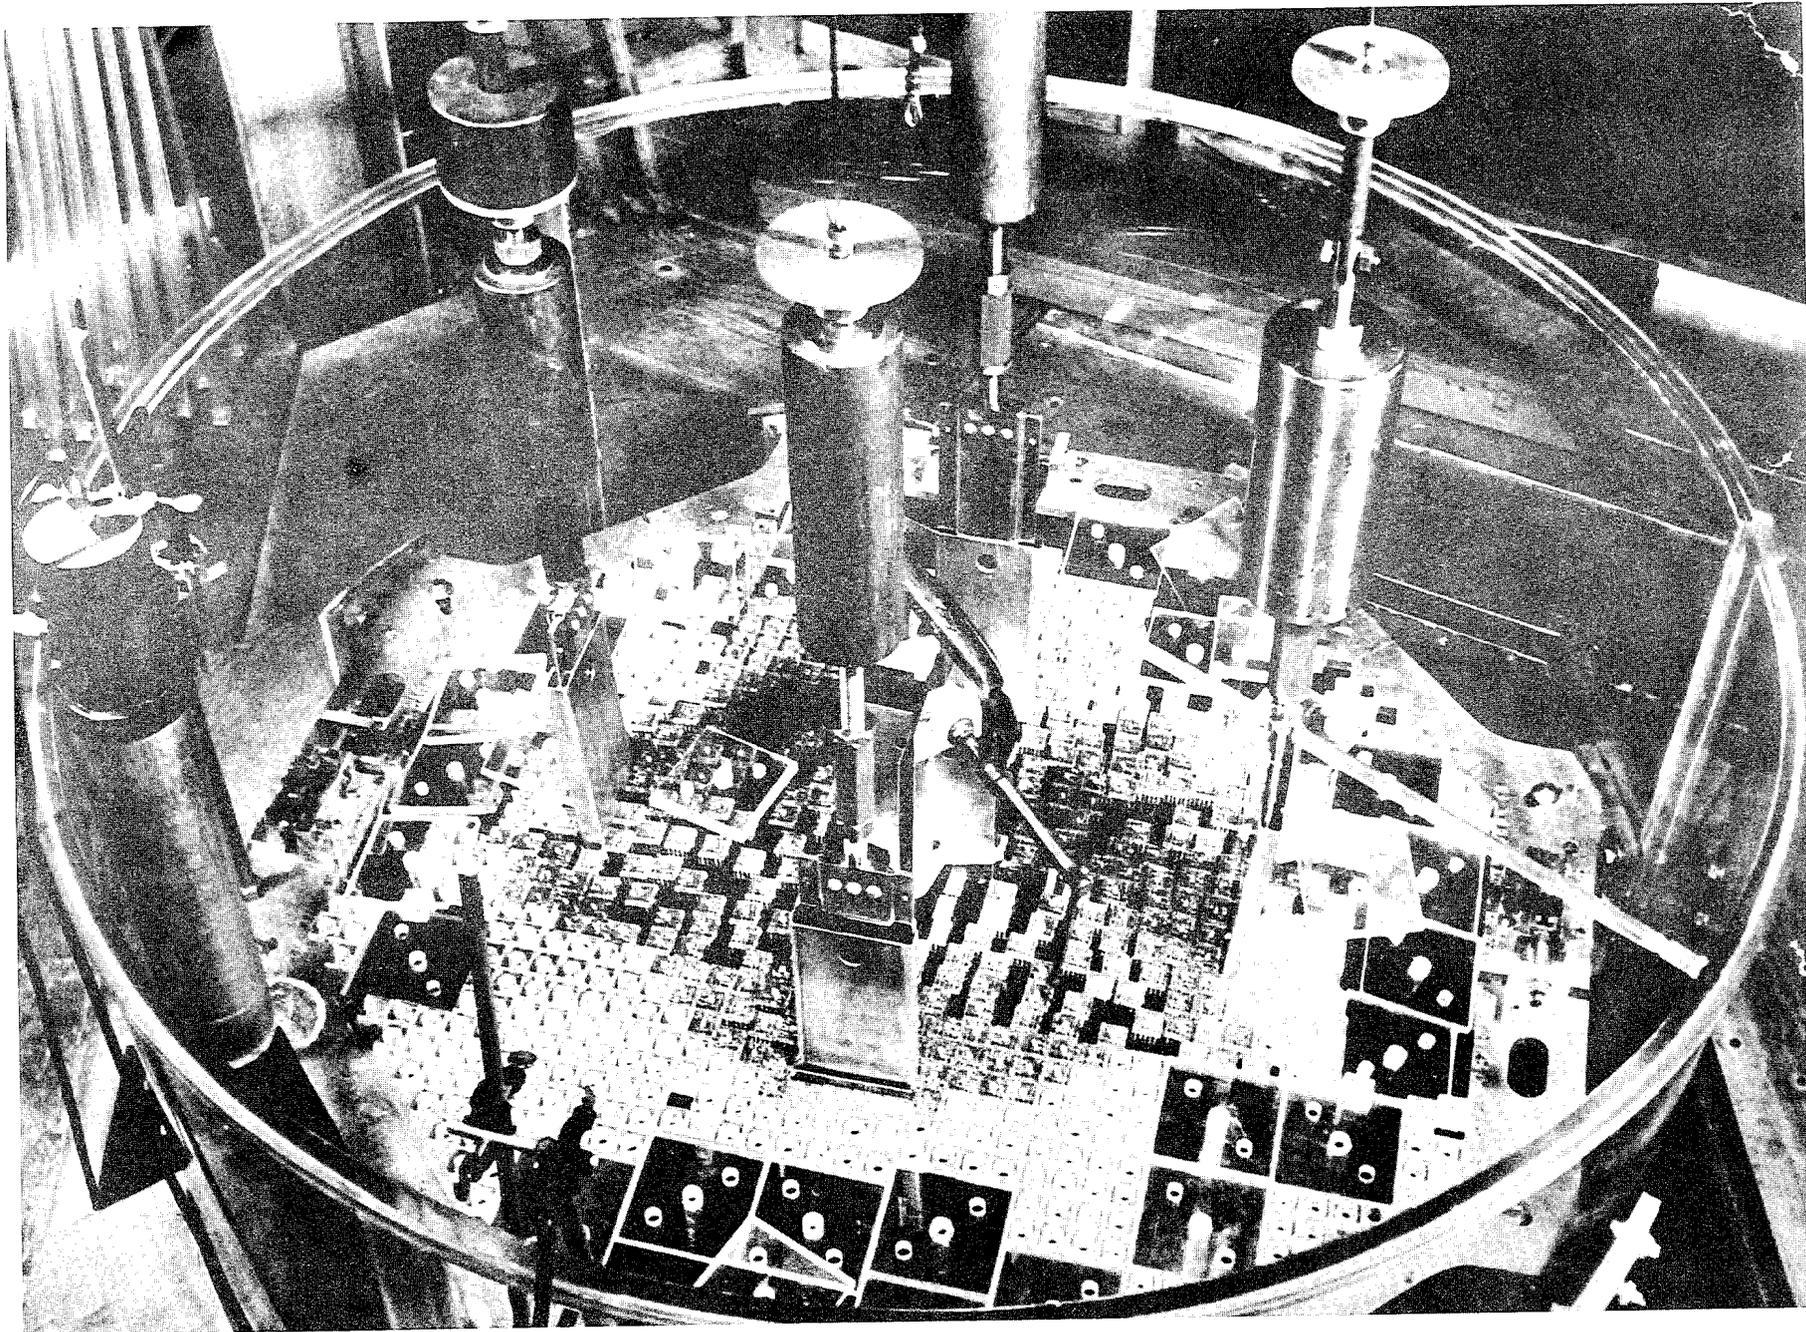
The reactor became super-critical because the test rod being removed by the leader was highly effective in suppressing the chain reaction when fully inserted. But, as it was being removed, a point was reached when the reactor was critical even with the standard type rods fully inserted. In removing this rod, the reactor passed through the critical into the prompt critical stage. This would not have occurred if water had not been in the reactor assembly, since this thermal reactor was dependent upon water to moderate the neutrons from the fast energy level to the thermal energy level and the fission process can only be supported by thermal energy neutrons.

Top view of test reactor.

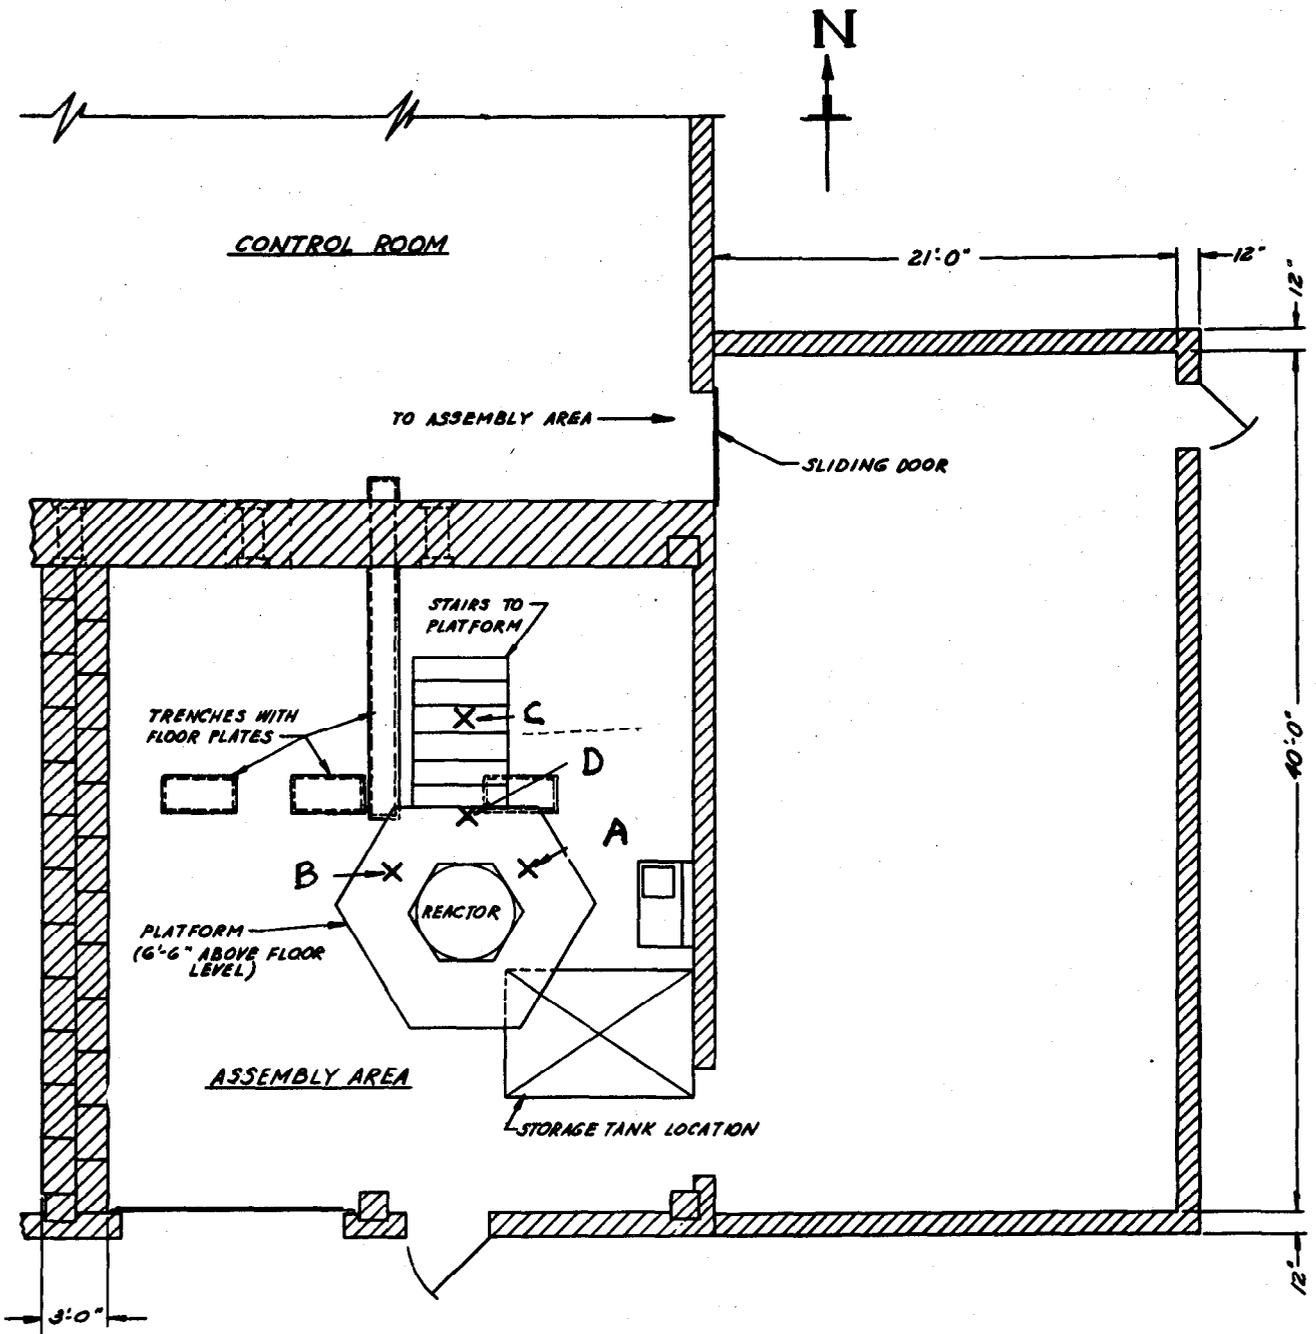
The direct cause of the nuclear reaction comprising the incident was the rapid withdrawal by hand of the control rod being tested from the water-filled assembly. This effected a large increase in reactivity and the reactor achieved super-criticality in a very short time. The following recommendations were made and have been carried out to prevent occurrence of a similar incident:

Layout of reactor showing position of crew at time of the accident.

1. Absolutely prevent access to assembly room when there is water in the reactor.
2. Prepare and keep up to date an operating manual which would include not only standard operating procedures but operating restrictions imposed by nuclear safety considerations.

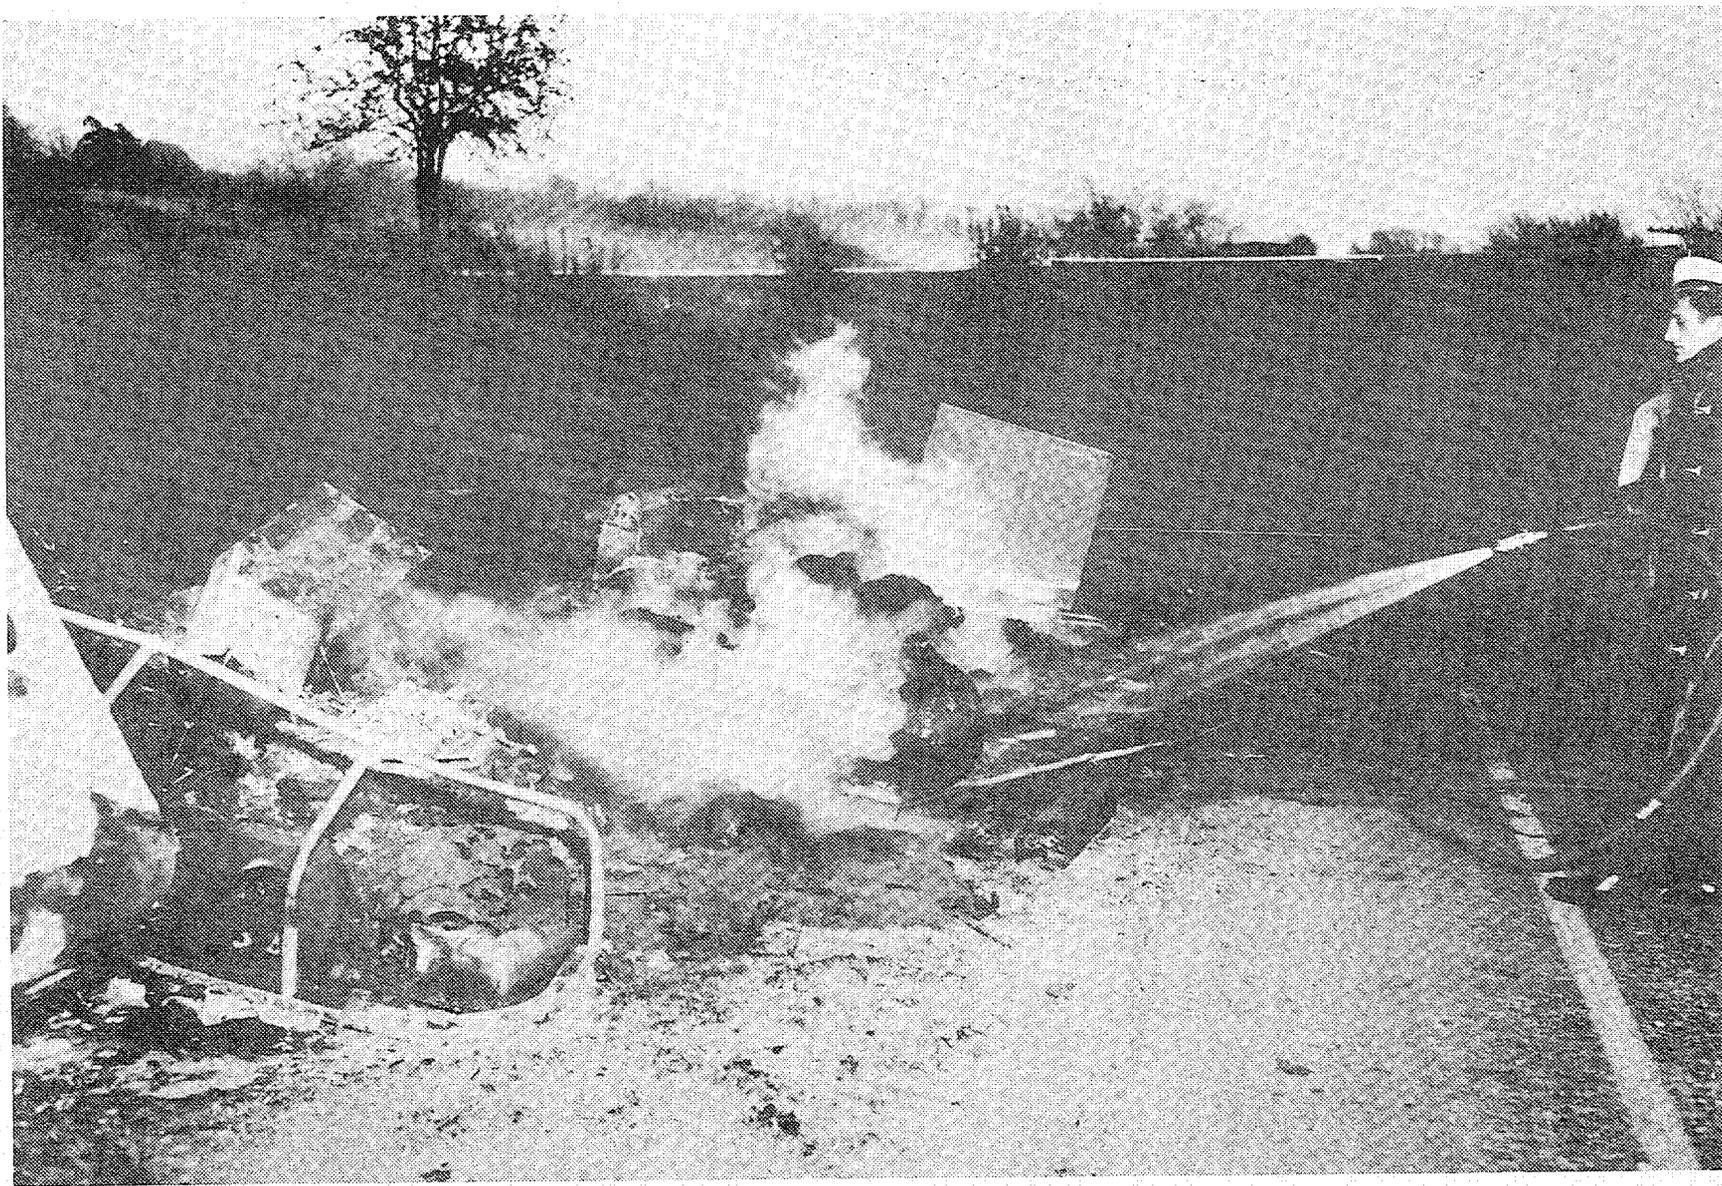
Final extinguishment of uranium truck fire.

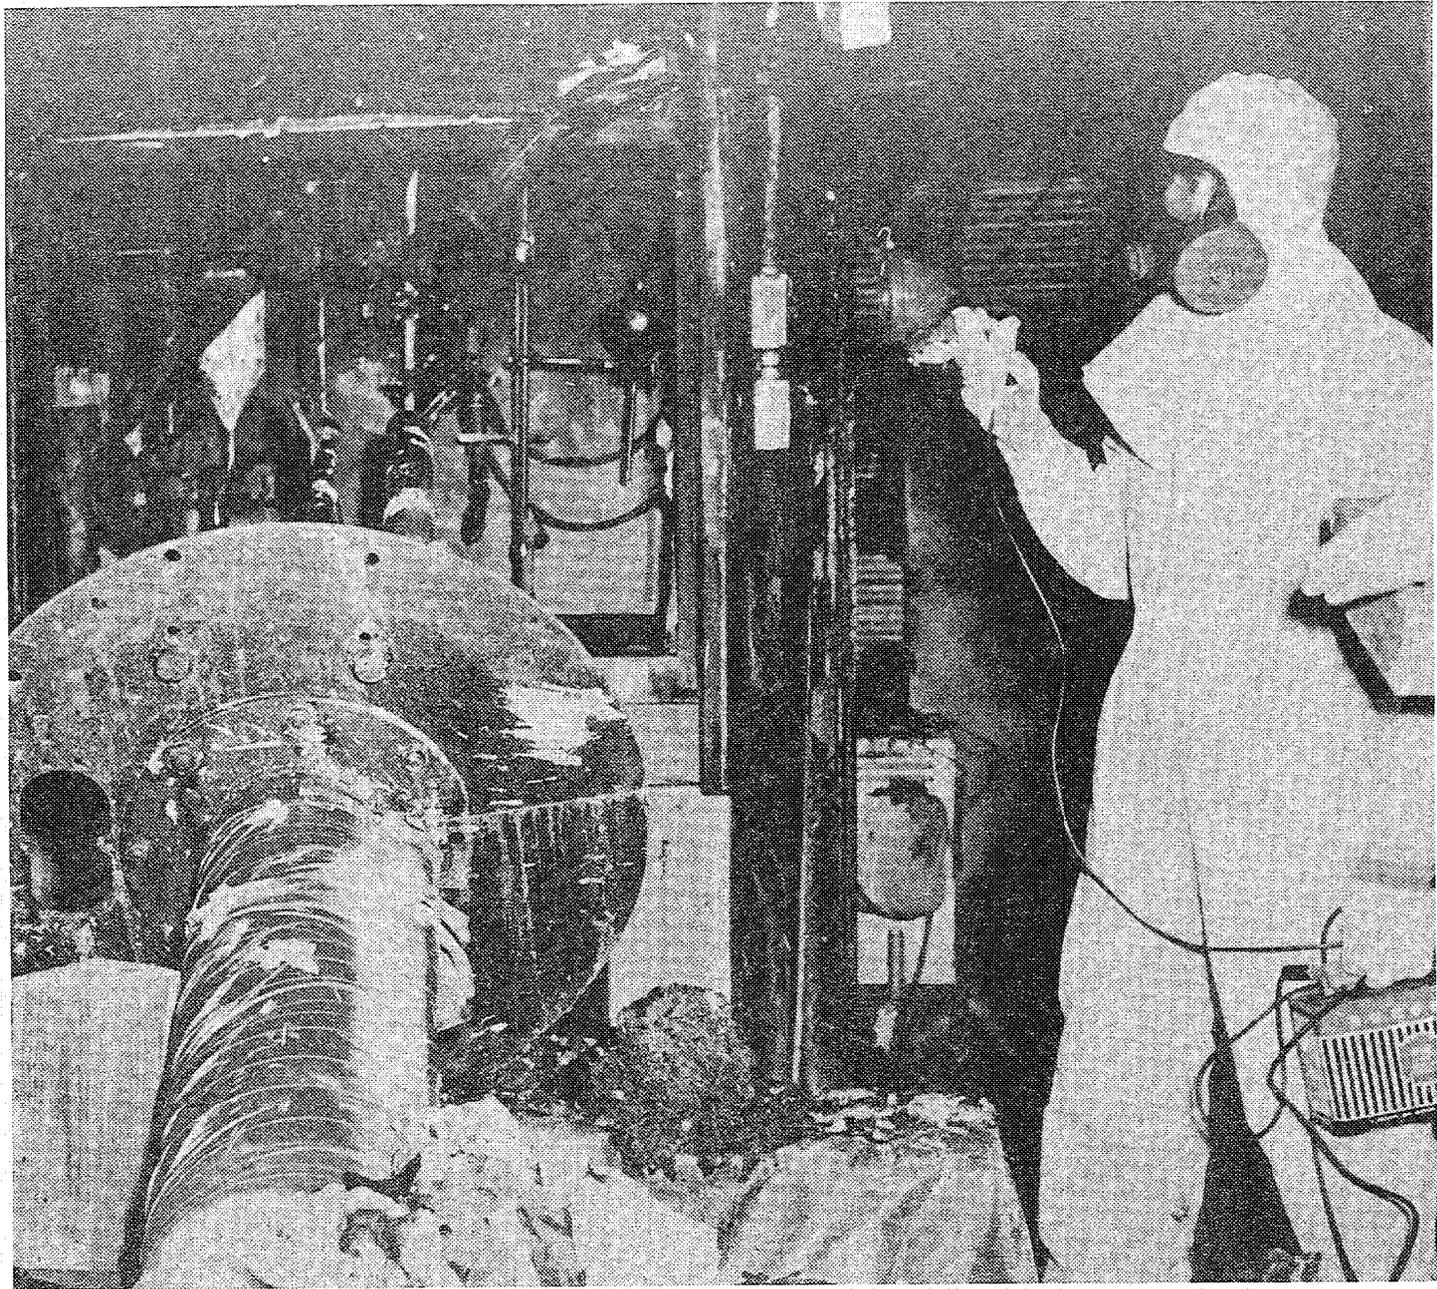
Considerable difficulty was experienced in extinguishing the blaze in the hood filters. It was necessary to break open the filter unit and remove the filter elements to put out the flames and prevent further release of plutonium to the atmosphere.

The total amount of plutonium released was estimated to be between one and four grams. Most of this came from the burned hood filter and the remainder from the previously contaminated waste material. All surveyable surfaces inside the building gave positive alpha readings. A part of the released plutonium was washed from the building by the water used to extinguish the fire, and deposited on the ground outside the building. The contaminated ground was covered with sand to prevent the pickup of active particles from the ground by winds.

Fire damage in contaminated waste fire.

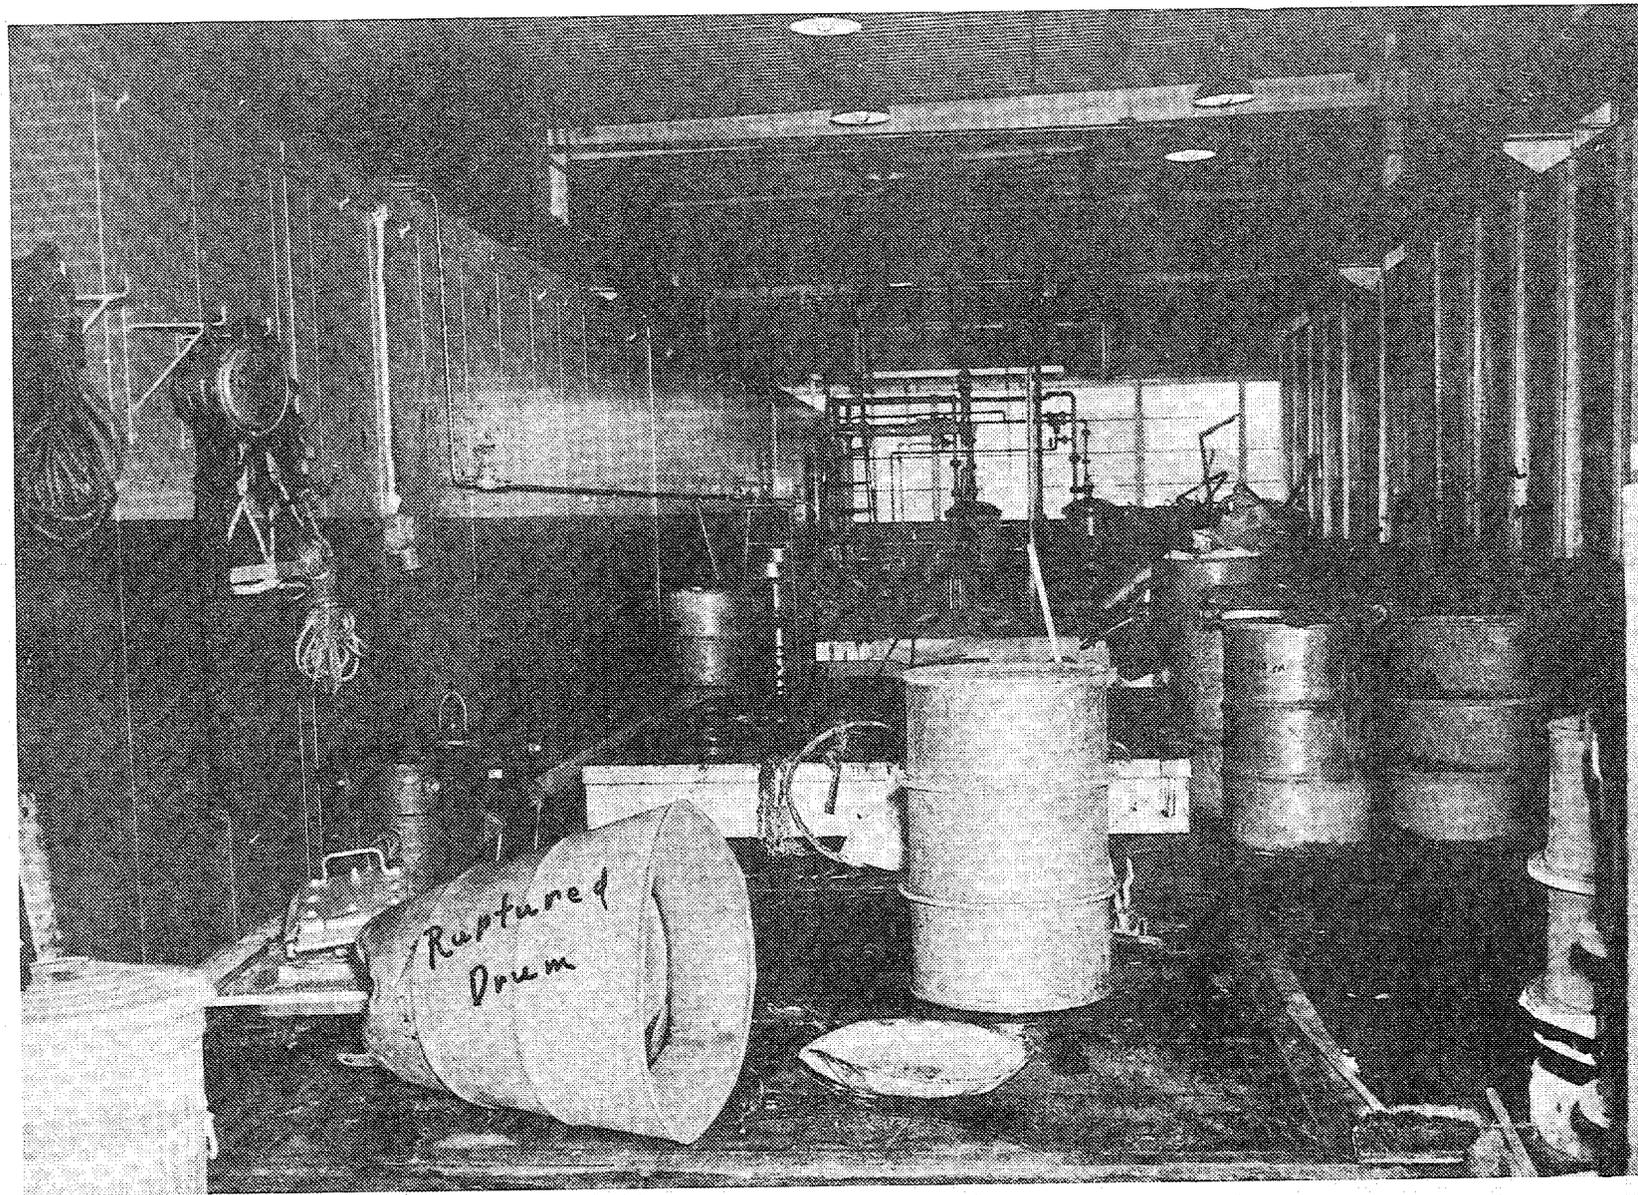
Ruptured drum.

- "1. Revision of existing operating procedures.
- "2. Closer supervision of operations to ensure that procedures are followed.
- "3. The pH of the evaporators must not go below 7 at any time during their operation.

- "4. To prevent any change of acidity during the operation, all evaporator feed tanks will be checked once a shift and will be maintained at a pH greater than 7, which in itself precludes the possibility of the evaporator becoming acidic.
- "5. Approval for drumming must be given by the engineer in charge and must be based on a laboratory analysis.
- "6. The Chemistry Section has been requested to study the nature of the reaction which generates gases in acidic slurries."

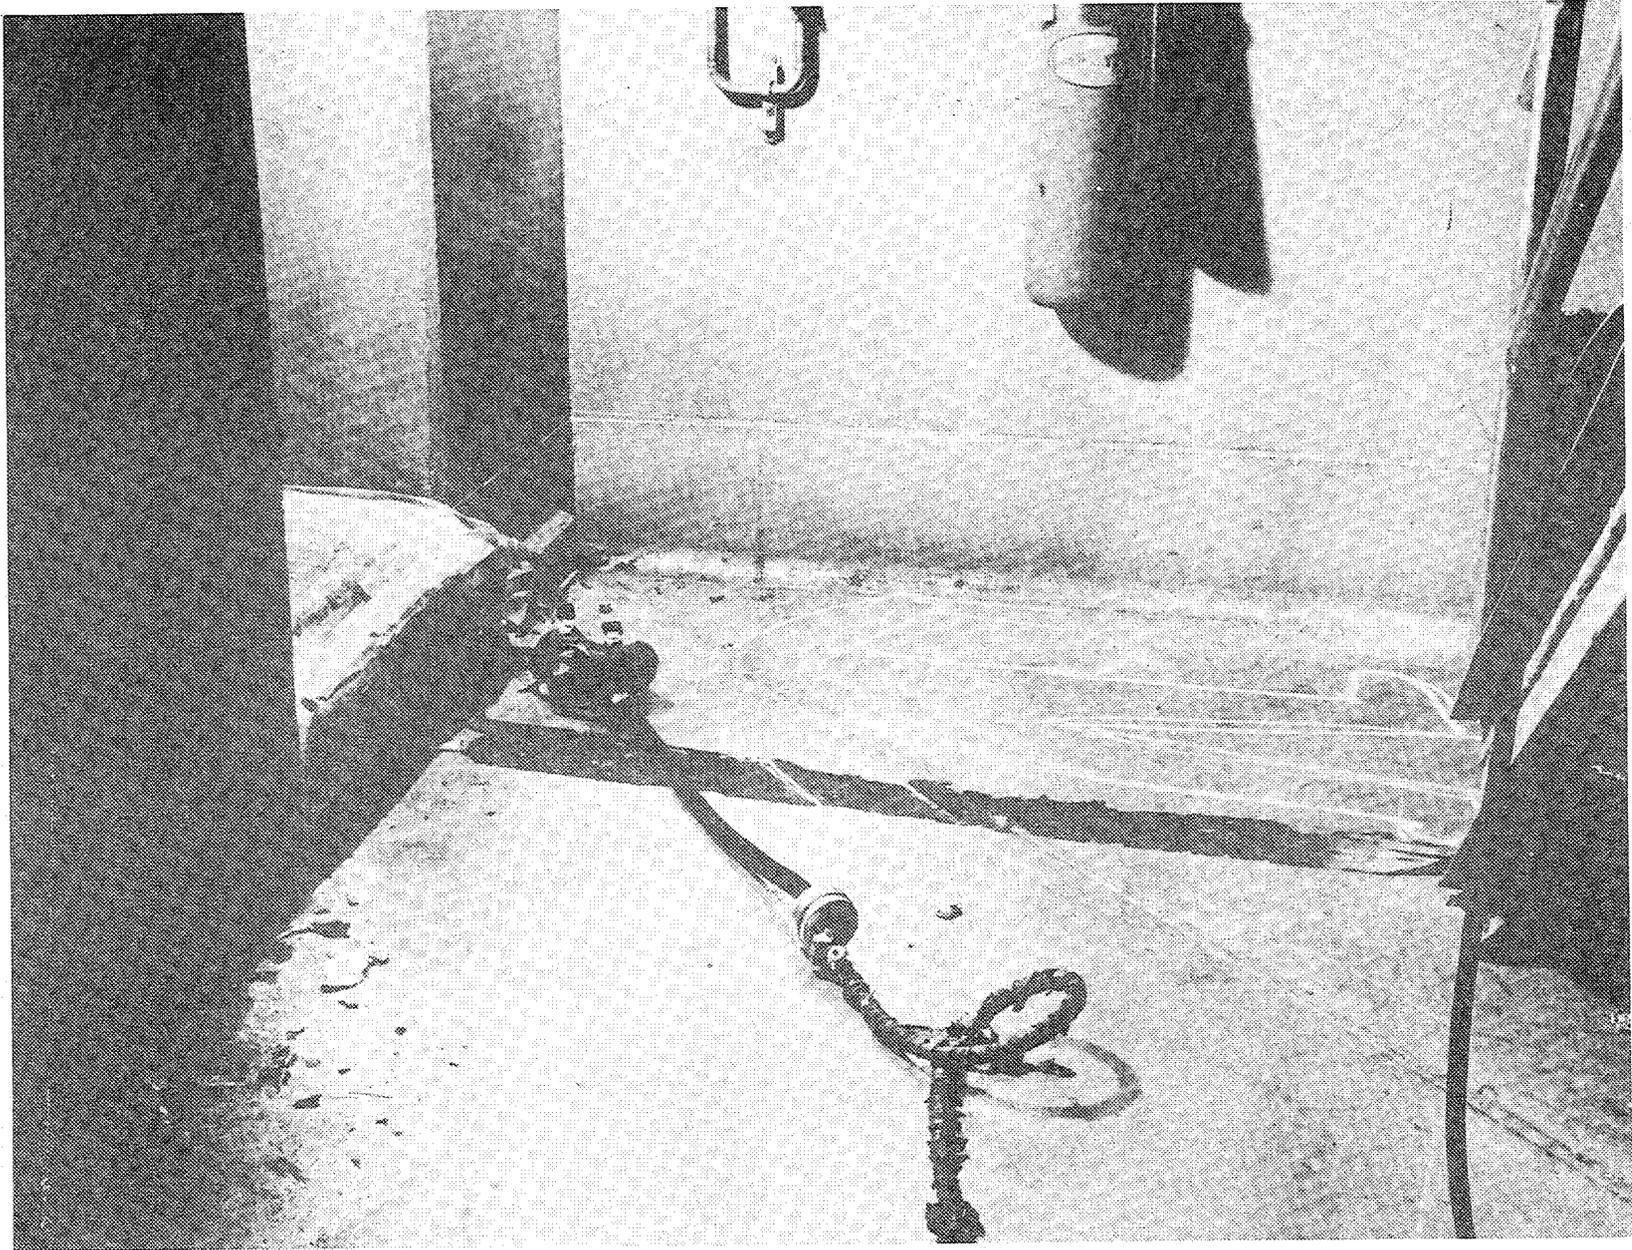
Chalk marks show position of body when found.

1. No employee should enter an area requiring such equipment unless tended from outside.
2. Breathing air systems should be used for this purpose only.
3. Air-line respirators should include a "self-rescue" air cylinder
4. Employees should be instructed in the difference between acute and chronic radiation hazard.
5. Where such equipment is used in a situation where the life hazard is not acute, employees should be instructed to remove the mask and leave the area if trouble develops with the mask.
