# TRANSACTIONS

OF THE  
AMERICAN NUCLEAR SOCIETY

### 5. The Hanford Pulsar Accident, E. D. Clayton (PNL)

## 6. The 1963 Livermore Criticality Accident Revisited, R. L. Kathren (PNL)

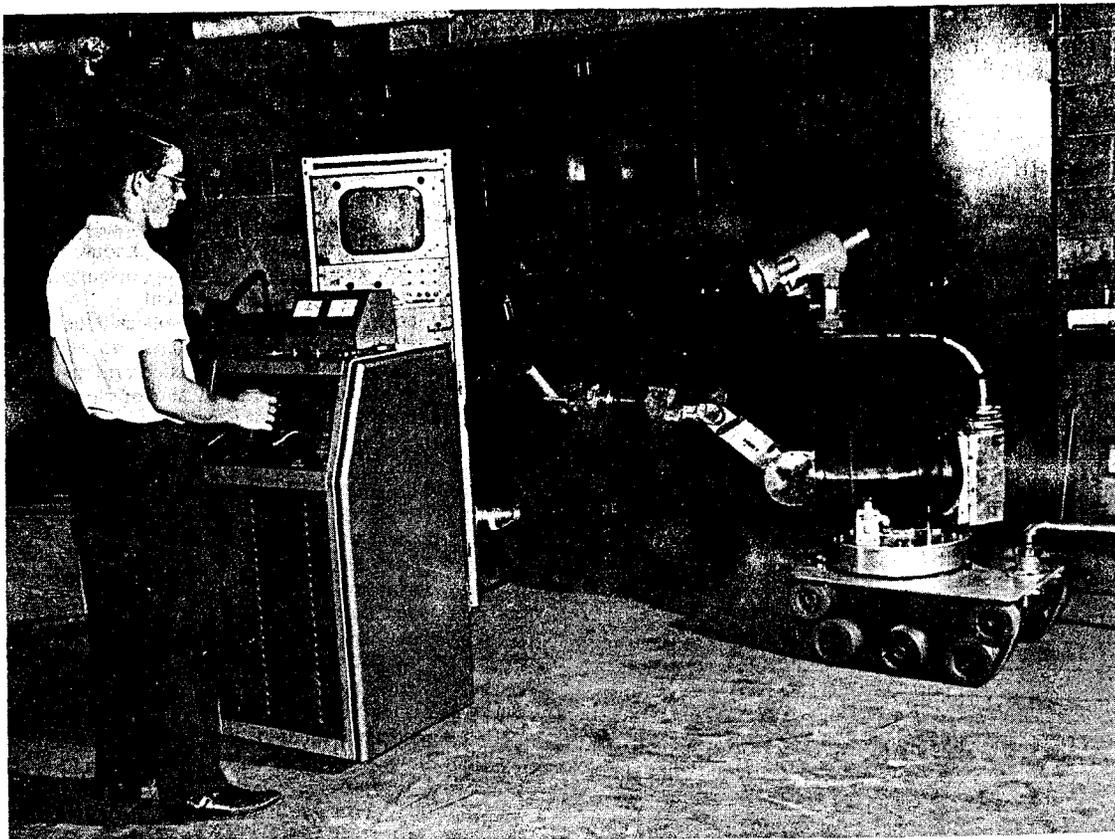
2. There was no spread of contamination.
3. There was no physical damage.
4. There was no serious radiation dosage to any staff member.
5. A remotely controlled mechanical robot was used for the first time in the aftermath of such an accident to perform various operations, position detectors, conduct surveys, turn valves, etc. (see Fig. 1).

Fig. 1 Remotely controlled mechanical robot used in plant recovery operation.
