TITLE: THE DECOMMISSIONING OF A TRITIUM-CONTAMINATED LABORATORY

SUBMITTED TO 1982 International Decommissioning Symposium,
Seattle, WA, October 10-14, 1982

A tritium laboratory facility at the Los Alamos National Laboratory, Los Alamos, New Mexico, was decommissioned in 1979. The project involved dismantling the laboratory equipment and disposing of the equipment and debris at an on-site waste disposal/storage area.

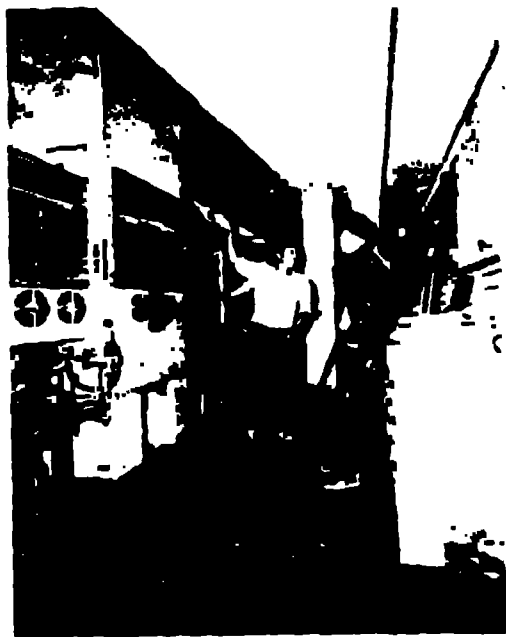
Fig. 2.
North glovebox line.

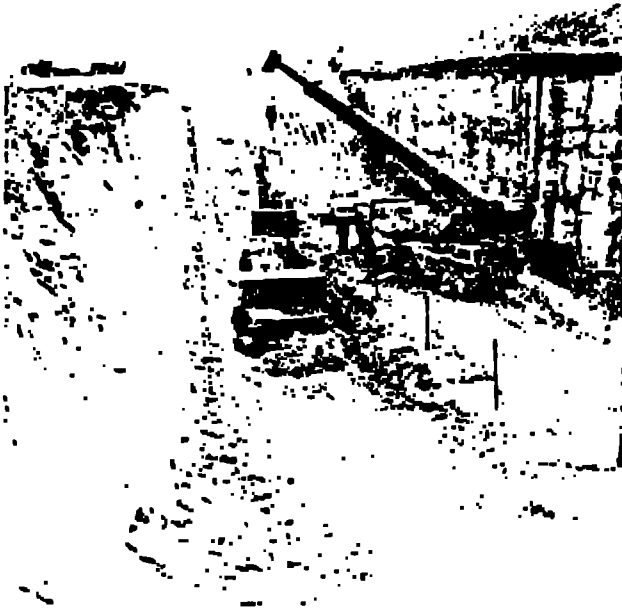
Fig. 20.
Disposal of tritium waste.

All wastes generated by this operation were buried at the Laboratory's Radioactive Waste Disposal/Storage Site in a 1.9-m-deep by 3.9-m-wide by 33-m-long trench at the bottom of a large burial pit (Fig. 20), located 8 km from the decommissioning site. Wastes were transported in plastic-lined dump trucks covered with tarpaulins. The 183 m^3 of contaminated debris containing an estimated 6×10^3 curies of tritium were placed in the trench, which was covered with noncontaminated soil. The pit was then used to receive other routine low-level solid radioactive wastes.
