March 20, 1951

LA-1289

A STUDY OF AN ACCIDENTAL RADIATION BURST

A STUDY OF THE ACCIDENTAL RADIATION BURST WHICH
OCCURRED AT THE PAJARITO REMOTE CONTROL
LABORATORY ON 1 FEBRUARY 1951.

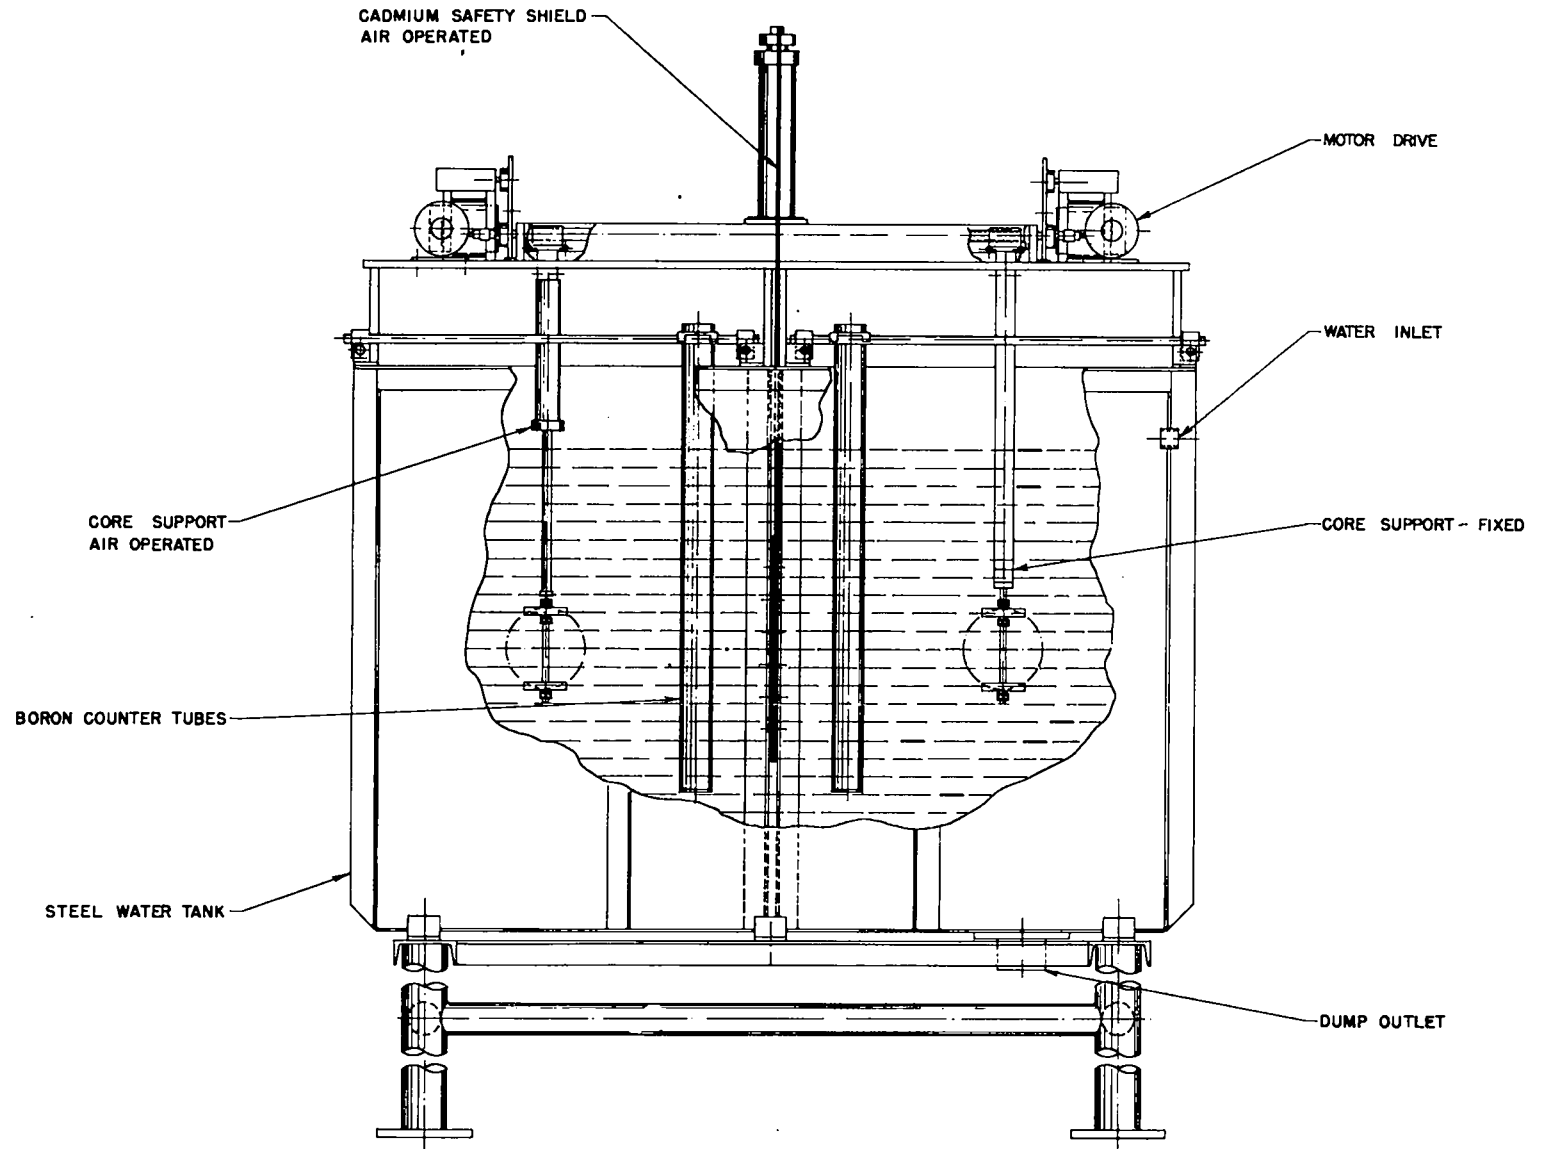
Figure 1 is a schematic drawing of the Aquarium machine as set up for proximity measurements. Figure 2 is a photograph of the machine. It consists essentially of a water tank with remotely controlled flood and drain valves, means for suspending two masses of active material in the tank, and remotely controlled means for running these masses together and apart. The machine is located in the Kiva at the Pajarito Canyon Site, about 1200 feet from the control

FIG. 1. General assembly Aquarium machine.

The Aquarium is fitted with three safety devices, all three of which act in case the neutron flux in or near the machine should exceed a predetermined value. These safety devices are:

- (1) A 2 1/2" water dump valve.
- (2) A Cd shield which drops between the two active-material masses.
- (3) An air-operated lift, which raises one of the two masses a distance of six inches, reducing the water tamping around that mass.

In addition, the mechanism controlling the horizontal motion of the masses starts moving them apart, continuing this motion until the two masses are at extreme separation (about 30 inches, center-to-center). These safety devices may be actuated by hand, or by any one or all of three neutron monitors, two of which are located at the tank, and one about 25 feet away across the Kiva.

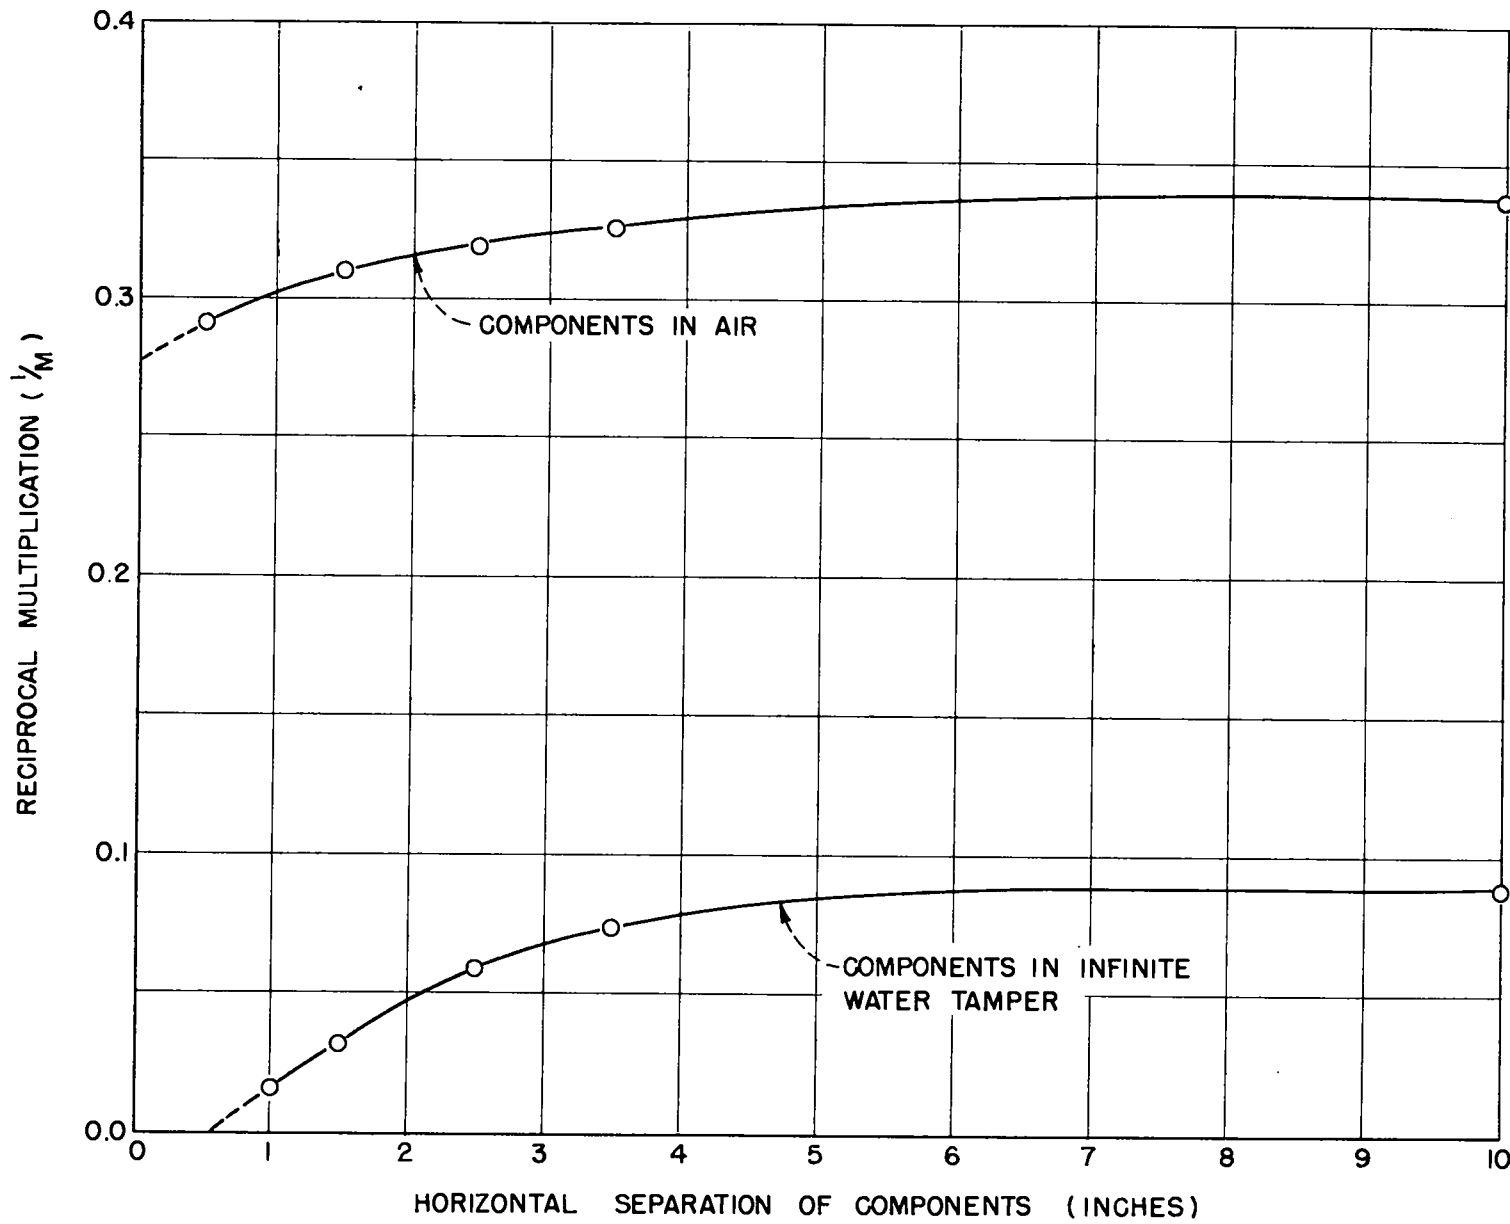
Proximity measurements were first made with the shapes in air. A series of multiplied counts was obtained for decreasing A - B separations, and reciprocal multiplication was plotted as a function of separation distance (see Fig. 3). The total multiplication for 0.50" separation of the masses was found to be 3.41, and the curve (Fig. 3) extrapolates to a total multiplication of 3.65 for the masses in contact.

A and B were then run apart to maximum separation, and water was run into the tank to the same level used in the unmultiplied counts. Once again the distance between the masses was decreased in steps, taking a multiplied count at each step, and plotting reciprocal multiplication as a function of separation distance after each step to monitor the safety of further reducing the separation distance (Fig. 3).

At a horizontal separation distance of 1.00 inch, the observed multiplication was 65.45, and extrapolation of the approach curve (Fig. 3) indicated that the assembly would reach delayed critical at a separation of about 0.60 inch. It was decided that no appreciable gain in accuracy could be realized by further reducing the separation⁽¹⁾,

FIG. 3. Proximity measurements on A and B, in air and in effectively infinite water tamping.

From Fig. 3, a reduction of the center-to-center distance of about 0.40" would be sufficient to bring the assembly as a whole to a delayed critical condition. From measurements made on other Oy assemblies, it has been found that the mass interval between a multiplication of 50 and delayed critical is the same as the mass interval between delayed critical and prompt critical. If we assume that this applies also to distances in proximity work, then from Fig. 3 the distance between a multiplication of 50 and delayed critical is 0.55". Thus the centers of reactivity of the two masses would have to be brought $0.40" + 0.55" = 0.95"$ closer together to reach a prompt critical condition.

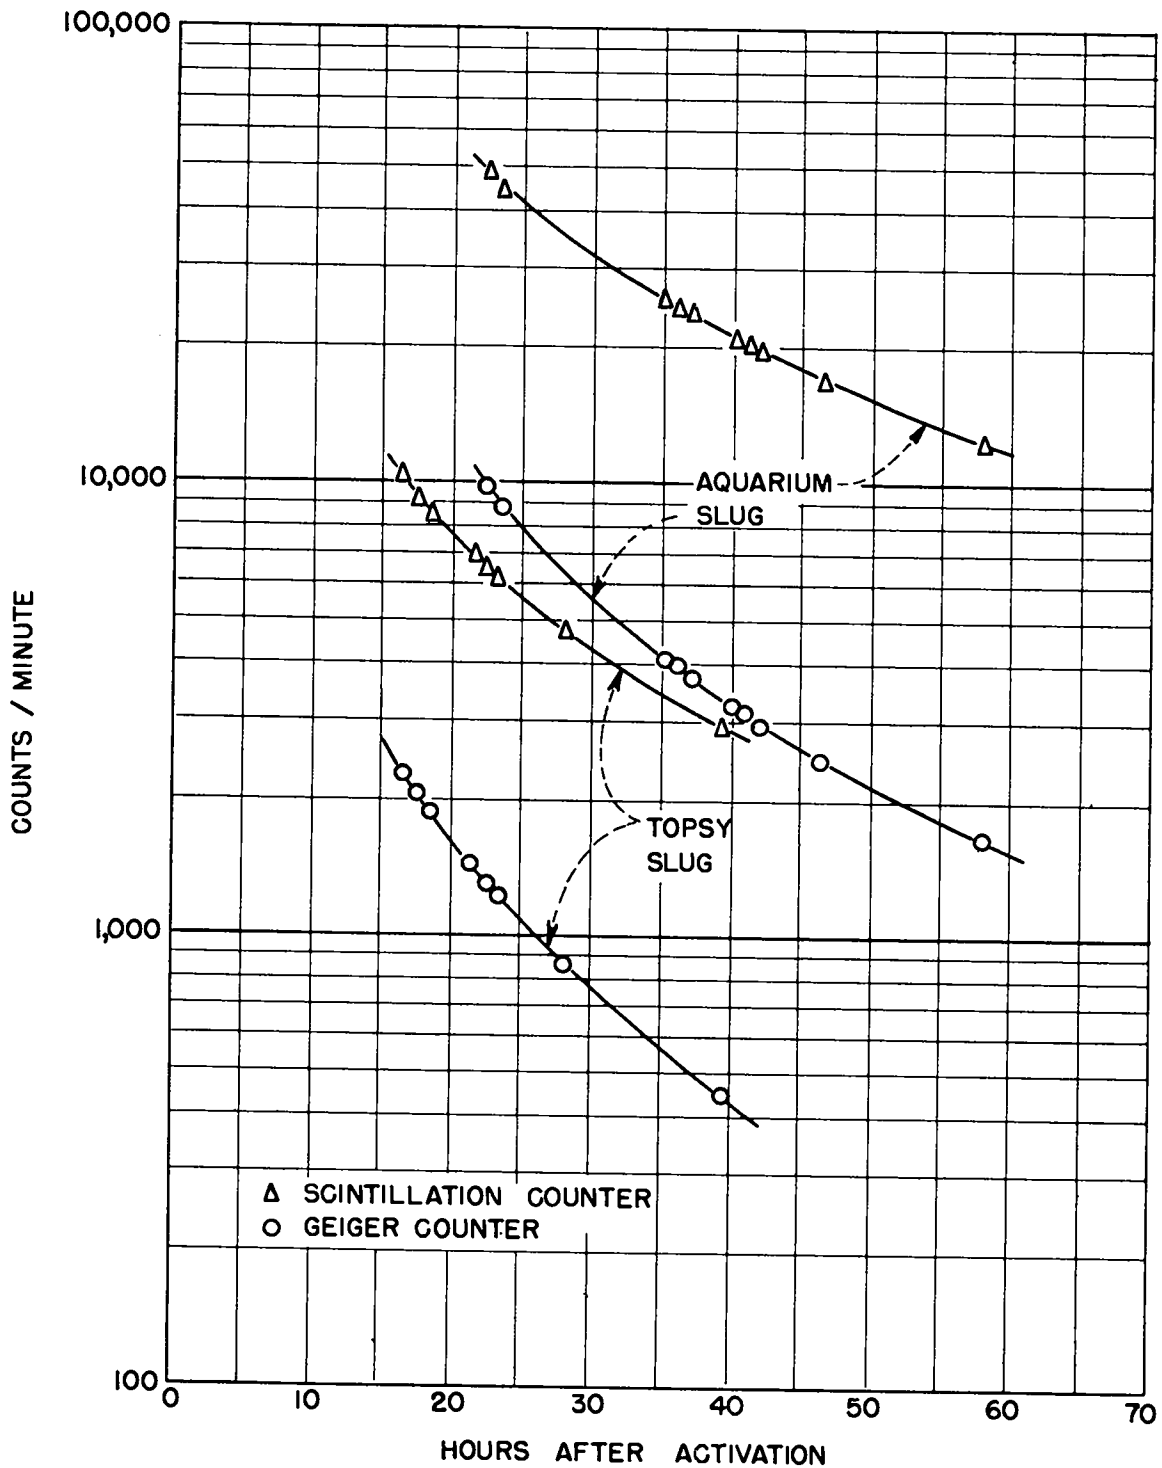
An estimate of the total number of fissions occurring in the burst was made by comparing the fission fragment gamma activity from the small cylinder of Oy taken from the center of A with a similar cylinder that was irradiated in the Topsy critical assembly machine. The decay curves of the two slugs are shown in Fig. 4. The gamma activities were counted with a Geiger counter and with a scintillation counter. The difference in curvature of the Geiger counter and scintillation counter curves is probably due to the fact that sensitivity dependence on energy of the two detectors is not the same.

FIG. 4. Comparative decay curves of Oy slugs from Topsy reactor irradiation and from the Aquarium radiation burst.

The average number of fissions per gram for the Topsy irradiation from the above data is 1.10×10^{11} . Since the fission rate in the center of Topsy is 1.68 times the average rate, the number of fissions per gram in the Topsy slug was 1.83×10^{11} . The number of fissions per gram in the Aquarium slug was therefore 1.6×10^{12} . Since the Aquarium assembly was quite non-symmetrical, one can only assume that the number of fissions occurring in the slug was representative of the assembly average. On the basis of this assumption, the total number of fissions occurring during the burst from the Aquarium assembly was 1.0×10^{17} fissions. Assuming 188 Mev of heat energy per fission, this represents an energy release of 835 watt-hours, which, for a burst duration of 0.2 second⁽¹⁾ would make the power developed during the burst ~15 megawatts.

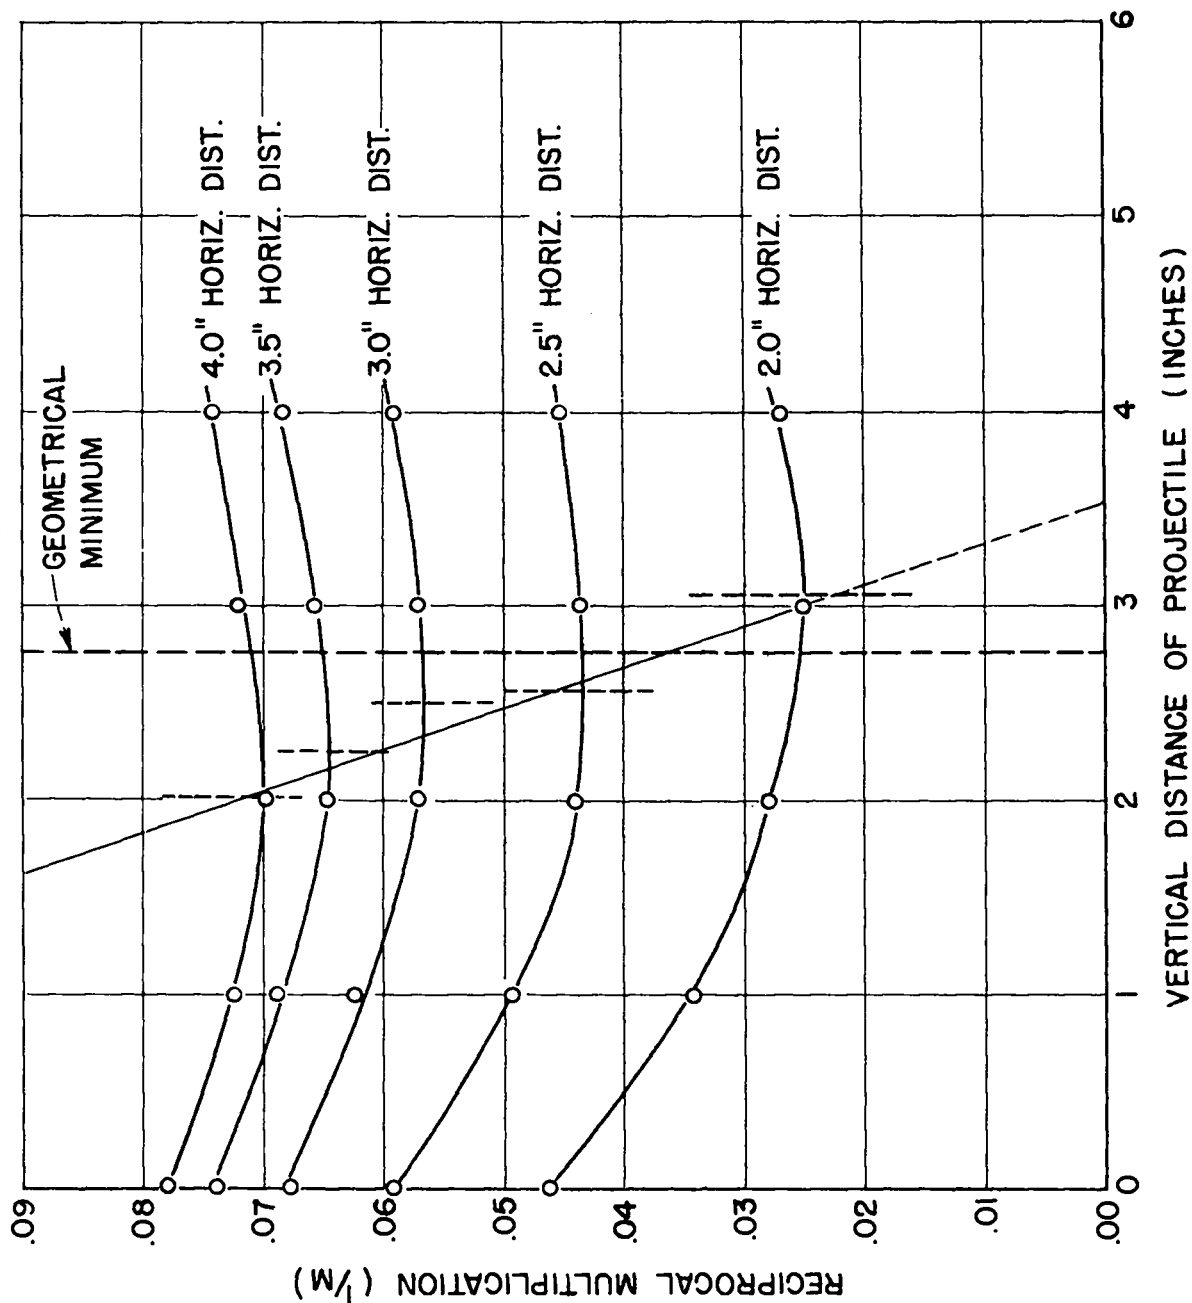
If there were no shift of the center of reactivity of A away from the center of O_y mass, one would expect the minimum for each of these curves to occur at an A vertical position of up 2.70", since at this position the O_y centers of mass are at the position of closest approach. Any displacement of minima away from 2.70" must be due to the competing Cause (2) effects described above.

The results of this experiment are illustrated in Fig. 5. For an A - B horizontal separation of 4.0", the center of reactivity of A is apparently 2.70" - 2.05" = 0.65" above the center of mass. As the horizontal distance between the components is decreased, the center of reactivity moves downward, until at a horizontal separation of about 2.3", the center of mass and the center of reactivity coincide. At a separation of 2.00", the center of reactivity of A is 0.30" below the center of O_y mass. By linear extrapolation for a critical condition, the center of reactivity would be 0.85" below the O_y center of mass. This would place the center of reactivity of A 2.70" + 0.85" = 3.55" below the center of reactivity of B, resulting in a distance of 7.12" between these centers. The distance between centers would thus be reduced by 7.12" - 6.19" = 0.93" by vertical upward motion of A, bringing the Assembly as a whole to the verge of prompt criticality.

FIG. 5. Plot of reciprocal multiplication vs vertical position of A for various horizontal separation distances between A and B, in effectively infinite water tamping.

It appears, therefore, that although a combination of Causes (1) and (2) may possibly bring about a prompt critical condition, a burst of the magnitude actually observed is unlikely from these two causes alone.

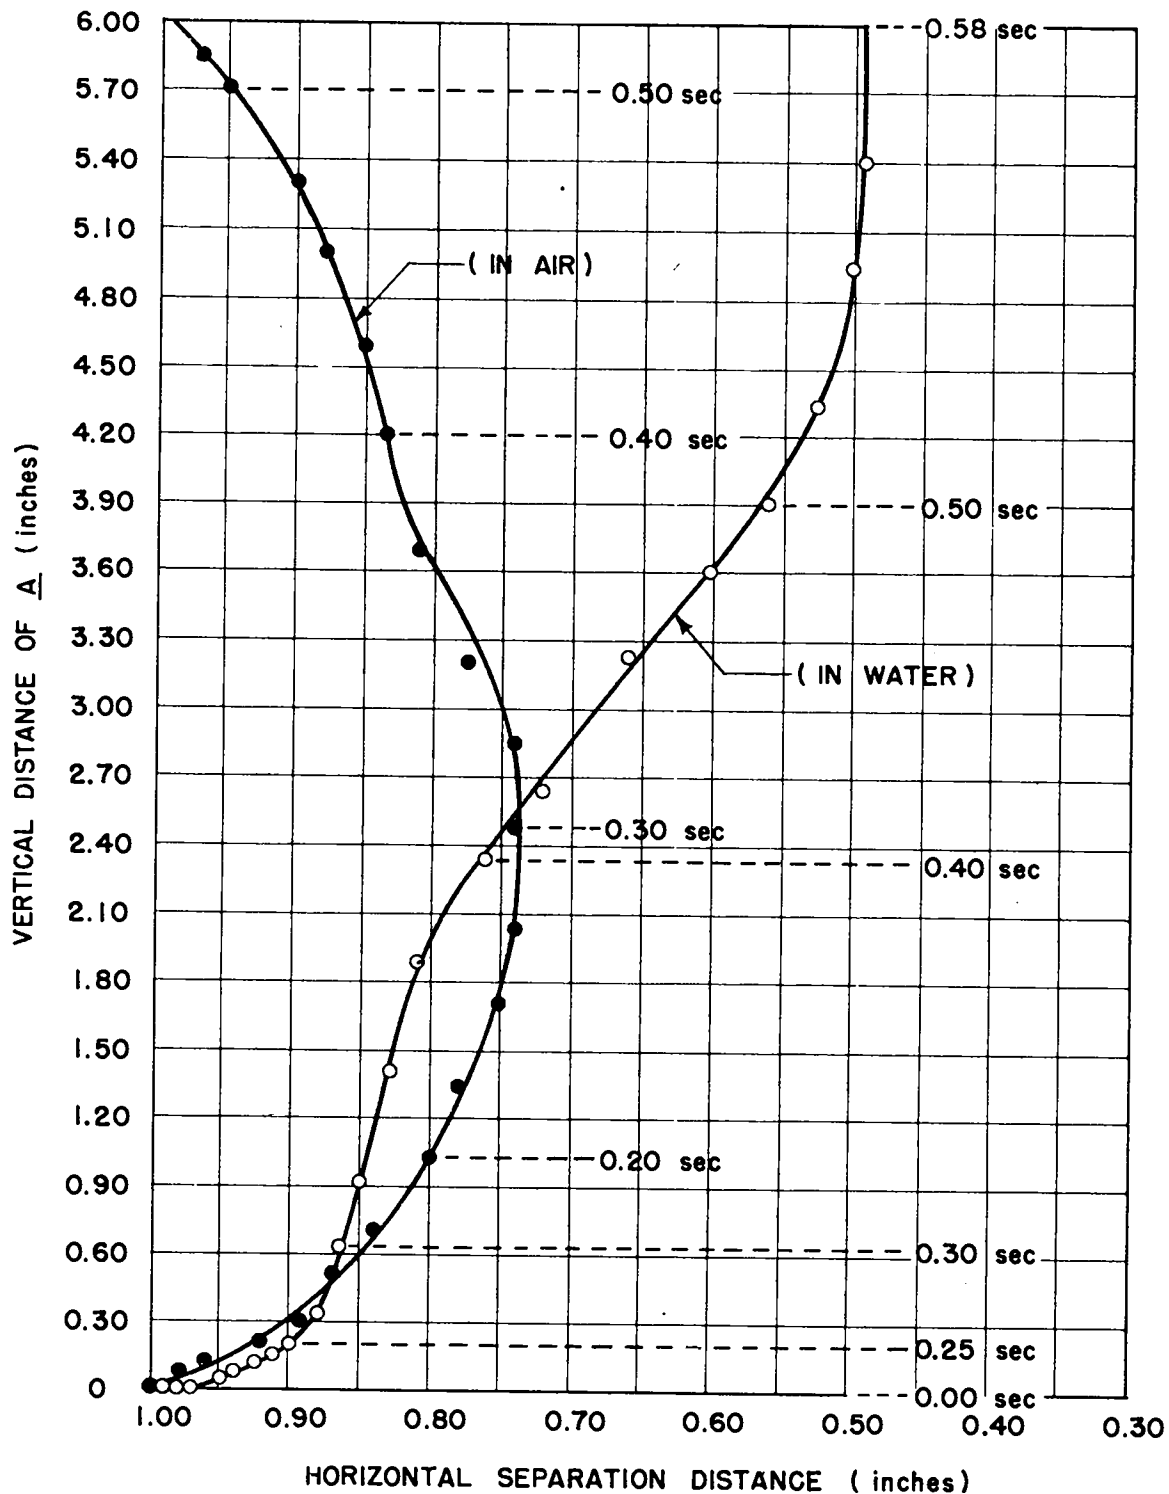
Sequences of sample films are shown in Fig. 6 for air and for water in the tank. In both cases, the first action of A is to move toward B. Figure 7 is a plot of the A - B separation distance as A moves upward on scrambling. Times from the start of the motion are also indicated. At an A position up 3.55" (in water), at which point the centers of reactivity of A and B should be directly opposite in a horizontal plane, A is seen to be 0.39" closer to B horizontally than at the start of the motion⁽¹⁾. This is more than enough, when combined with Causes (1) and (2) to drive the assembly well into the prompt critical region.

FIG. 7. Plot of the relative motion of A and B during scrambling action, in air and in water, as read by comparator from Fastax camera traces.

Following up the underwater curve of Fig. 7, and combining effects with those due to Causes (1) and (2), the points in the vertical travel of A at which the assembly as a whole became delayed critical, then (potentially) prompt critical⁽²⁾, and back through prompt critical to delayed critical and subcritical, have been estimated. From this, the periods of time during which the assembly was delayed critical and prompt critical have also been estimated. These data are summarized below.

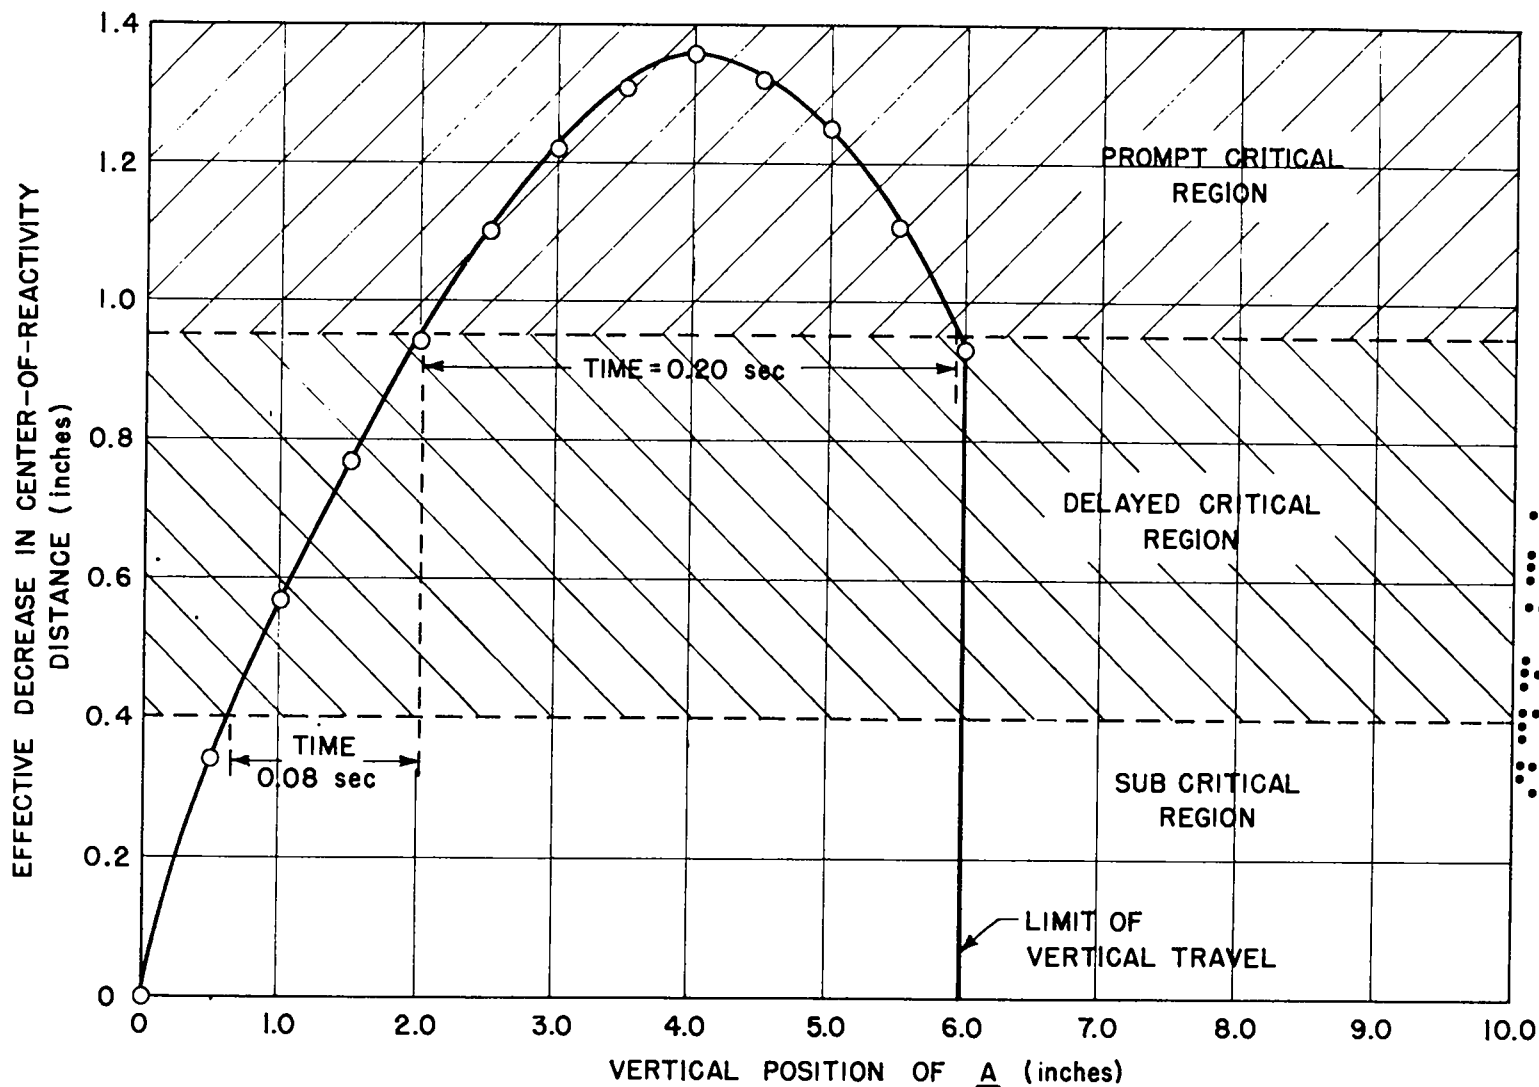
Assembly delayed critical for A "up 0.65" to "up 2.0", a period of 0.08 second.

Assembly potentially prompt critical for A "up 2.0" to "up 5.9", a period of 0.20 second.

Assembly delayed critical for A "up 5.9" to limit of travel (6.0), and for a period of 0.2 second thereafter.

These results are shown graphically in Fig. 8, which is a plot of the effective separation distance between A and B centers of reactivity as a function of the vertical position of A during scrambling action, representing the combined effect of Causes (1), (2), and (3).

FIG. 8. Plot showing the combined effect of Causes (1), (2), and (3).

It is evident that it took all three of the causes discussed in Section IV to make a serious burst; in the absence of any one of the three, the relatively slight momentary rise in radiation level caused by the other two might have escaped notice altogether.
