SANDIA REPORT

A Microstructural Analysis of Solder Joints from the Electronic Assemblies of Dismantled Nuclear Weapons

P. T. Vianco, J. A. Rejent

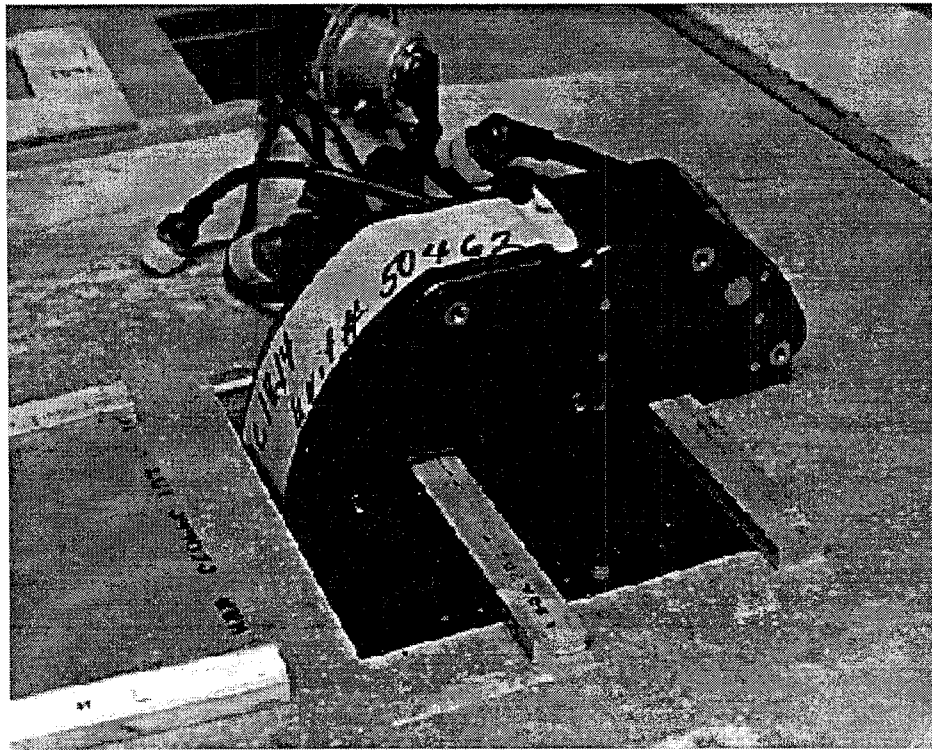
Figure 23. An MC1814 unit in place in the abrasive water jet cutting machine.
