LA-3446

Gamma Dose Rate Measurements --
Kiwi Transient Nuclear Test

Report written: December 1965

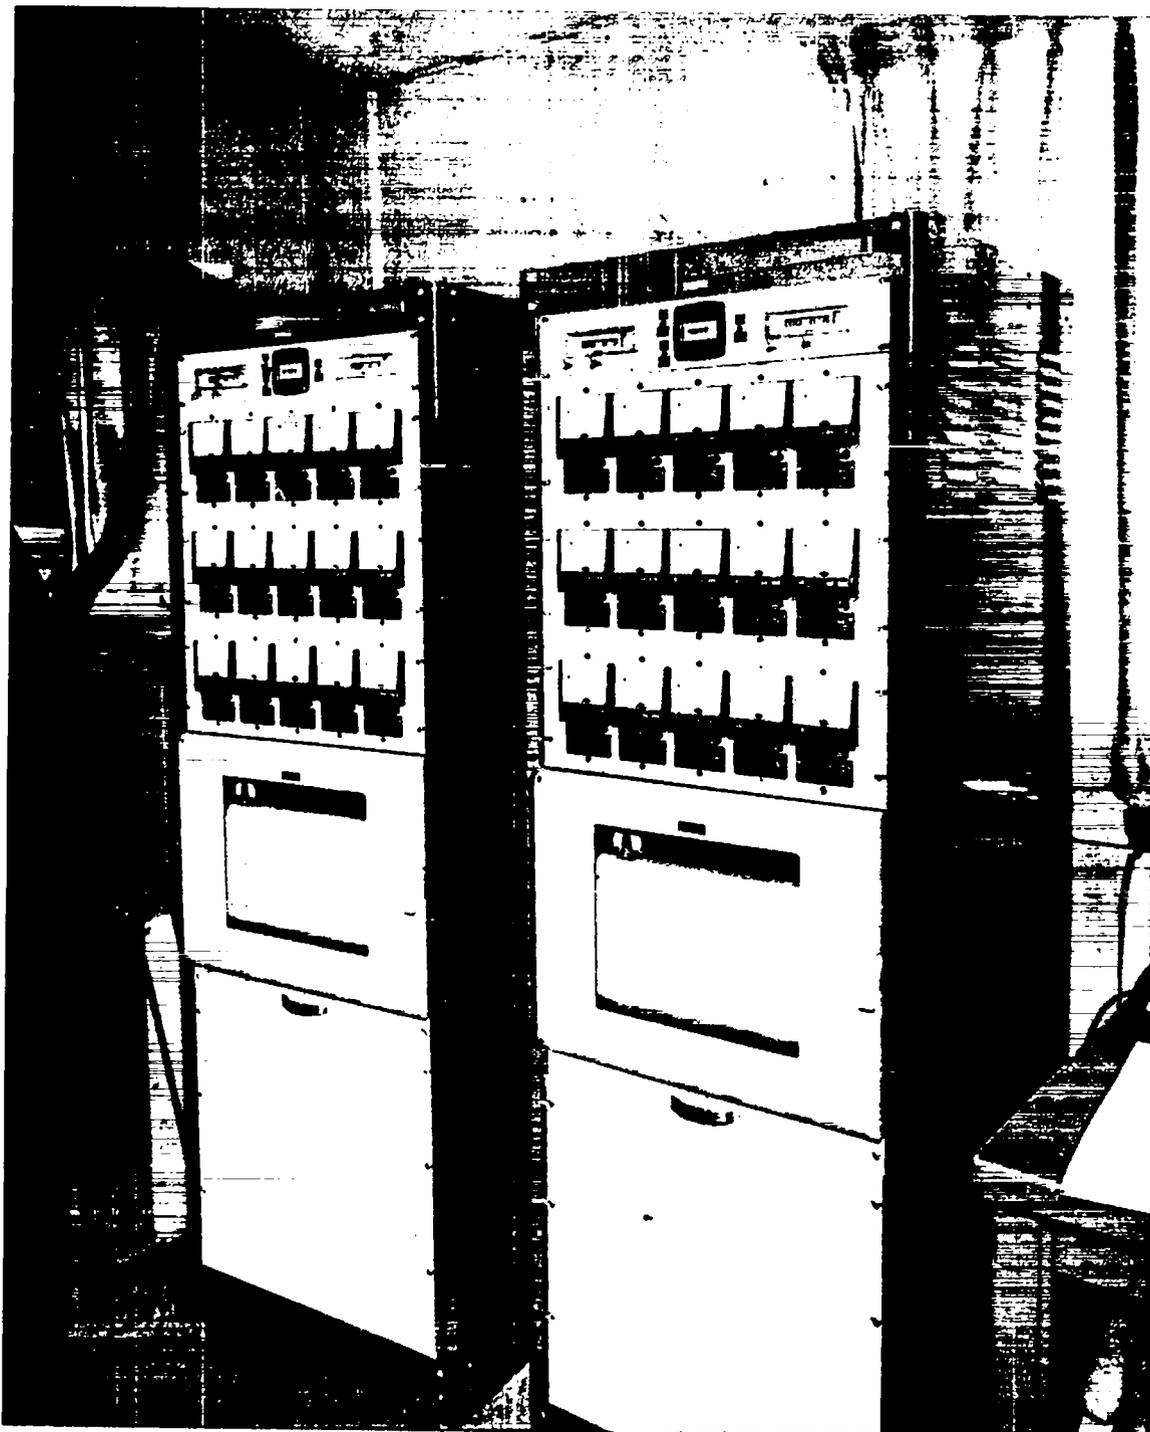
Fig. 9. Ionization chamber readout units.

The ionization chamber system used was commercially obtained (Victoreen Instrument Co., Jordan Electronic Div.). It included probes (Fig. 8) each consisting of a Nehr-White ionization chamber and a battery-operated power supply, and readout units (Fig. 9). The probes and readout units were connected by pairs of signal wires which were generally more than two miles long. Nehr-White ionization chambers contain an electrometer tube (5886), the grid of which is connected only to the collector electrode of the chamber. These chambers respond logarithmically to gamma radiation. The readout units are provided with two ranges, 1 to 10^3 mR/hr and 1 to 10^3 R/hr.
