LA-1289

A STUDY OF AN ACCIDENTAL RADIATION BURST

A STUDY OF THE ACCIDENTAL RADIATION BURST WHICH
OCCURRED AT THE PAJARITO REMOTE CONTROL
LABORATORY ON 1 FEBRUARY 1951.

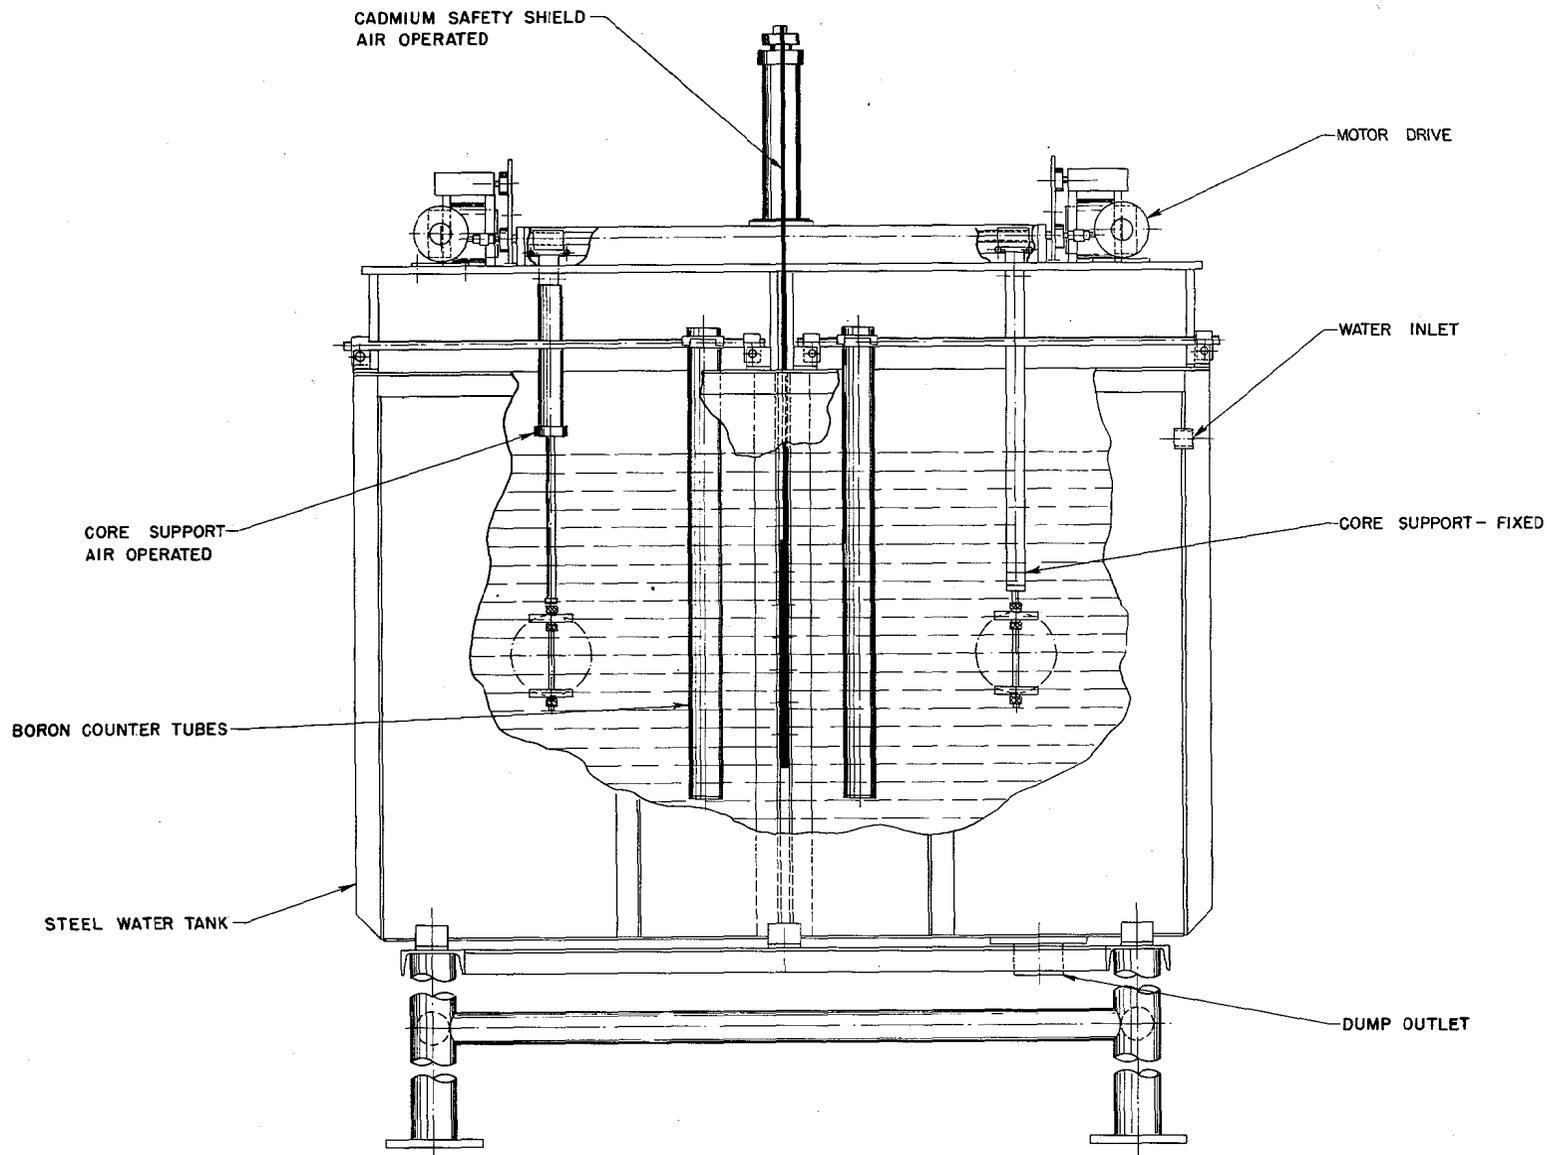
Figure 1 is a schematic drawing of the Aquarium machine as set up for proximity measurements. Figure 2 is a photograph of the machine. It consists essentially of a water tank with remotely controlled flood and drain valves, means for suspending two masses of active material in the tank, and remotely controlled means for running these masses together and apart. The machine is located in the Kiva at the Pajarito Canyon Site, about 1200 feet from the control

FIG. 1. General assembly Aquarium machine.

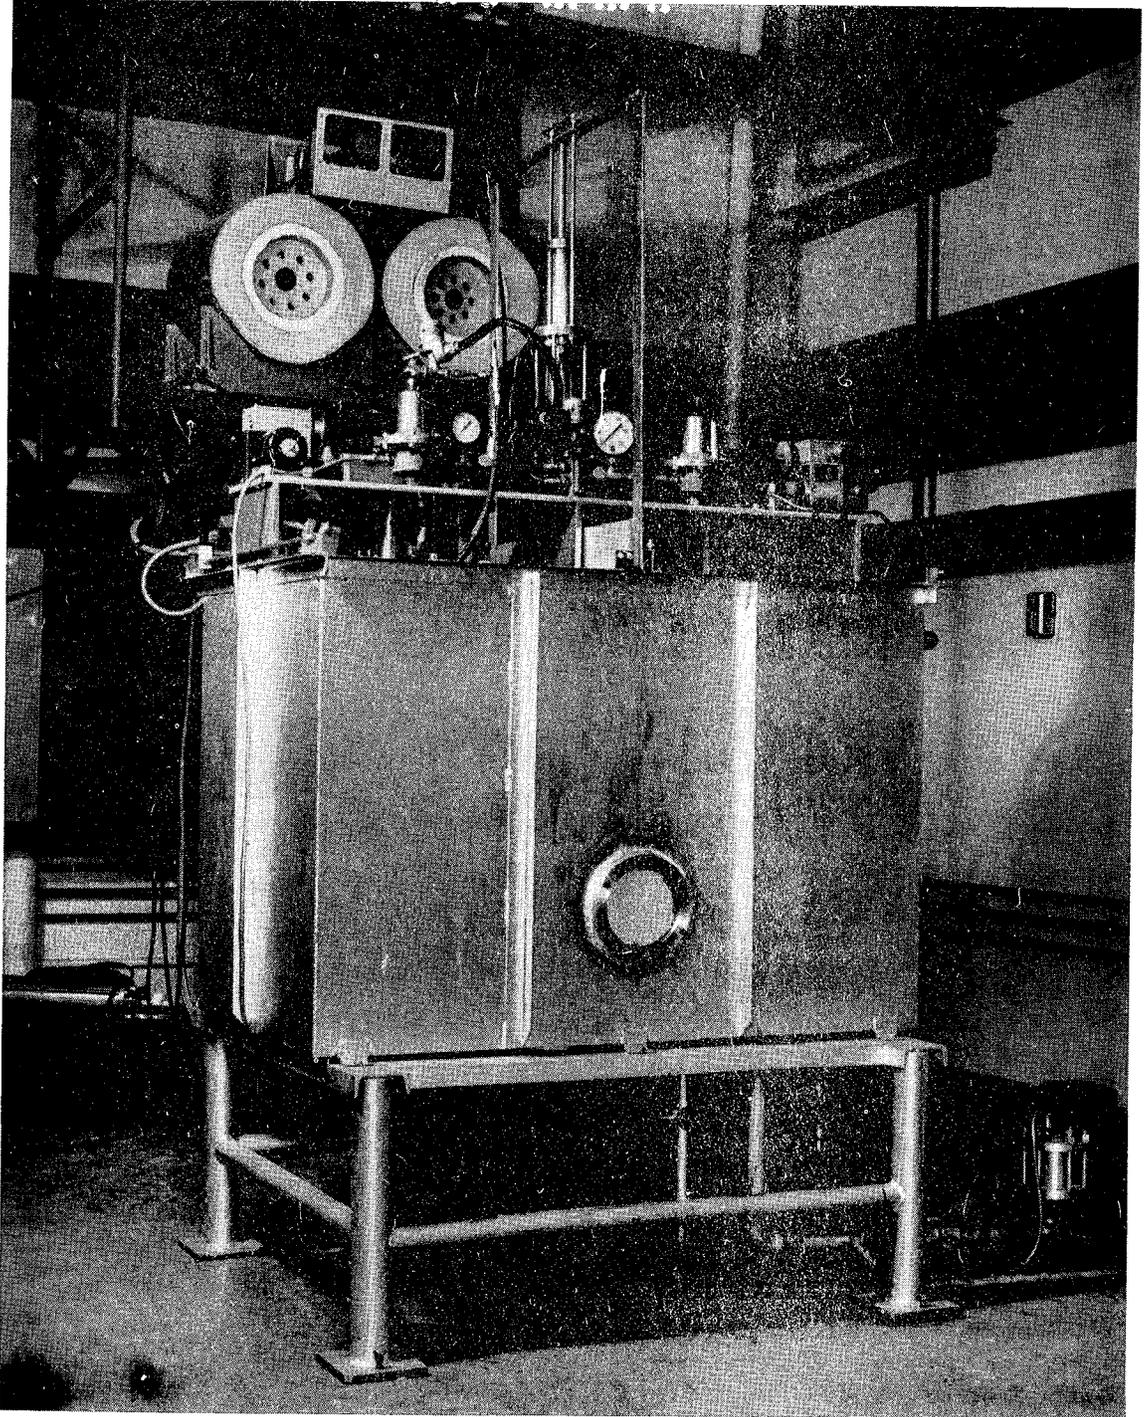
FIG. 2. The Aquarium machine.

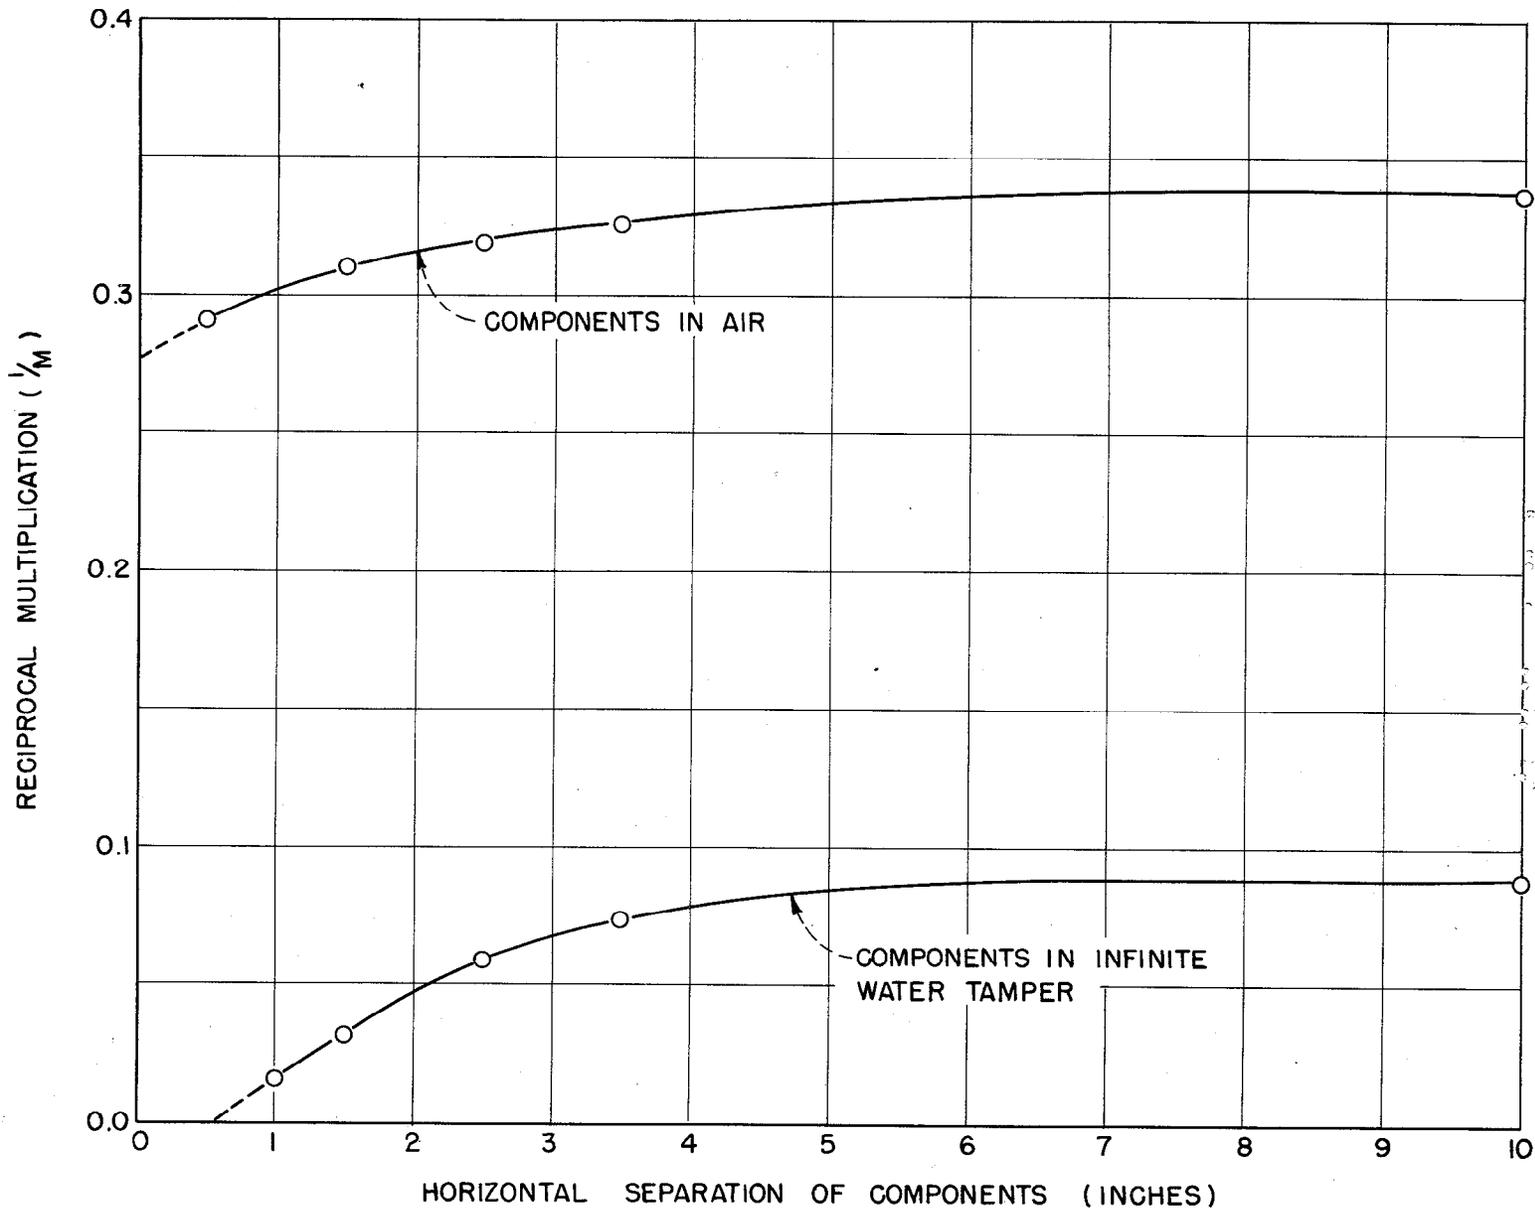
Proximity measurements were first made with the shapes in air. A series of multiplied counts was obtained for decreasing A - B separations, and reciprocal multiplication was plotted as a function of separation distance (see Fig. 3). The total multiplication for 0.50" separation of the masses was found to be 3.41, and the curve (Fig. 3) extrapolates to a total multiplication of 3.65 for the masses in contact.

A and B were then run apart to maximum separation, and water was run into the tank to the same level used in the unmultiplied counts. Once again the distance between the masses was decreased in steps, taking a multiplied count at each step, and plotting reciprocal multiplication as a function of separation distance after each step to monitor the safety of further reducing the separation distance (Fig. 3).

At a horizontal separation distance of 1.00 inch, the observed multiplication was 65.45, and extrapolation of the approach curve (Fig. 3) indicated that the assembly would reach delayed critical at a separation of about 0.60 inch. It was decided that no appreciable gain in accuracy could be realized by further reducing the separation⁽¹⁾,

FIG. 3. Proximity measurements on A and B, in air and in effectively infinite water tamping.

From Fig. 3, a reduction of the center-to-center distance of about 0.40" would be sufficient to bring the assembly as a whole to a delayed critical condition. From measurements made on other Oy assemblies, it has been found that the mass interval between a multiplication of ≈ 50 and delayed critical is the same as the mass interval between delayed critical and prompt critical. If we assume that this applies also to distances in proximity work, then from Fig. 3 the distance between a multiplication of 50 and delayed critical is 0.55". Thus the centers of reactivity of the two masses would have to be brought $0.40" + 0.55" = 0.95"$ closer together to reach a prompt critical condition.

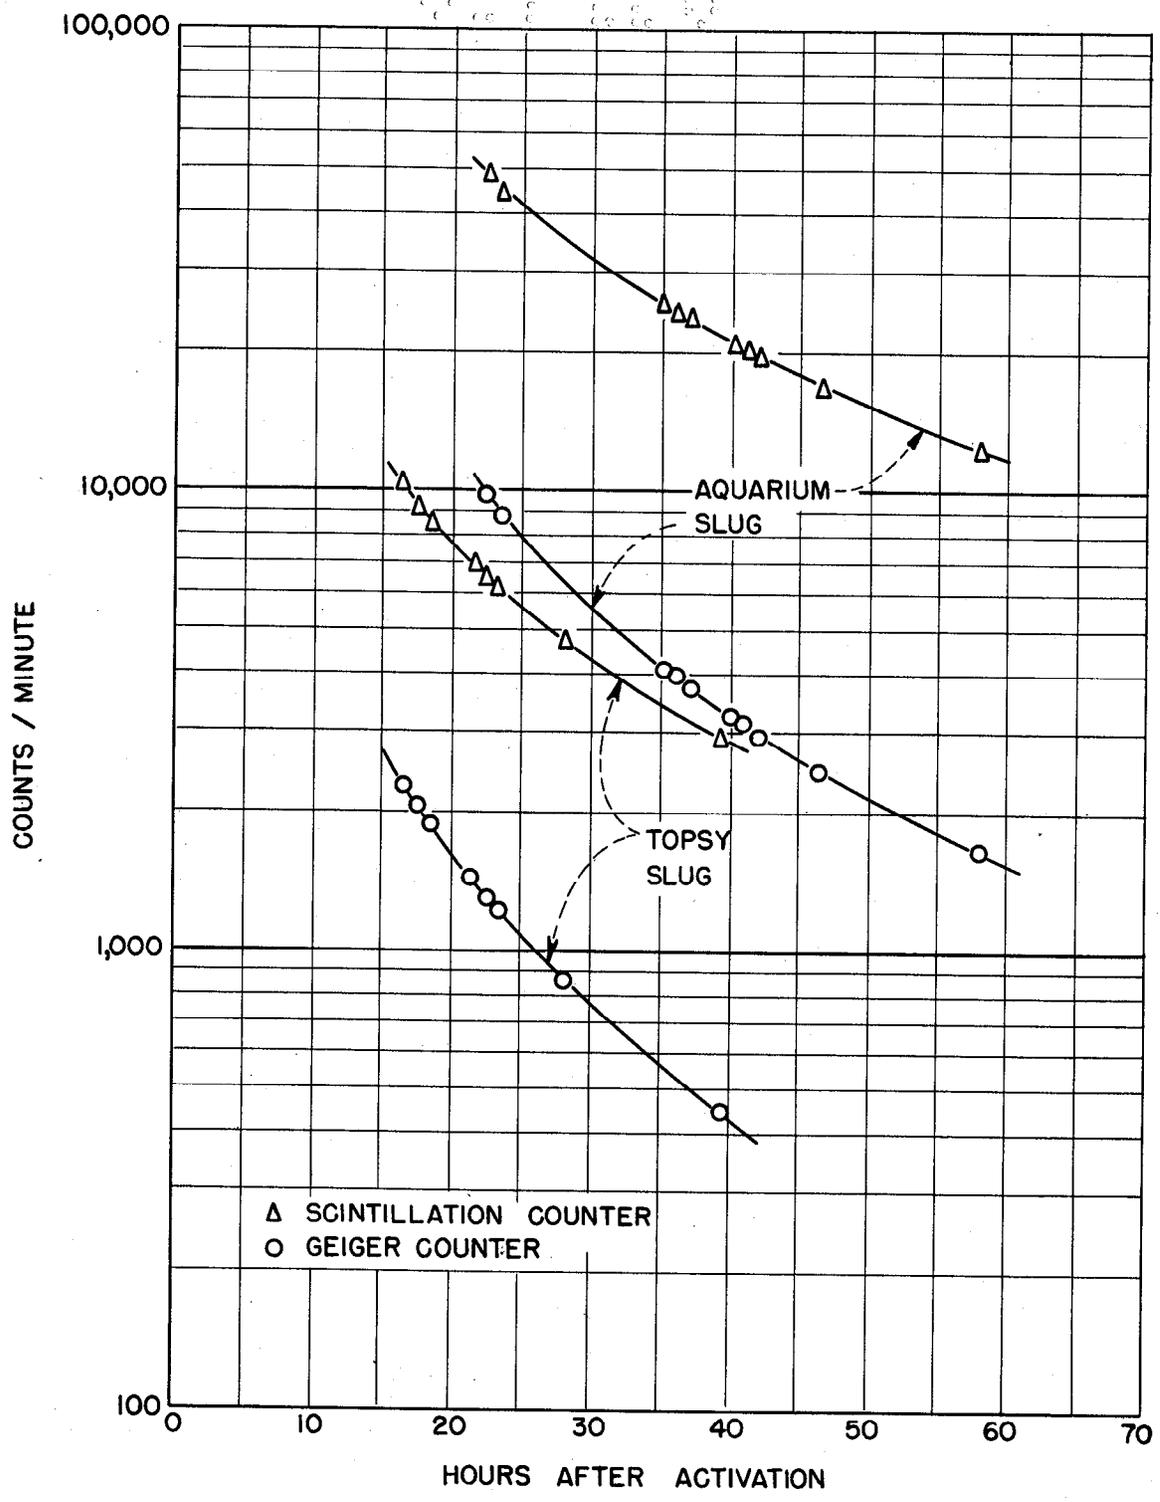
An estimate of the total number of fissions occurring in the burst was made by comparing the fission fragment gamma activity from the small cylinder of Oy taken from the center of A with a similar cylinder that was irradiated in the Topsy critical assembly machine. The decay curves of the two slugs are shown in Fig. 4. The gamma activities were counted with a Geiger counter and with a scintillation counter. The difference in curvature of the Geiger counter and scintillation counter curves is probably due to the fact that sensitivity dependence on energy of the two detectors is not the same.

FIG. 4. Comparative decay curves of Oy slugs from Topsy reactor irradiation and from the Aquarium radiation burst.

The average number of fissions per gram for the Topsy irradiation from the above data is 1.10×10^{11} . Since the fission rate in the center of Topsy is 1.68 times the average rate, the number of fissions per gram in the Topsy slug was 1.83×10^{11} . The number of fissions per gram in the Aquarium slug was therefore 1.6×10^{12} . Since the Aquarium assembly was quite non-symmetrical, one can only assume that the number of fissions occurring in the slug was representative of the assembly average. On the basis of this assumption, the total number of fissions occurring during the burst from the Aquarium assembly was 1.0×10^{17} fissions. Assuming 188 Mev of heat energy per fission, this represents an energy release of 835 watt-hours, which, for a burst duration of 0.2 second⁽¹⁾ would make the power developed during the burst ~ 15 megawatts.

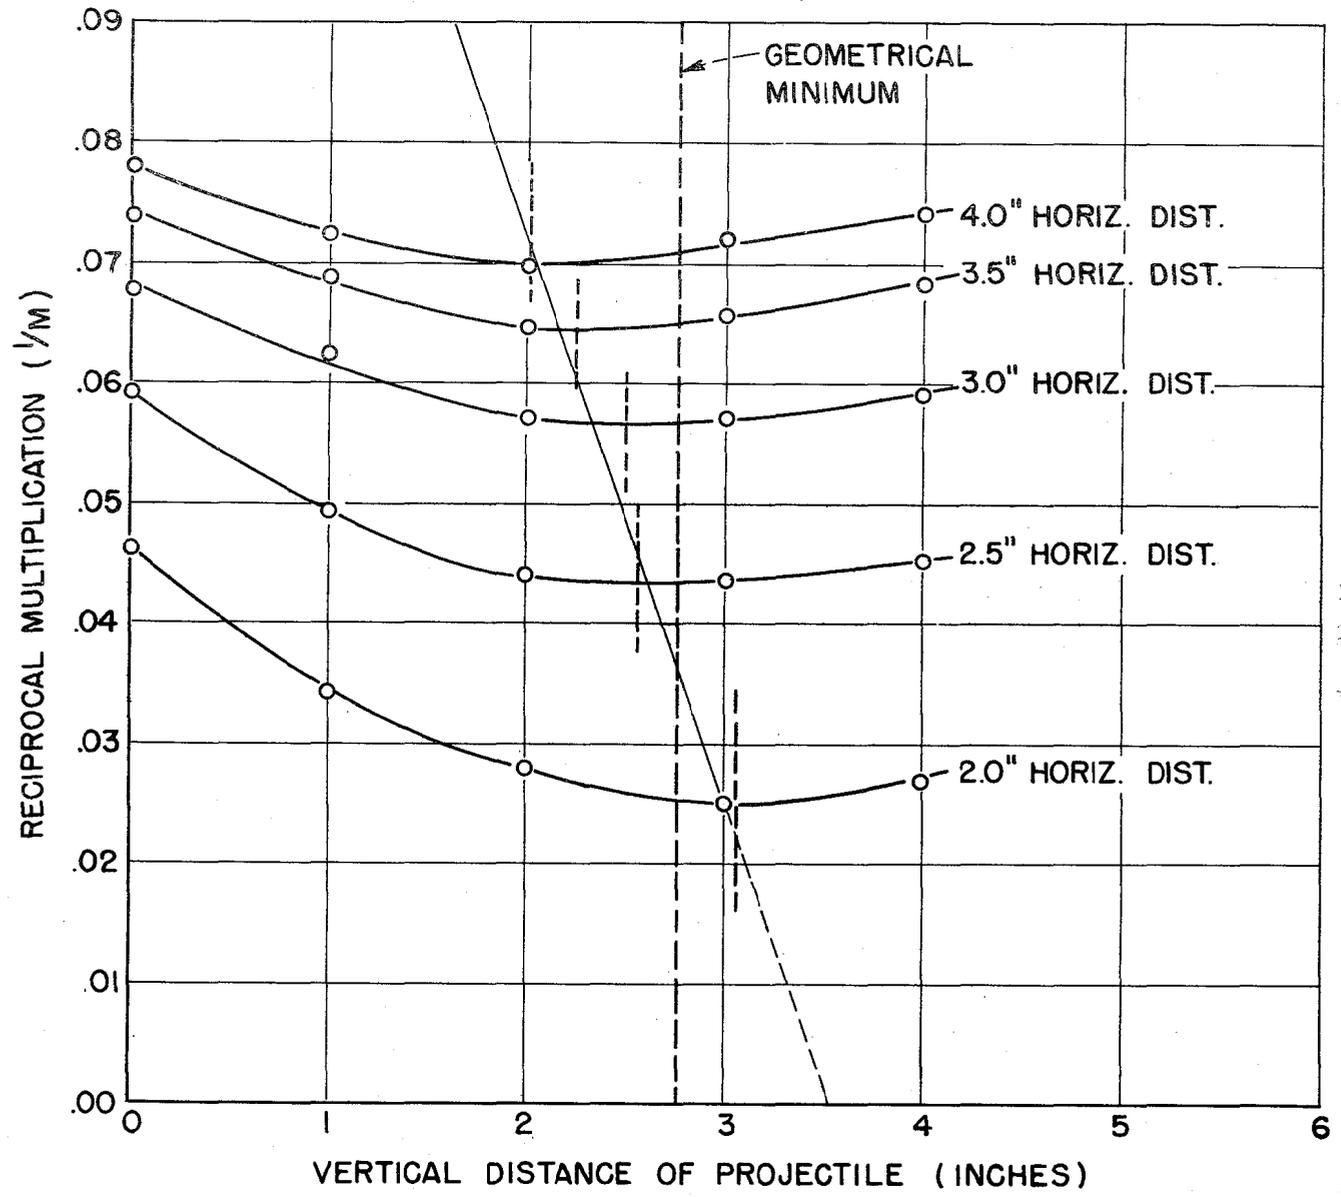
The results of this experiment are illustrated in Fig. 5. For an A - B horizontal separation of 4.0", the center of reactivity of A is apparently $2.70'' - 2.05'' = 0.65''$ above the center of mass. As the horizontal distance between the components is decreased, the center of reactivity moves downward, until at a horizontal separation of about 2.3", the center of mass and the center of reactivity coincide. At a separation of 2.00", the center of reactivity of A is 0.30" below the center of O_y mass. By linear extrapolation for a critical condition, the center of reactivity would be 0.85" below the O_y center of mass. This would place the center of reactivity of A $2.70'' + 0.85'' = 3.55''$ below the center of reactivity of B, resulting in a distance of 7.12" between these centers. The distance between centers would thus be reduced by $7.12'' - 6.19'' = 0.93''$ by vertical upward motion of A, bringing the Assembly as a whole to the verge of prompt criticality.

FIG. 5. Plot of reciprocal multiplication vs vertical position of A for various horizontal separation distances between A and B, in effectively infinite water tamping.

If there were no shift of the center of reactivity of A away from the center of O_y mass, one would expect the minimum for each of these curves to occur at an A vertical position of up 2.70", since at this position the O_y centers of mass are at the position of closest approach. Any displacement of minima away from 2.70" must be due to the competing Cause (2) effects described above.

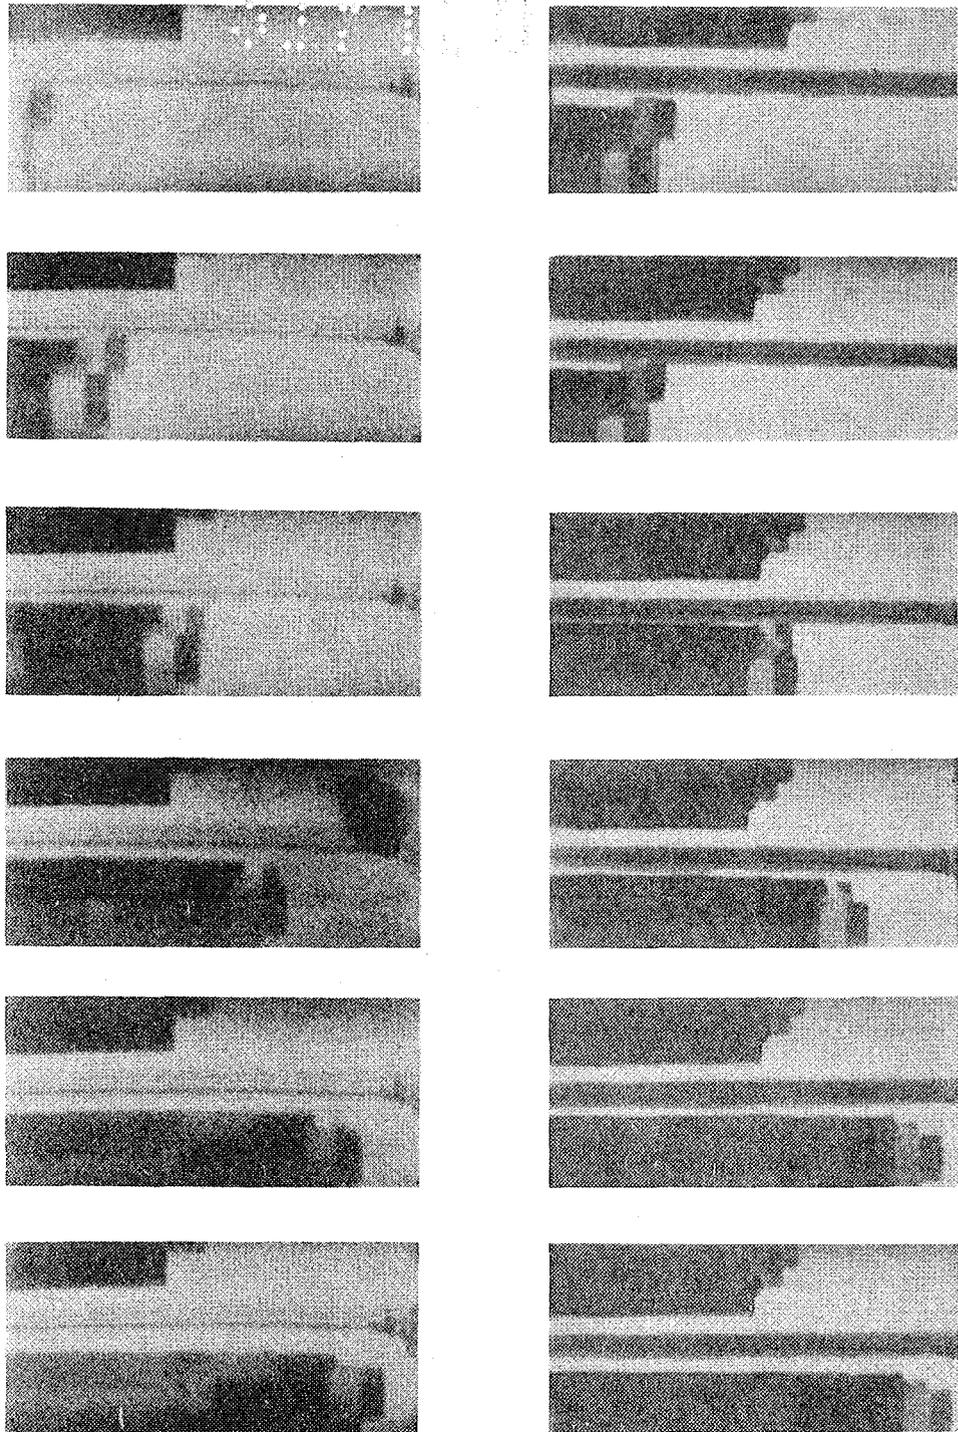
Sequences of sample films are shown in Fig. 6 for air and for water in the tank. In both cases, the first action of A is to move toward B. Figure 7 is a plot of the A - B separation distance as A moves upward on scrambling. Times from the start of the motion are also indicated. At an A position up 3.55" (in water), at which point the centers of reactivity of A and B should be directly opposite in a horizontal plane, A is seen to be 0.39" closer to B horizontally than at the start of the motion⁽¹⁾. This is more than enough, when combined with Causes (1) and (2) to drive the assembly well into the prompt critical region.

FIG. 6. Sequences of Fastax camera films indicating relative positions of A and B during the scrambling action. The sequence in the vertical column on the left was taken with the masses in air; that in the vertical column on the right was taken with the masses under water.

The motion of A under the action of the air-lift plunger was studied employing Tu mockups of the active assemblies, both in air and in water, by means of a Fastax camera. A glass "porthole" six inches in diameter was installed in the Aquarium tank directly opposite the position of the assemblies (see Fig. 2). The Fastax camera was mounted outside the tank adjacent to the porthole in such a position as to view the motion of A relative to B when the A air-lift was actuated by scrambling the assembly. A and B were set at a horizontal separation distance of 1.00", the camera was started at a rate of 840 frames per second, and the scram button on the control panel in the control room was pushed. This was done for the parts in air as well as in 22.5" water. The films were then developed and read using a comparator.

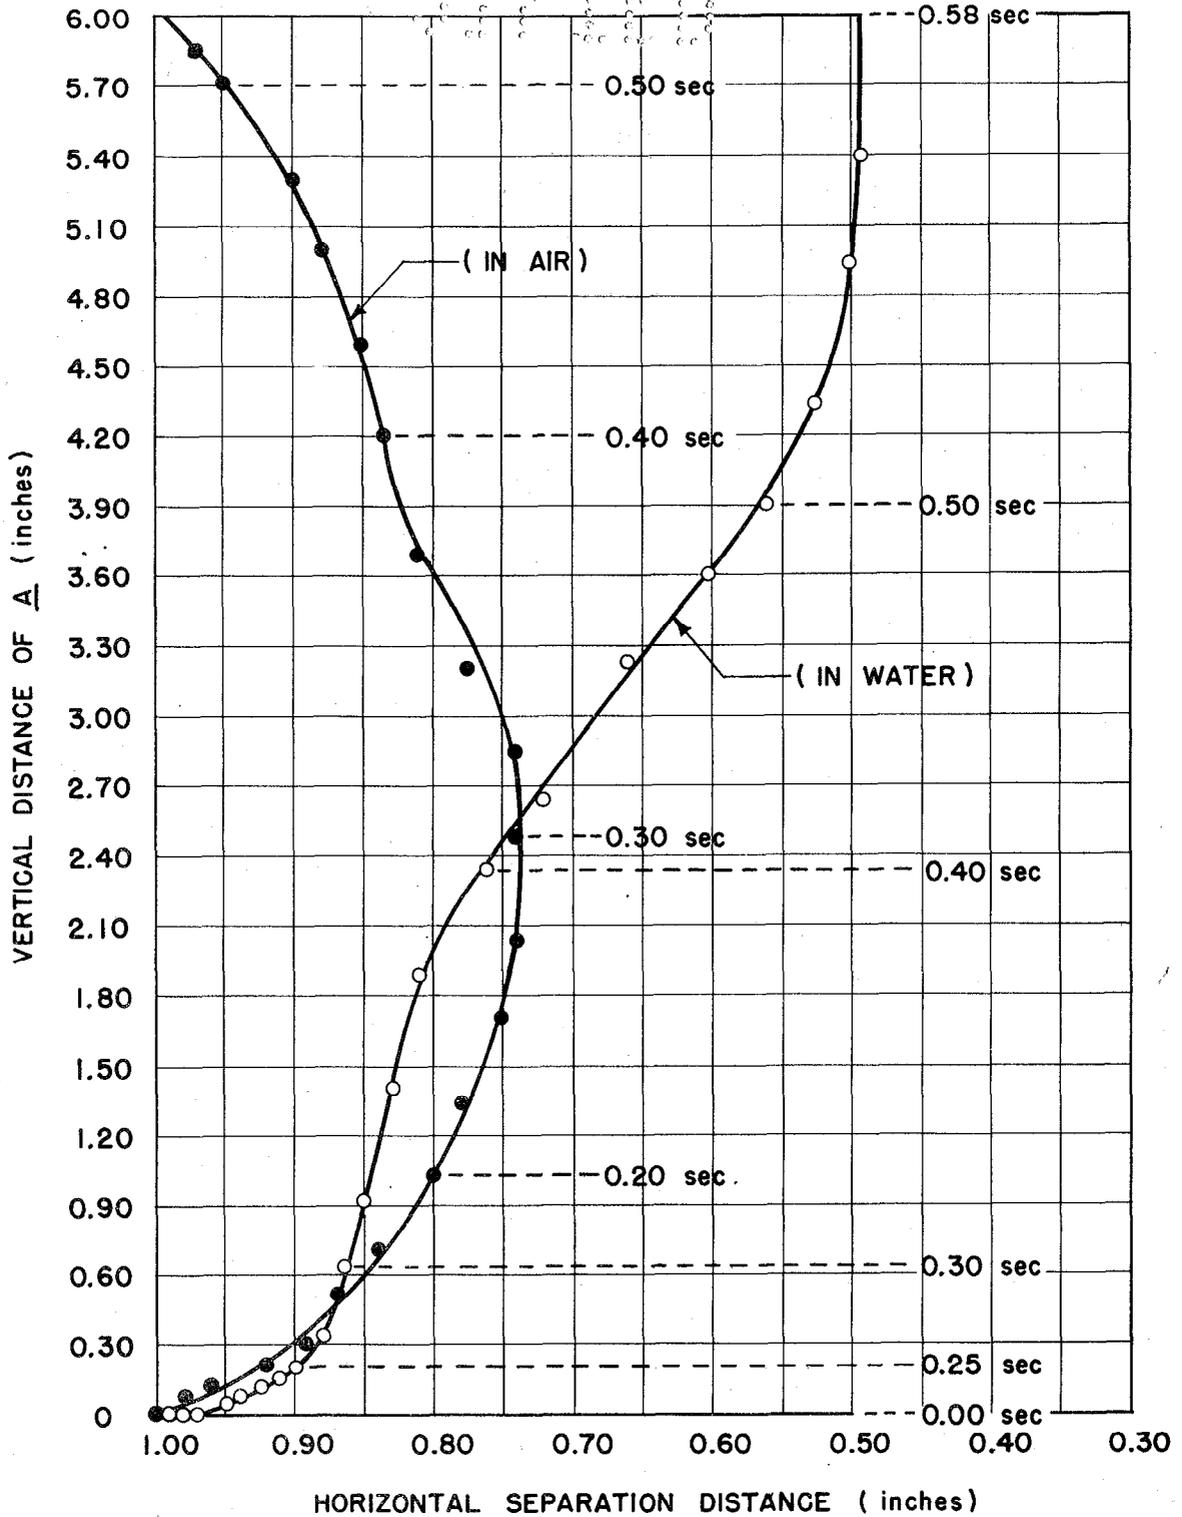
FIG. 7. Plot of the relative motion of A and B during scrambling action, in air and in water, as read by comparator from Fastax camera traces.

Following up the underwater curve of Fig. 7, and combining effects with those due to Causes (1) and (2), the points in the vertical travel of A at which the assembly as a whole became delayed critical, then (potentially) prompt critical⁽²⁾, and back through prompt critical to delayed critical and subcritical, have been estimated. From this, the periods of time during which the assembly was delayed critical and prompt critical have also been estimated. These data are summarized below.

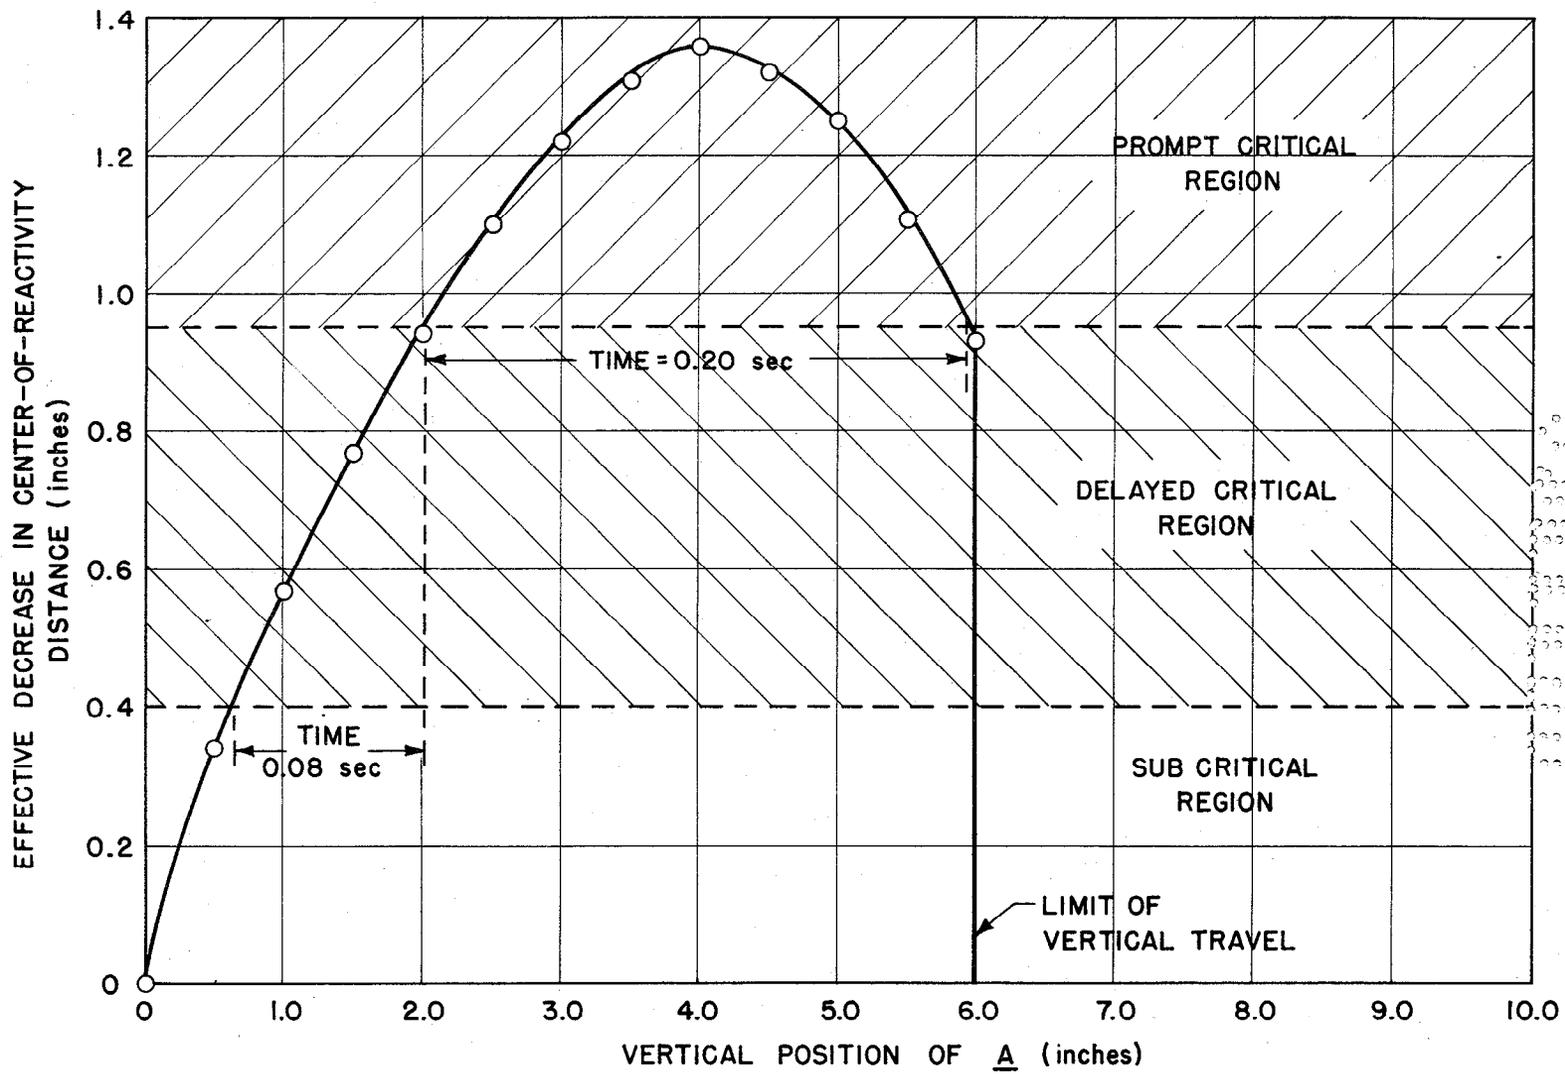
These results are shown graphically in Fig. 8, which is a plot of the effective separation distance between A and B centers of reactivity as a function of the vertical position of A during scrambling action, representing the combined effect of Causes (1), (2), and (3).

FIG. 8. Plot showing the combined effect of Causes (1), (2), and (3).

Assembly delayed critical for A "up 0.65" to "up 2.0", a period of 0.08 second.

Assembly potentially prompt critical for A "up 2.0" to "up 5.9", a period of 0.20 second.

Assembly delayed critical for A "up 5.9" to limit of travel (6.0), and for a period of 0.2 second thereafter.
