LA-13638

A Review of Criticality Accidents

2000 Revision

Issued: May 2000

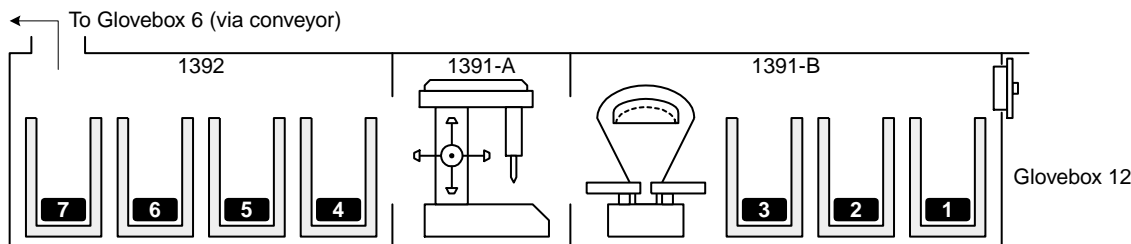
Figure 29. A simplified layout of Glovebox 13.

Glovebox 13, where the criticality accident took place, consisted of three workstations, (1391-A, 1391-B, and 1392, see Figure 29) and was connected to gloveboxes 12 and 6 by a pass-through port and conveyor, respectively. All of the ingots produced at the plant passed through this glovebox operation. For these particular workstations, the administrative limit for the containers was even stricter, allowing only one ingot regardless of its mass. Workstation 1391-A was used for extracting drill samples (up to 0.1 g) for chemical analysis of the impurities. The ingots were weighed in workstation 1391-B, where the samples were also temporarily stored. Workstation 1392 was used for measuring the dimensions of the ingots. Within the workstations the ingots were removed and returned to their original containers one at a time. The workstations were equipped with pass-through ports in the connecting walls, gloveports, and 50 mm thick leaded glass windows. The front of the workstation had a 30 mm thick lead shield to reduce the γ -radiation from the plutonium.

At the beginning of the shift on 13 December 1978, three containers were in workstation 1391-B, and four containers were in workstation 1392, each with one ingot. The ingots are numbered sequentially in Figure 29 for the purpose of the discussion that follows. Although the containers are depicted as being linearly arranged, in actuality the containers holding ingots 4 and 5 were behind those with ingots 6 and 7, making visual inspection of the contents more difficult

than implied by the figure. At the time of the accident, processing of six of the ingots had been completed, and only ingot 3 needed to remain in 1391-B. According to the shift instructions, Operator A was to

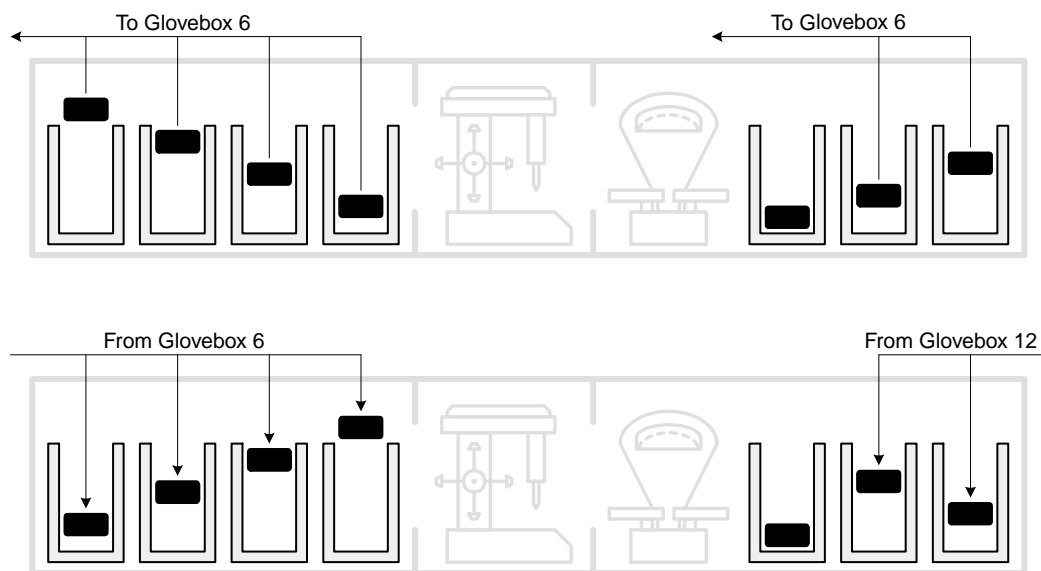
Figure 30. Intended sequence for the transfer of ingots from and to Glovebox 13.

The intended order of ingot transfers, as specified in the shift instructions, is illustrated in Figure 30. The actual order of ingot transfer is shown in Figure 31, Frames 1 through 6. Operator A transferred two ingots, 6 and 7, from workstation 1392 to glovebox 6. These ingots were replaced in workstation 1392 by two ingots, 8 and 9, from glovebox 6. Both of these actions were in accordance with the shift instructions.

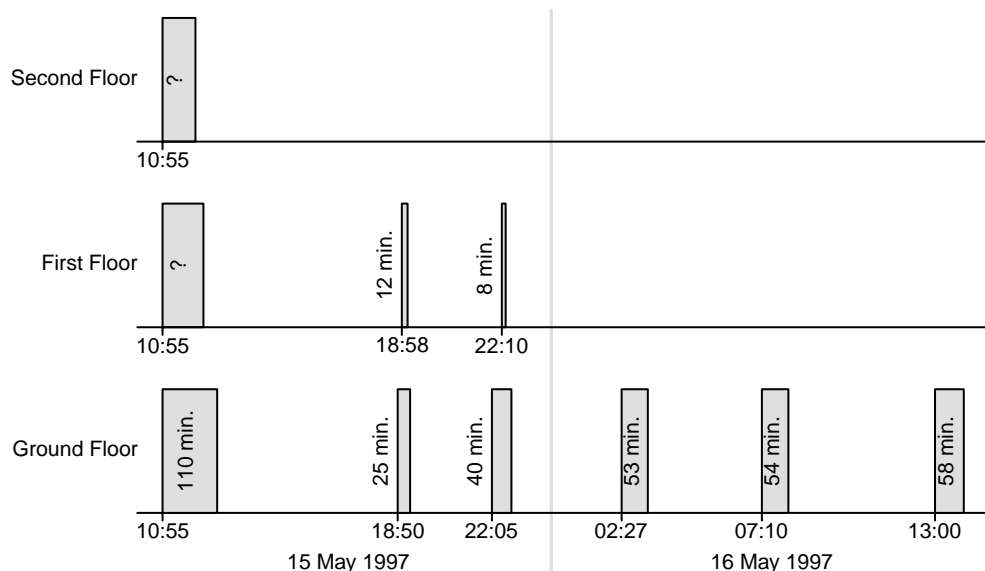
Figure 33. Sequence of alarms and duration that the radiation levels exceeded the alarm level (36 mR/h).

samples of the UO_2 particles taken on 20 May. The detectors were located at 12 monitoring stations. However, during the excursions, at most only three of the monitoring stations alarmed, indicating very low peak power for each excursion. These three stations were located on the ground, first, and second floors directly above one another. From the central control room, health physicists documented the sequence of excursions, the response of the detectors, and the length of time that the detector alarm threshold (36 mR/h) was exceeded (Figure 33).

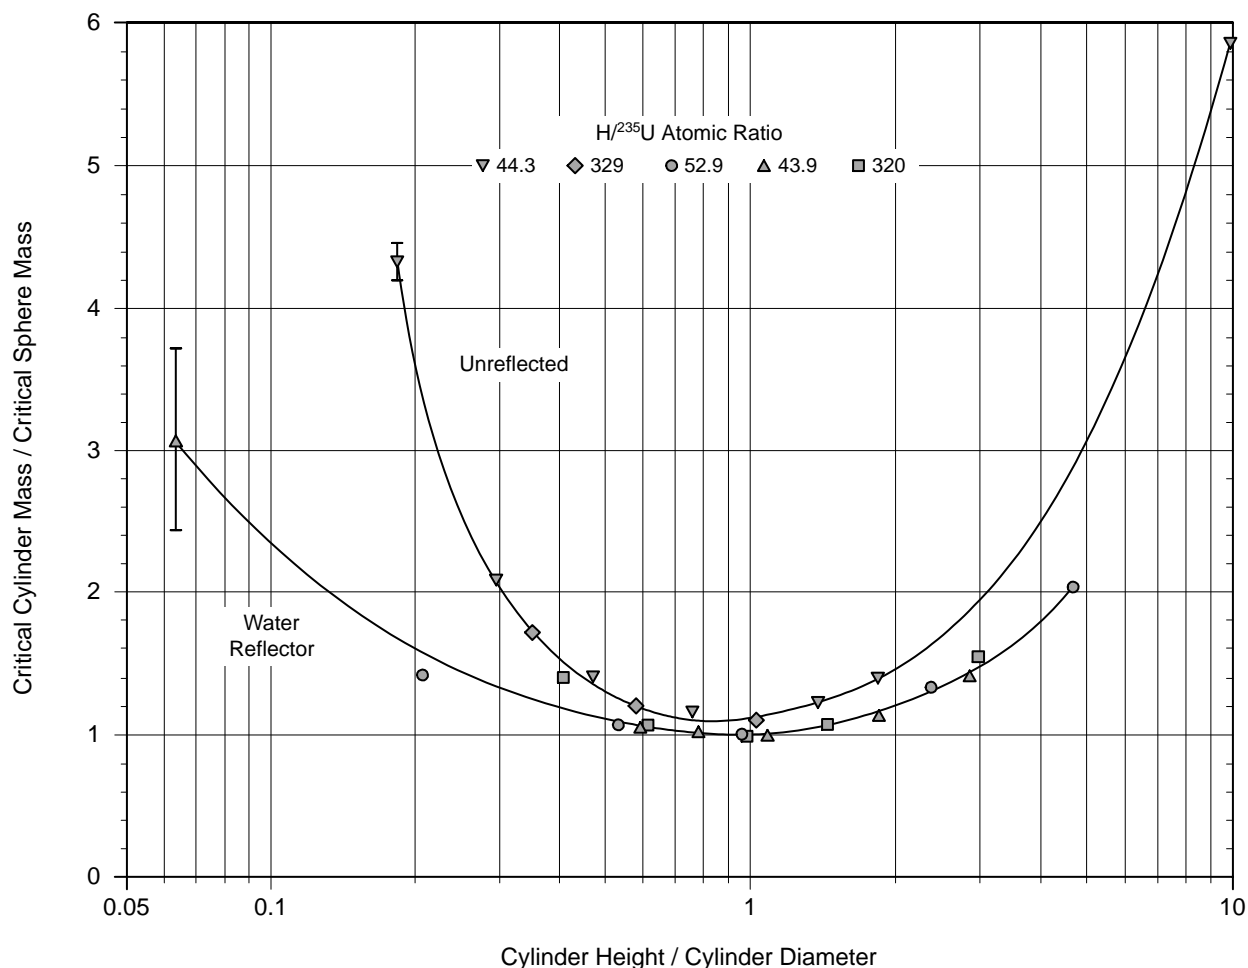
Figure 36. The ratio of cylindrical to spherical critical masses of $\text{U}(93)\text{O}_2\text{F}_2$ solutions, unreflected and with water reflector, as a function of cylinder height to cylinder diameter ratio.

For the 18 accidents where h/D is specified, the unreflected curve in Figure 36³⁴ was used to determine the shape factor. The curve in Figure 36 is based directly on experimental results minimizing dependence on calculations. For the remaining 3 accidents (numbers 2, 6, and 20), buckling or other mathematically simple approximations were used to estimate the shape factor.

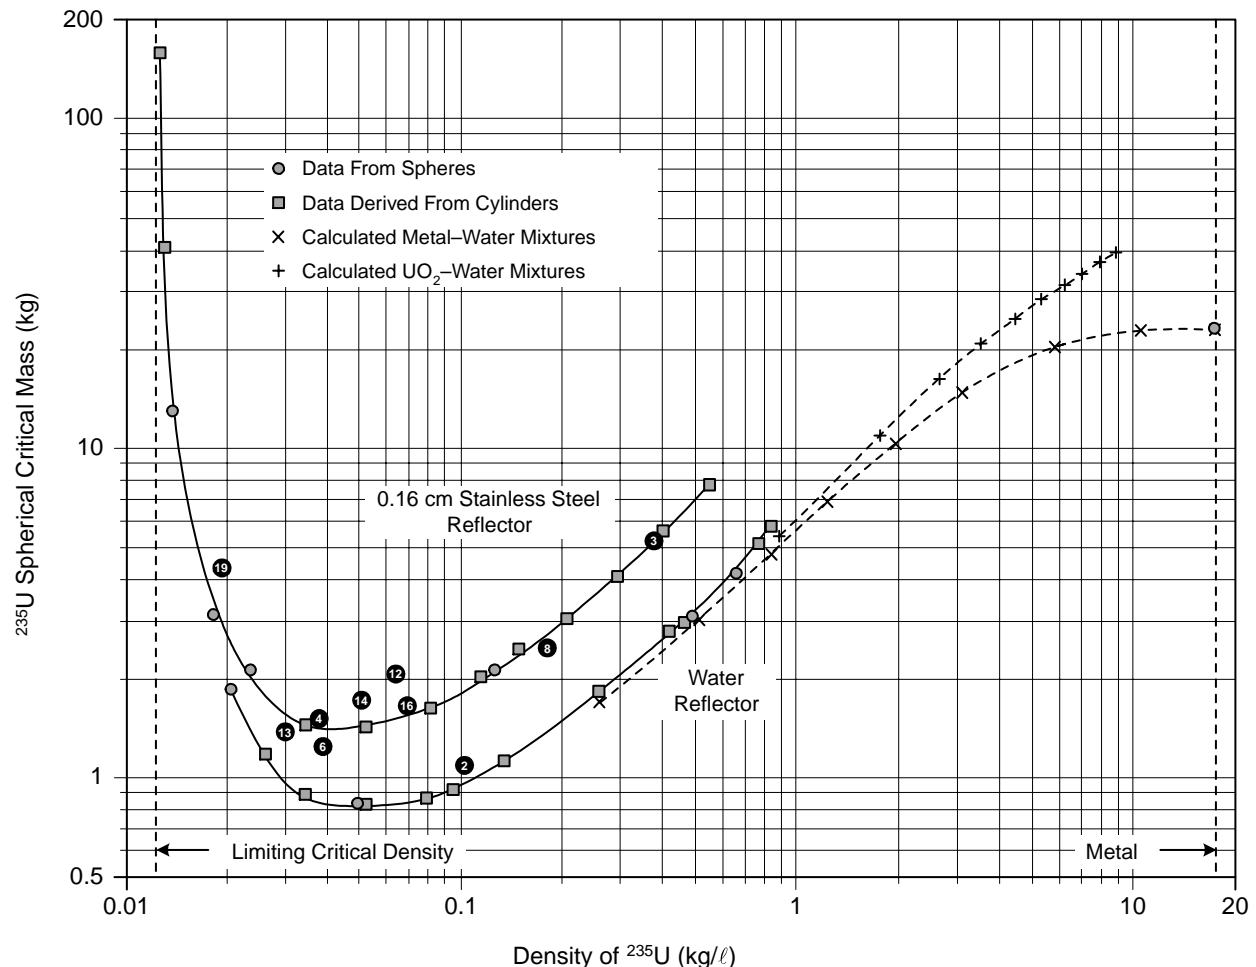
Figure 37. Critical masses of homogeneous water moderated U(93.2) spheres. Solution data appear unless indicated otherwise. The accidents are shown by numbered circles.

Figures 37, 38, and 39 are selected and adapted from Los Alamos report LA-10860.³⁴ These three figures include points corresponding to fissile density (or atom ratio) and the estimated spherical critical mass for the twenty-one accident re-constructions in Table 9. Figure 38 includes curves for systems with uranium enrichment corresponding

Considering the effects of partial reflection and inherent uncertainties in the estimates, it is judged that the position of 18 of the 21 points plotted in Figures 37, 38, and 39 are sufficient for establishing credible agreement between the reported accident conditions and known conditions for criticality. The estimates for accidents 1, 7, and 9 appear to be somewhat questionable in that more mass than reported in the accident would be required for criticality under the hypothesized unreflected accident conditions. However, accidents 1 and 7, would be in reasonable agreement if the partial reflection present during the accident were taken into account. It should be noted that for these two cases, the "missing" mass is no greater in magnitude than other accident reconstructions (notably, accidents 12, 14, and 17) in which the reported mass exceeds the known conditions for criticality. The discrepancy surrounding accident 9 is also consistent with the large reported uncertainty in the amount of mass present. No systematic features are distinguishable that differentiate the R.F., U.S., U.K., and Japanese accidents.

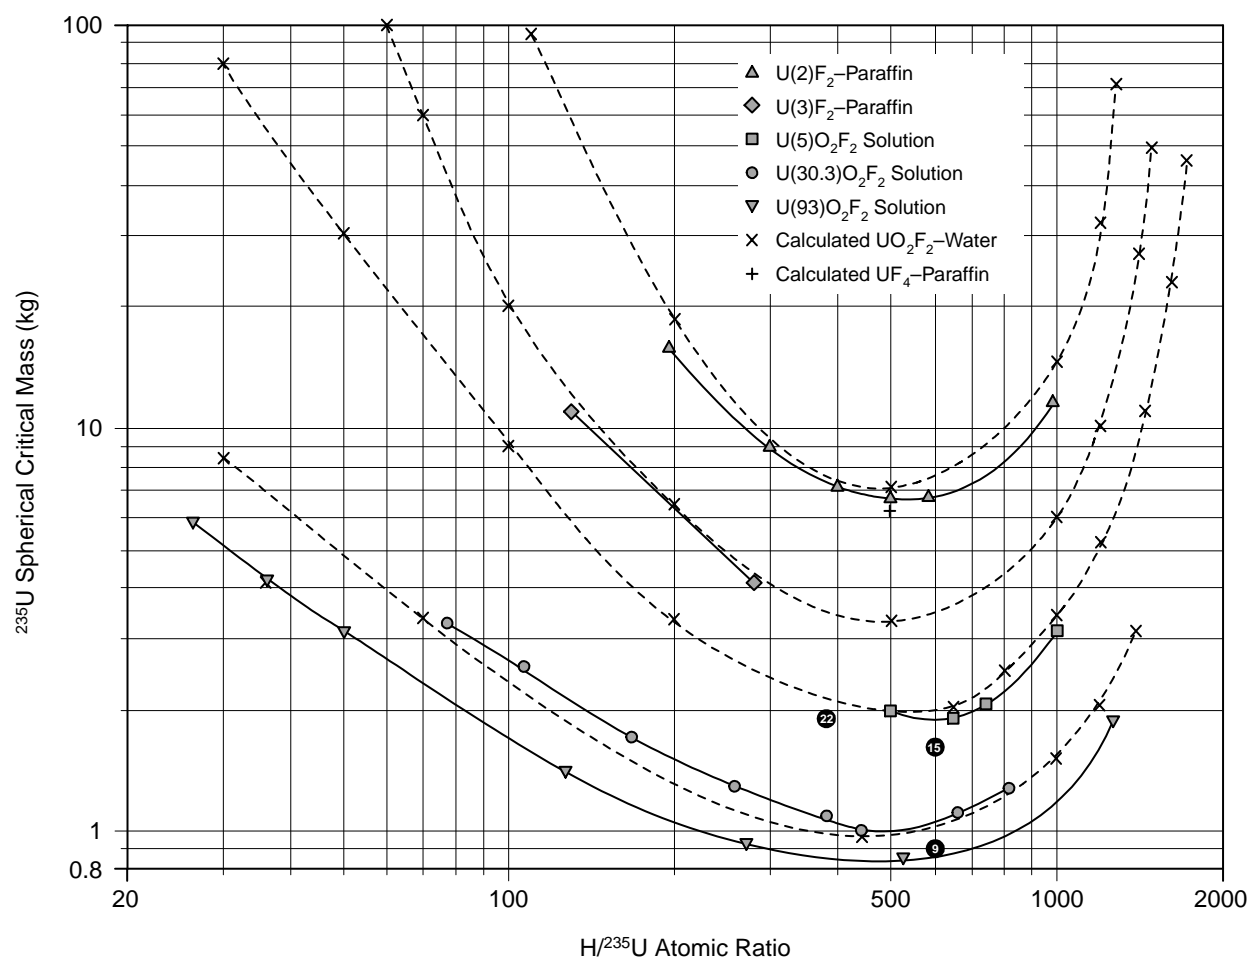
Figure 38. Critical masses of water-reflected spheres of hydrogen-moderated U(93), U(30.3), U(5.00), U(3.00), and U(2.00). The accidents are shown by numbered circles.

to 2.0, 3.0, 5.0, 30.3, and 93.0. Accidents 9, 15, and 22 are superimposed on this figure. Since the curves in Figure 38 are for water reflected systems, these points have been adjusted downward since the actual accidents were relatively unreflected.
