# Argonne National Laboratory

## THE EBR-I MELTDOWN - PHYSICAL AND METALLURGICAL CHANGES IN THE CORE

Final Report - Metallurgy Program 7.2.18

November 1957

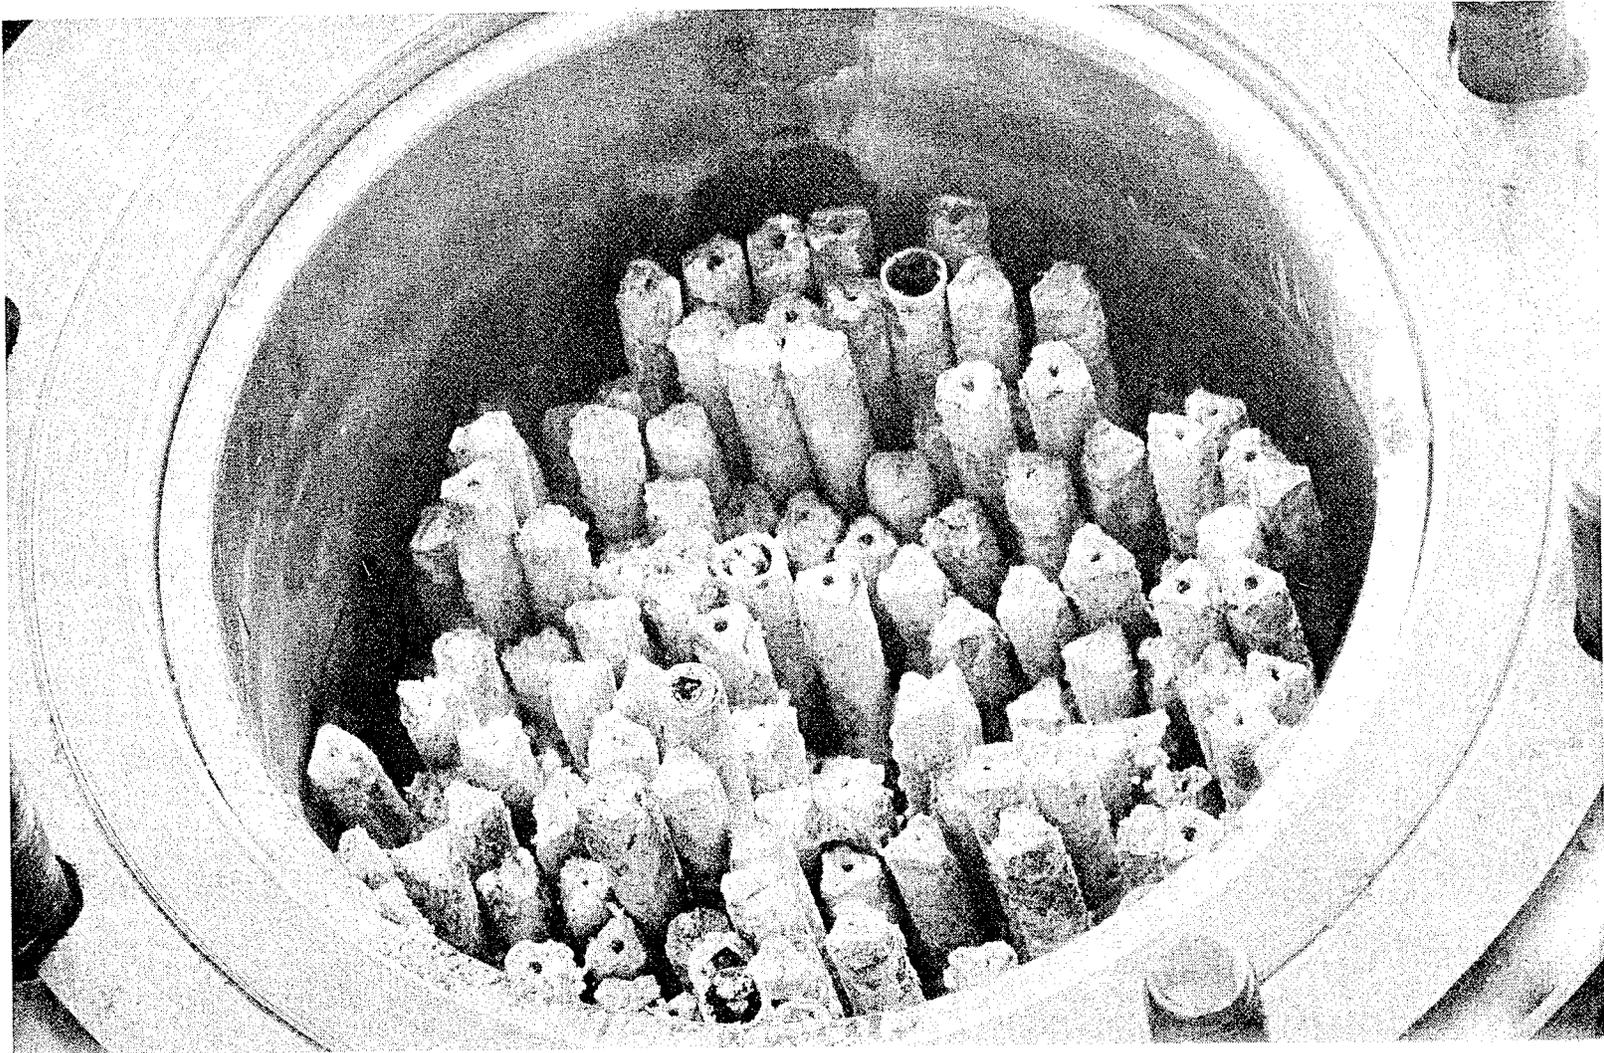
Figure 26. Appearance of the top of the damaged EBR-I core before final disassembly operations were started.

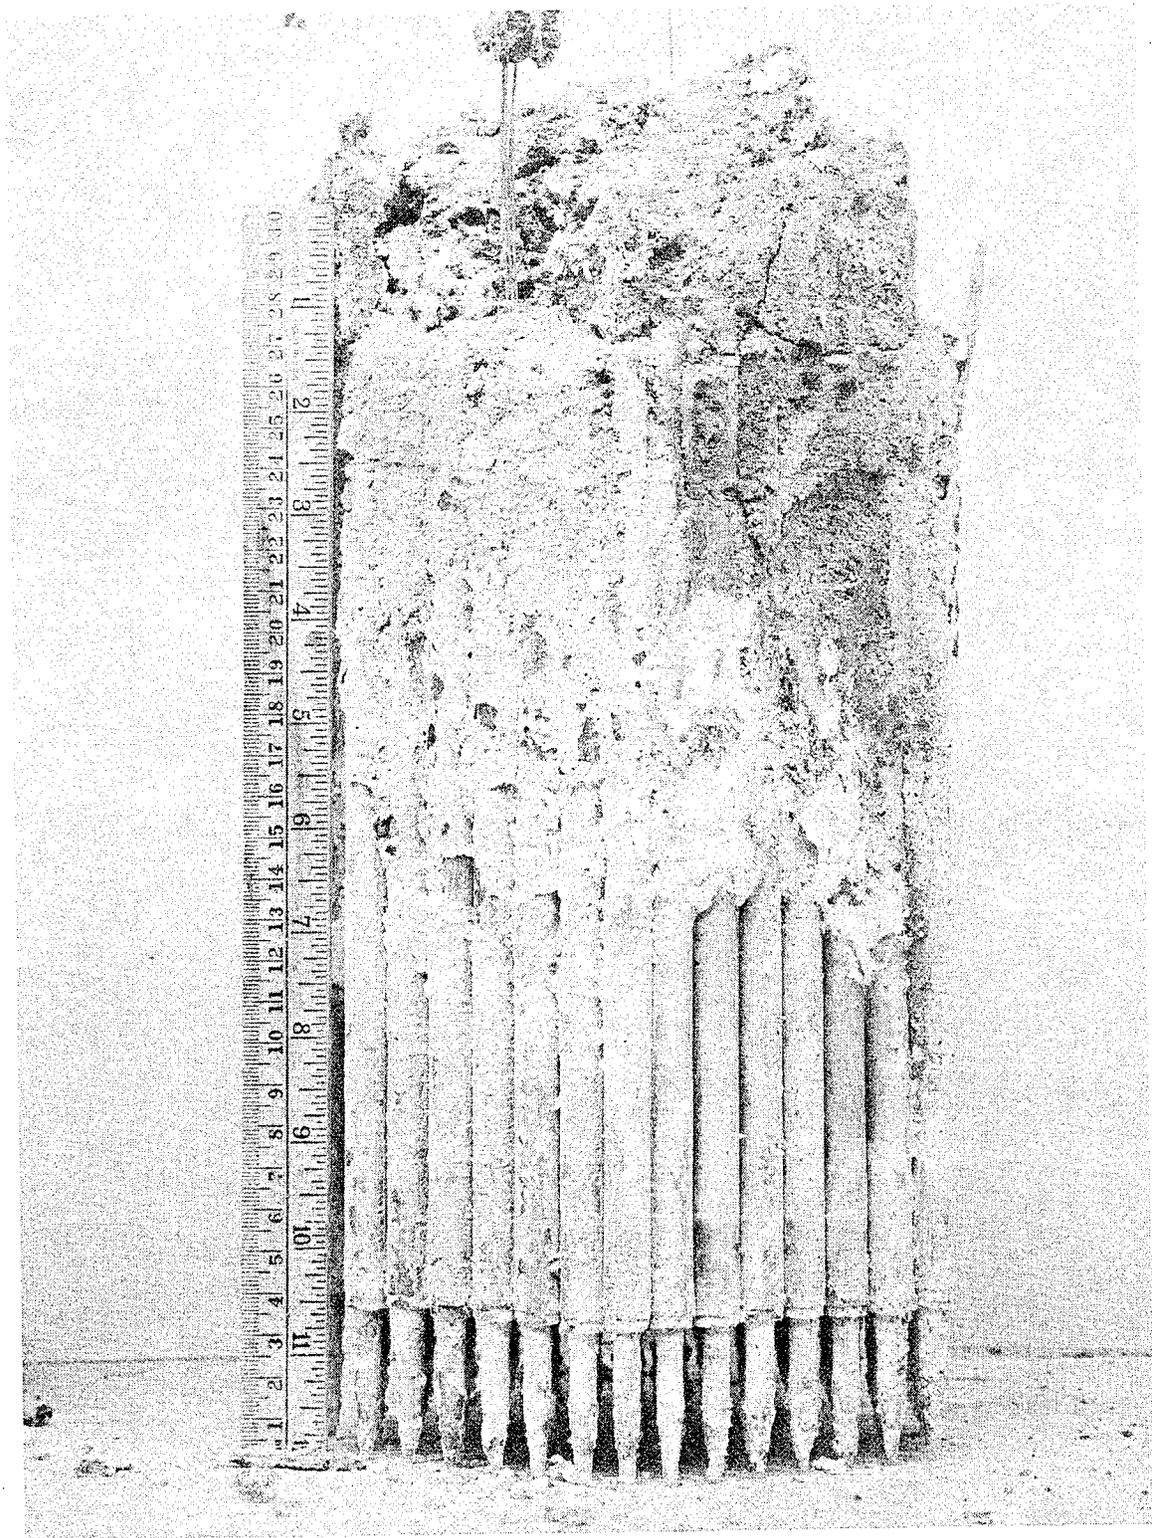
Figure 31. Appearance of the damaged EBR-I core after removal of the upper blanket section.

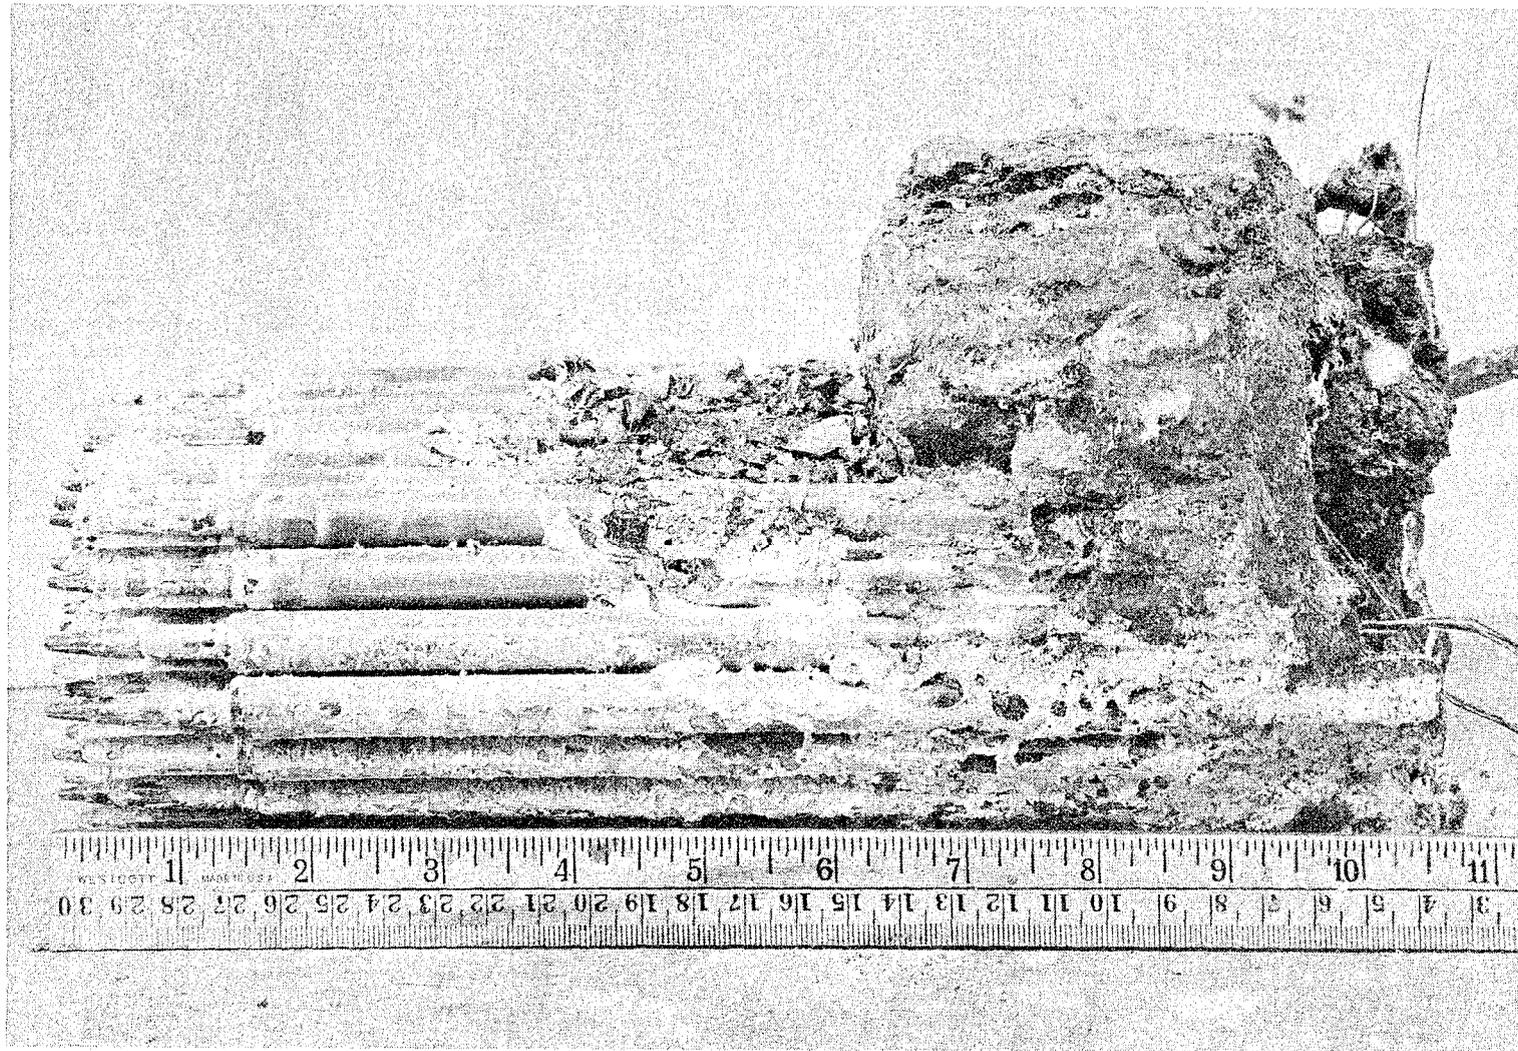
The next part of the core assembly that was removed was about half of the lower blanket rods. As was the case with the upper blanket section, it was found that the lower blanket rods broke away from the fuel section, as shown in Figures 33 and 34. Also, as was the case in the upper blanket, the coolant passages in the lower blanket were filled with solidified material from the fuel section. It was noted that this material when freshly broken was black, but on standing for an hour or two became covered with white oxide. The material had moved downward between the outer jackets for varying distances depending upon the distance from the center of the reactor. The maximum downward travel was approximately three inches and occurred at the center of the reactor. The solidified material could easily be removed from the outer jackets of the lower blanket section, and, as shown in Figure 35, no melting damage was observed.

Figure 33. Side view of core assembly after partial removal of lower blanket section.

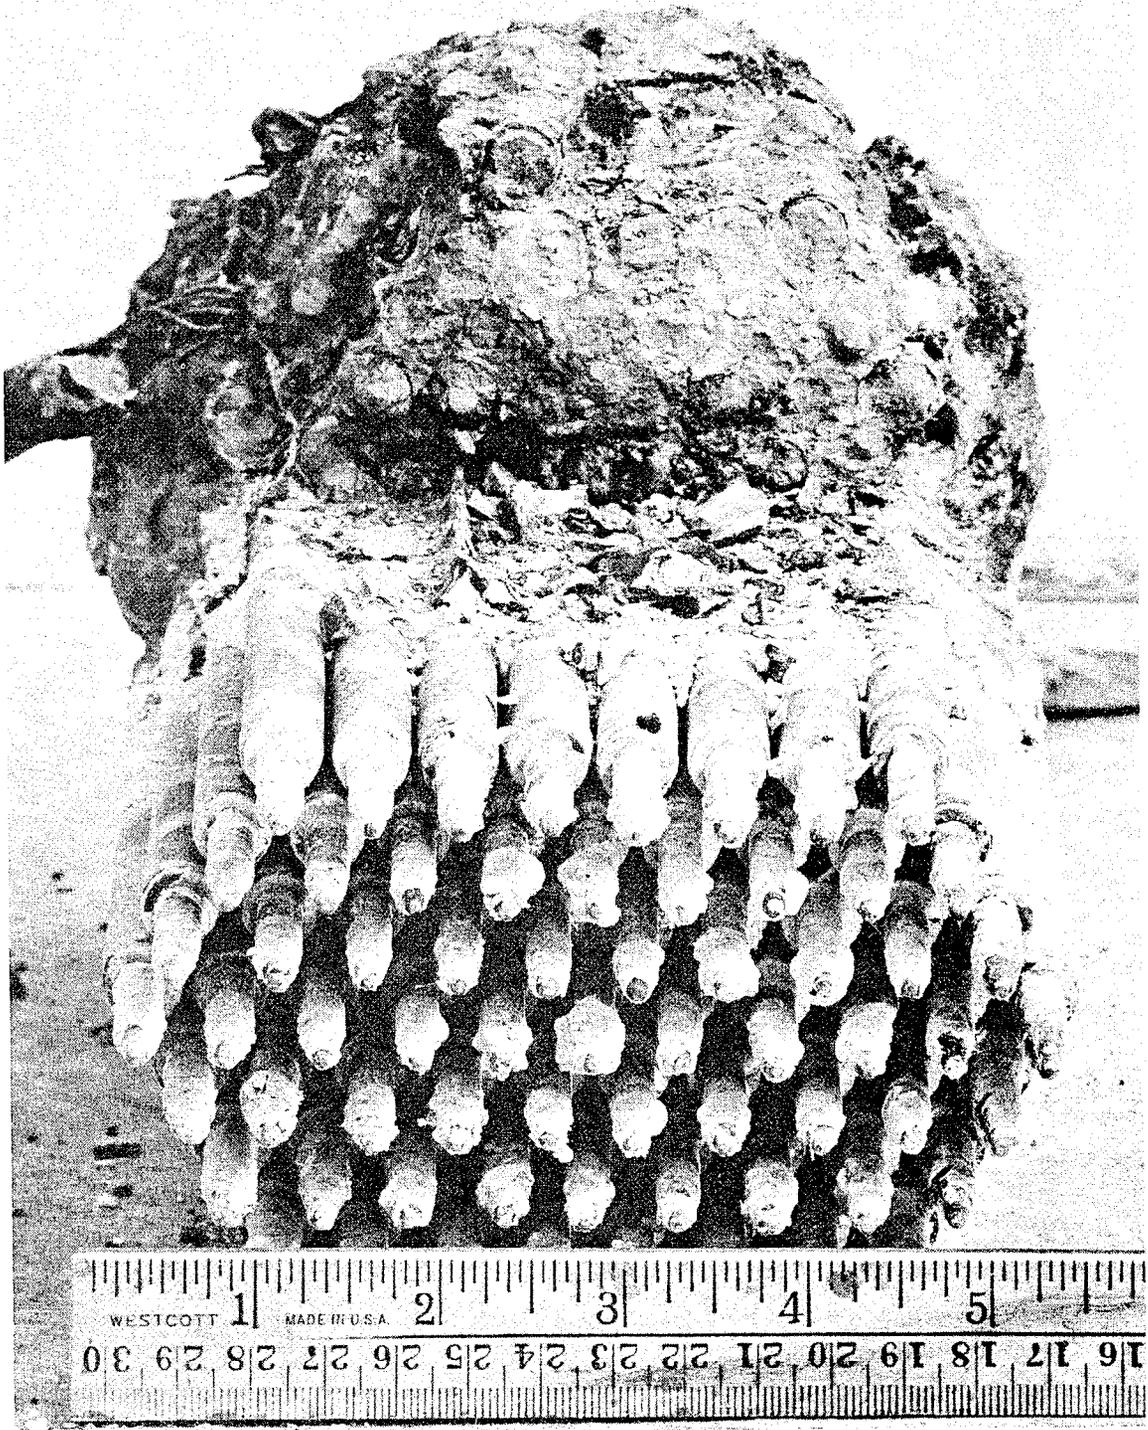
Figure 34. Bottom of fuel section, after partial removal of lower blanket rods.

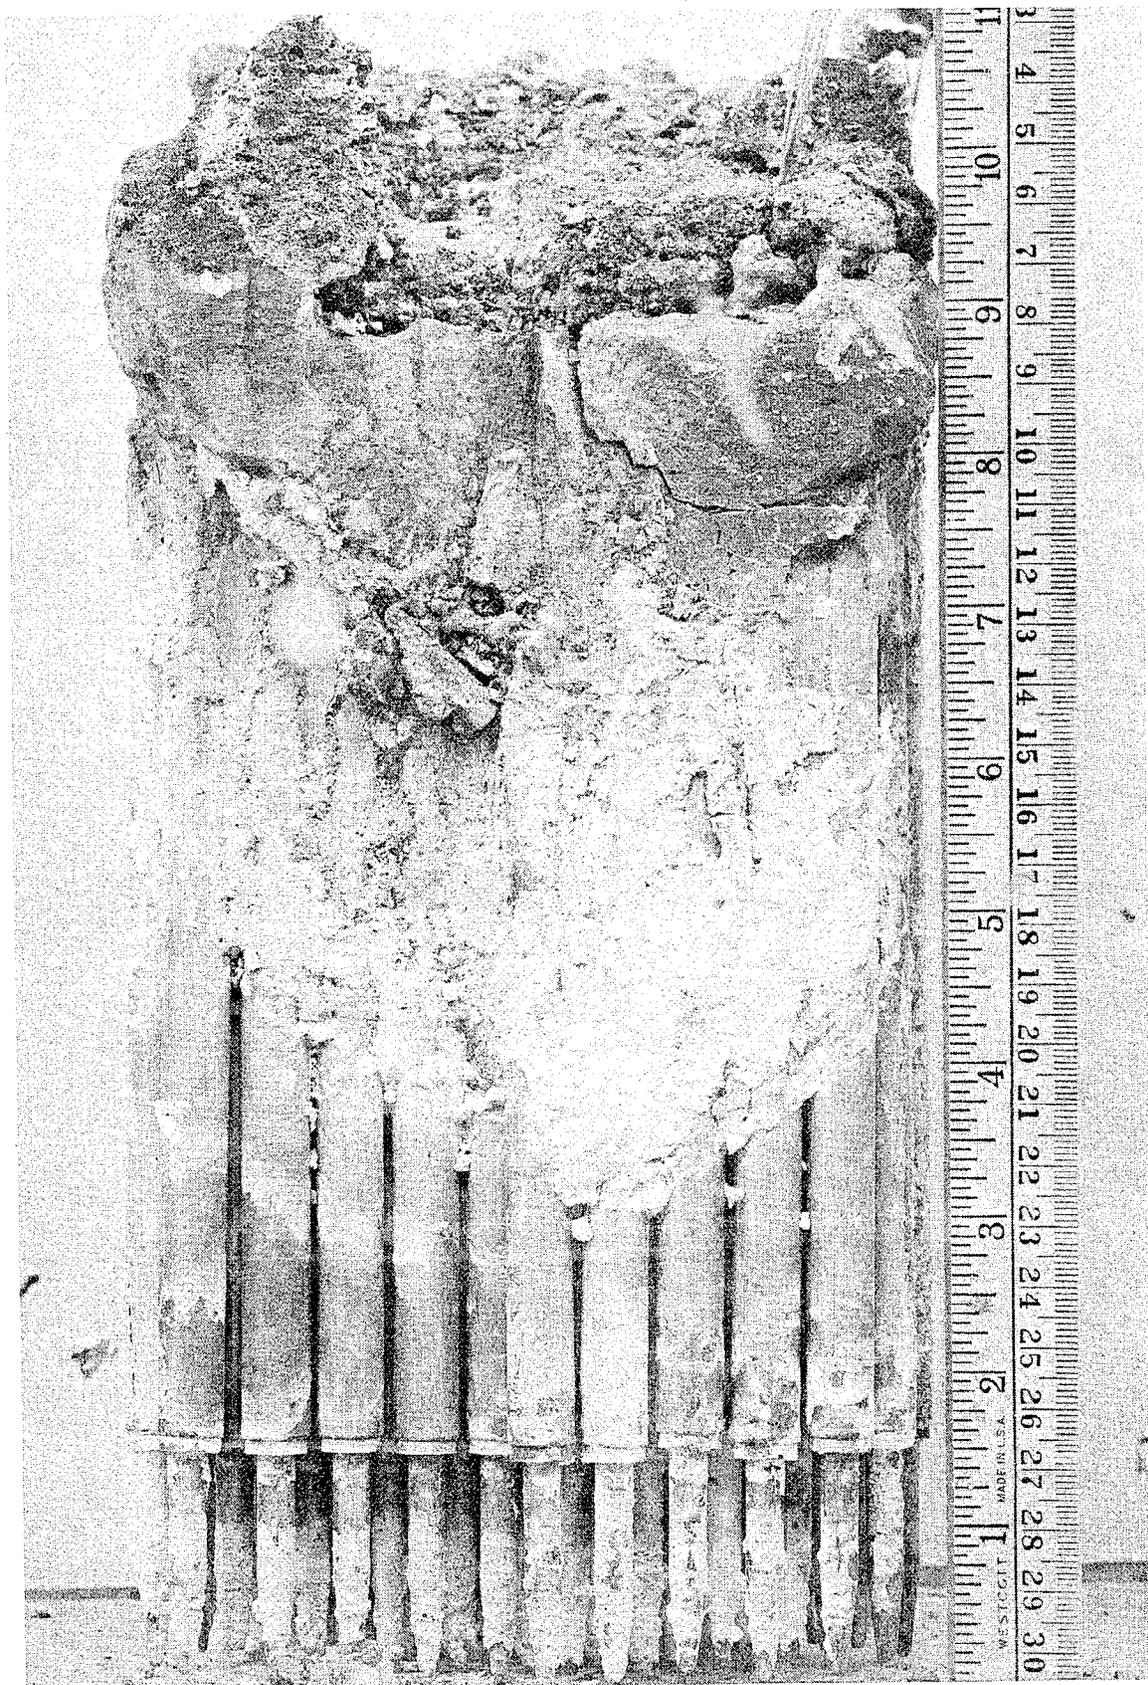
The half of the fuel section from which the lower blanket had been removed, shown projecting upward in Figures 33 and 34, was then split off to make a vertical cross section of the lower half of the core assembly, shown in Figure 36. The junction between fuel and lower blanket is at the  $6\frac{1}{4}$ -in. level of the adjoining scale. This section showed that the lower side of the coarse and fine sponge-like zones terminated abruptly and that the lower part of the fuel section consisted of a dense, relatively non-porous mass. This material could be fractured only with difficulty because it was tough and somewhat ductile. It was observed that this material evidently also contained entrapped finely dispersed NaK. When freshly broken it showed a bright silvery appearance, which turned dark within about a minute. Several hours later, if sufficient oxygen were present, the black product, which was perhaps nitrides or sub-oxides of NaK, was replaced with normal white oxide.

This dense zone was found to contain at least 12 or 15 partially dissolved fuel slugs which were jumbled together near the center line of the reactor. Although three fuel slugs can be seen in the photograph in Figure 36, the piece of material shown in Figure 37 shows more clearly the random manner in which the fuel slugs were embedded in the dense

Figure 36. Vertical cross section of the lower half of the core. The junction between fuel and lower blanket is at the 6-1/4 in. level.

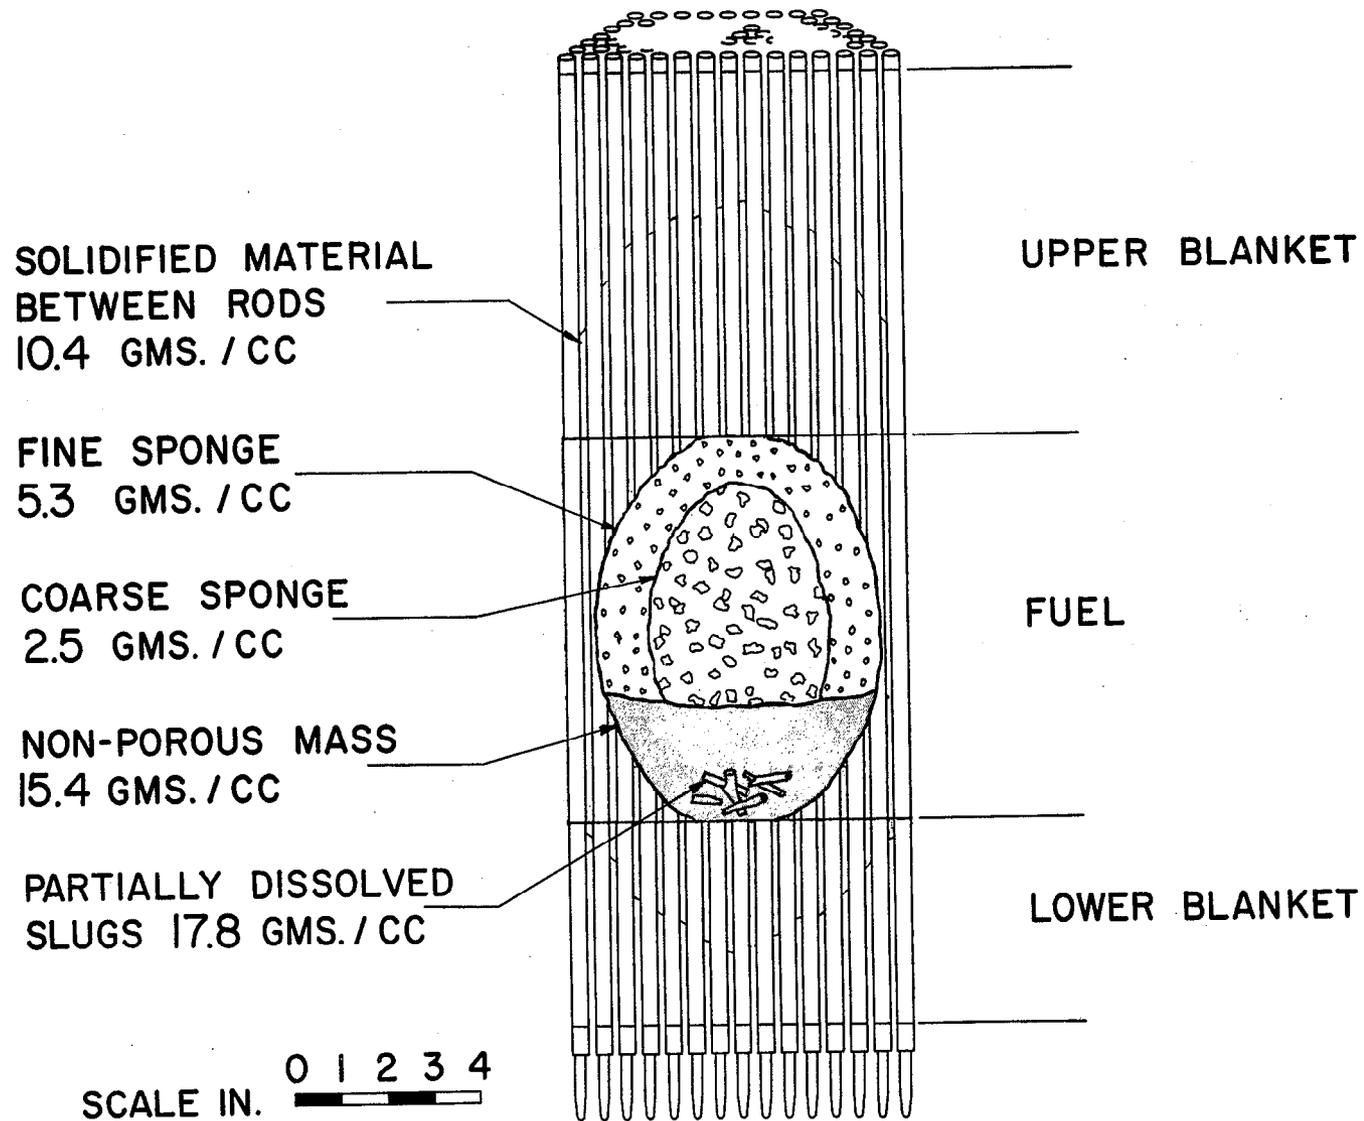
Based on observations and measurements made on the core itself during disassembly and on photographs, an artist's reconstruction of a vertical section through the damaged core was made as shown in Figure 40. Also shown in the figure are what are considered to be the most reliable values of densities of the various areas. The greater density of the partially dissolved fuel slugs evidently permitted them to fall completely through the molten volume, and they finally came to rest at the bottom of the fuel section. It appeared that between 40 and 50% of the volume of the fuel section had entered a molten phase during the meltdown, and that the shape of the molten volume approximated that of a prolate spheroid.

Figure 40. Artist's reconstruction of a vertical cross section through the damaged EBR-I core. The most reliable values for the densities of the various areas are shown at the left.

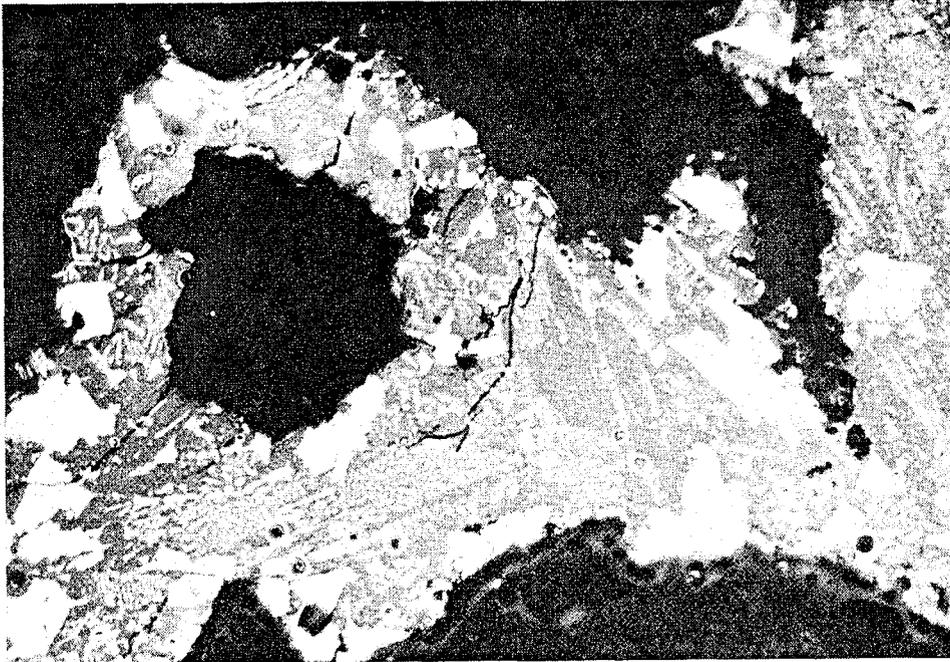
Figures 50 through 54 show the microstructures present in the five metallographic samples. The samples were all characterized by a two-phase structure, which in some samples appeared to be near a eutectic composition. The two phases which formed the eutectic are believed to be analogous to  $UFe_2$  and  $U_6Fe$ , which form a eutectic in the U-Fe system.<sup>(15)</sup> The relative amounts of each phase present in the samples depended upon their original location in the core. Thus, samples 29 and 30 from the porous zones, shown in Figures 50 and 51, contained an excess of the " $UFe_2$ " phase, sample 31 from the material between the lower blanket rods, shown in Figure 52, appeared to be near the actual eutectic composition, and the dense samples 32 and 33, shown in Figures 53 and 54, contained large amounts of the " $U_6Fe$ " phase.

In the second experiment, an attempt was made to increase the porosity of the casting by reducing the mold diameter to 1/2 in. and by using the more fluid eutectic alloy, uranium - 12 w/o iron. In this experiment a porous mass was obtained, similar in certain respects to the structure observed in the actual meltdown. The density of the second casting was measured to be 13.9 gm/cm<sup>3</sup> by immersion in CCl<sub>4</sub> and 10.6 gm/cm<sup>3</sup> by metallographic sectioning and measurement. The porosity in this casting and the microstructure of the material are shown in Figures 58 through 60. The microstructure of this casting, shown in Figure 60, shows some similarities to that observed in samples from the porous zones of the meltdown, shown in Figures 50 and 51.

Figure 50. Microstructure in sample No. 29, from coarse sponge zone. The light phase is believed to be analogous to  $UFe_2$  and the dark phase analogous to  $U_6Fe$ .

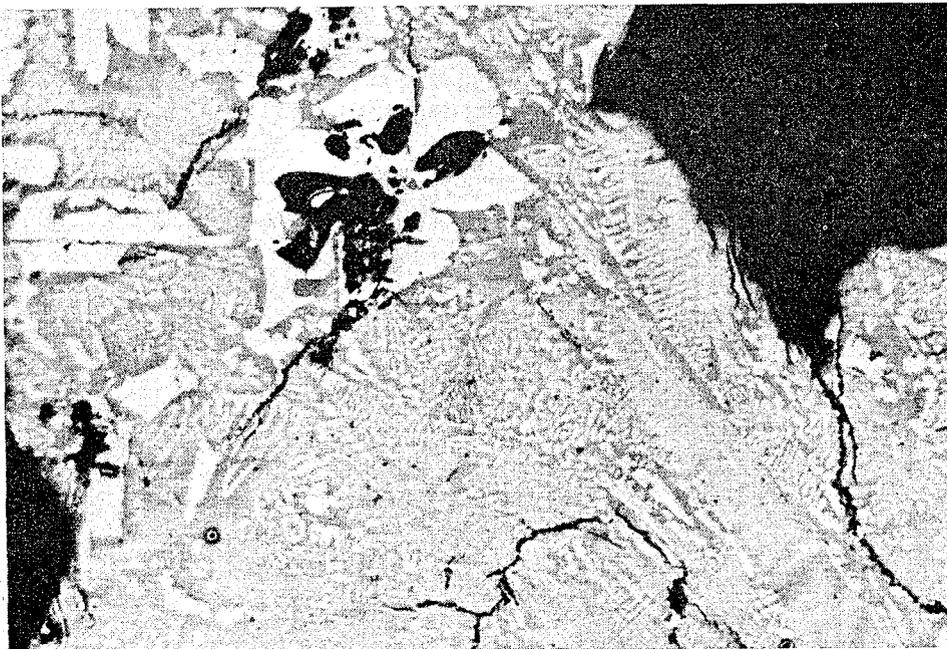
Figure 51. Microstructure in sample No. 30, from fine sponge zone. The light phase is believed to be analogous to  $UFe_2$  and the dark phase analogous to  $U_6Fe$ .

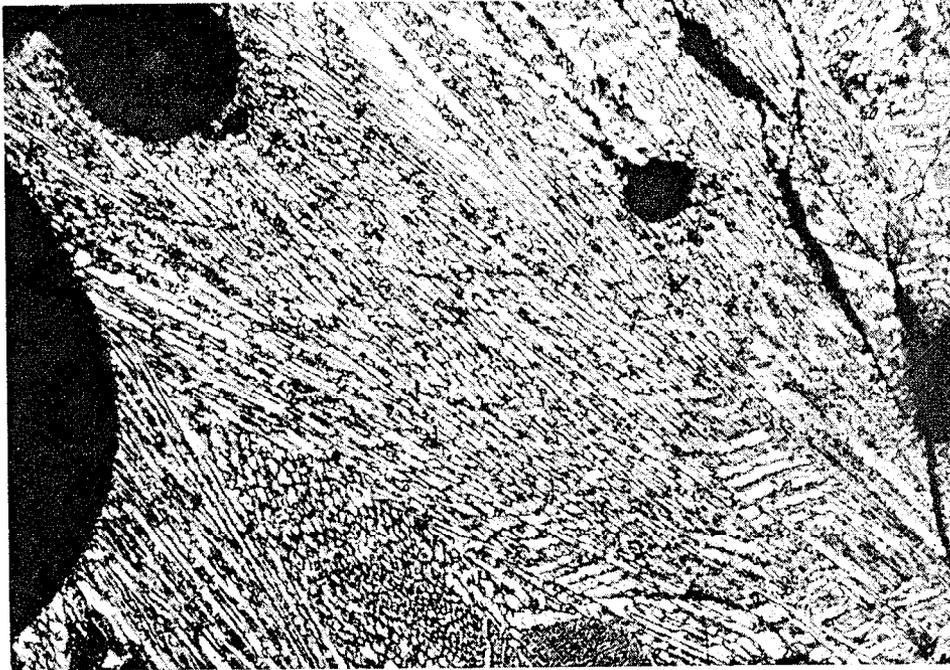
Figure 52. Microstructure in sample No. 31, from material between blanket rods. The light phase is believed to be analogous to  $UFe_2$  and the dark phase analogous to  $U_6Fe$ .

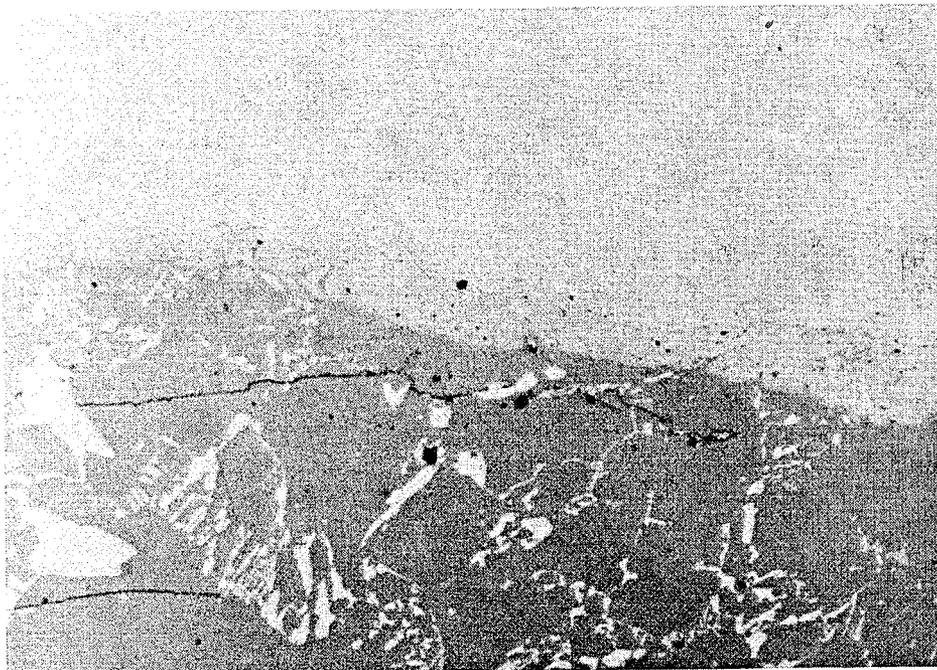
Figure 53. Microstructure of sample No. 32, showing junction between embedded fuel slug and adjoining material. The undissolved fuel slug is shown in the upper half of the photograph. The light phase is believed to be analogous to  $UFe_2$  and the dark phase analogous to  $U_6Fe$ .

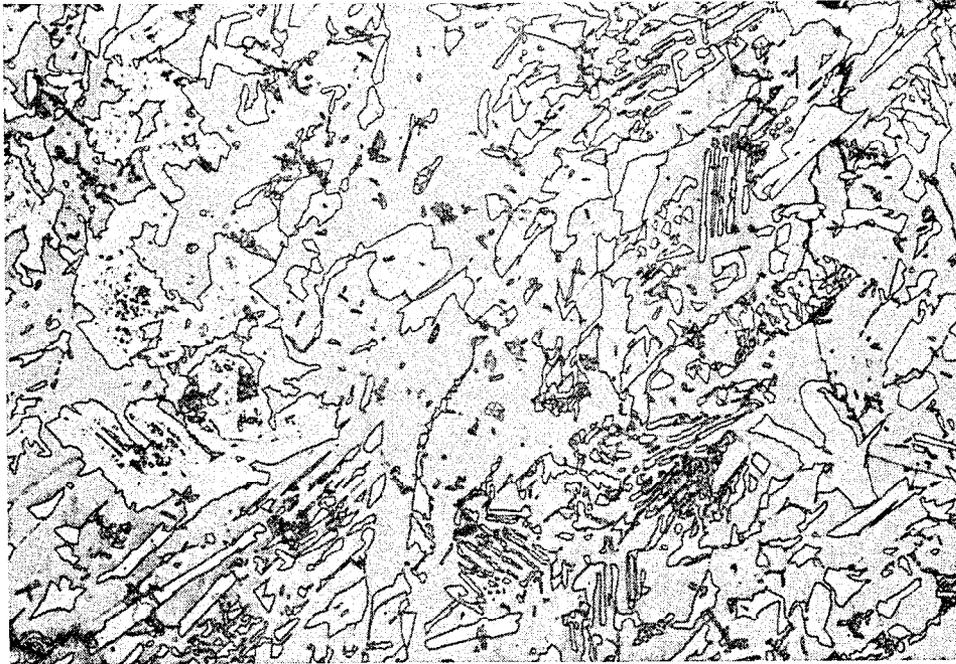
In the first experiment, an alloy of uranium - 2 w/o zirconium alloy and stainless steel with final composition similar to that resulting from the meltdown was prepared and was observed to melt near 860° C. A charge of 176 grams of this alloy, just above the melting point, was poured into NaK at 400° C in a  $1\frac{7}{8}$ -in. diameter mold. A casting with a small amount of porosity was obtained with a density of 16.0 gm/cm<sup>3</sup>. Figures 55 through 57 show the porosity and microstructure which was obtained. It can be noted that the microstructure of this casting, shown in Figure 57, is not unlike that shown in Figure 54, which is the microstructure of a sample taken from the densest zone in the damaged core.

Figure 54. Microstructure in sample No. 33, from high-density zone. The light phase is believed to be analogous to  $UFe_2$  and the dark phase analogous to  $U_6Fe$ .

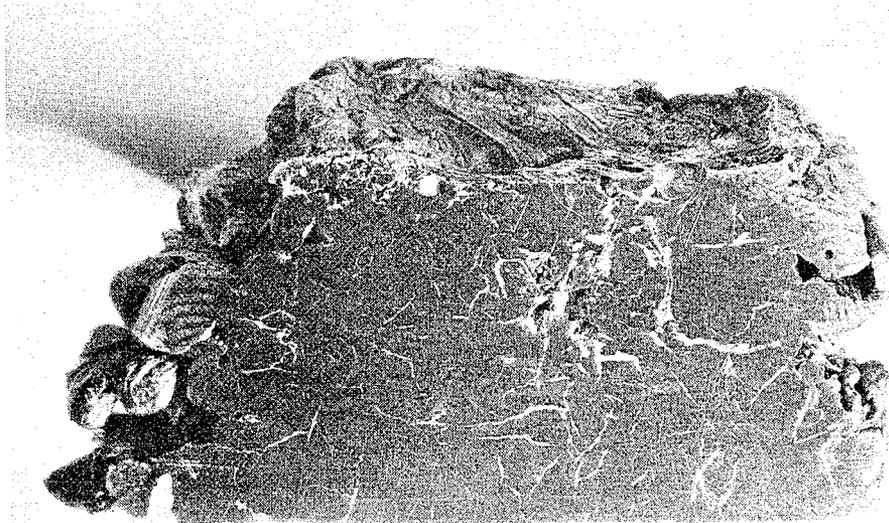
Figure 55. Cross section of first casting made by pouring uranium-stainless steel alloy into NaK. A small amount of NaK was trapped in the casting, evidenced by the traces of NaK oxide.

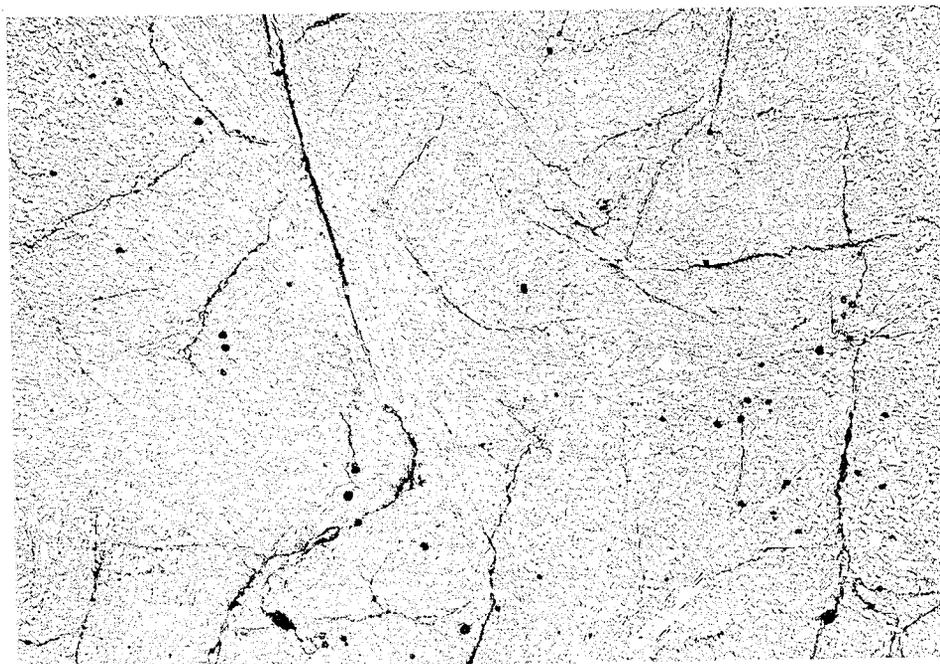
Figure 56. Porosity in casting shown in Figure 55.

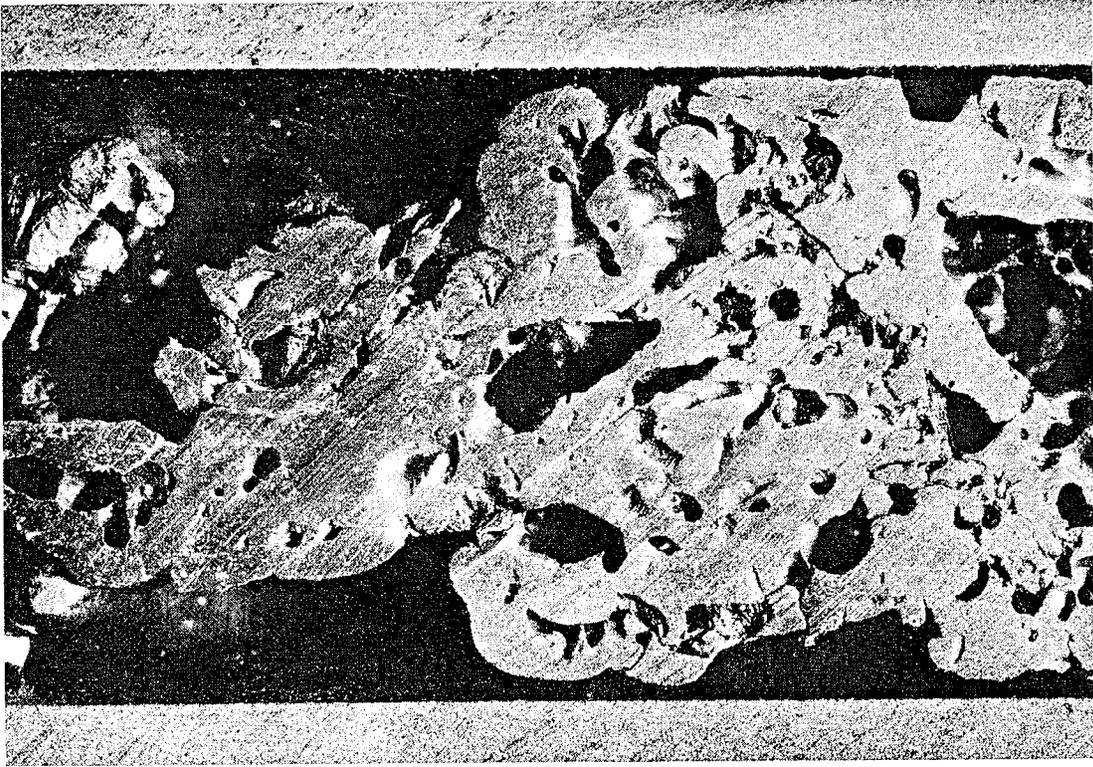
Figure 58. Cross section of second casting made by pouring uranium-iron alloy into NaK.

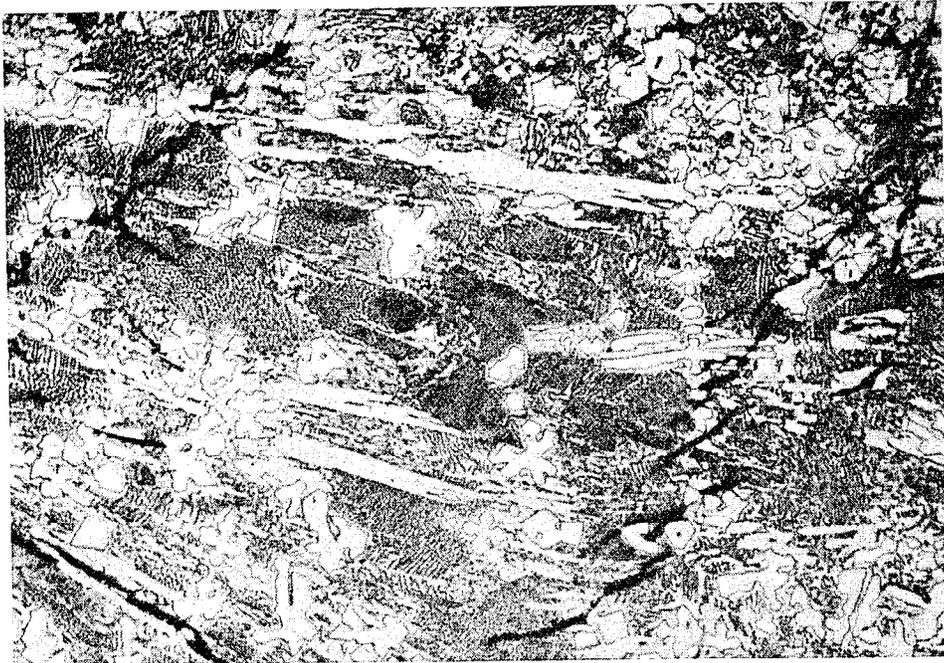
Figure 60. Microstructure of casting shown in Figure 58. The light phase was identified as  $UFe_2$  and the dark phase is believed to be  $U_6Fe$ .
