FINAL REPORT
OF
ACCIDENTAL NUCLEAR EXCURSION
RECUPLEX OPERATION
234-5 FACILITY

DATE OF INCIDENT: APRIL 7, 1962

HW-74723

August 1962

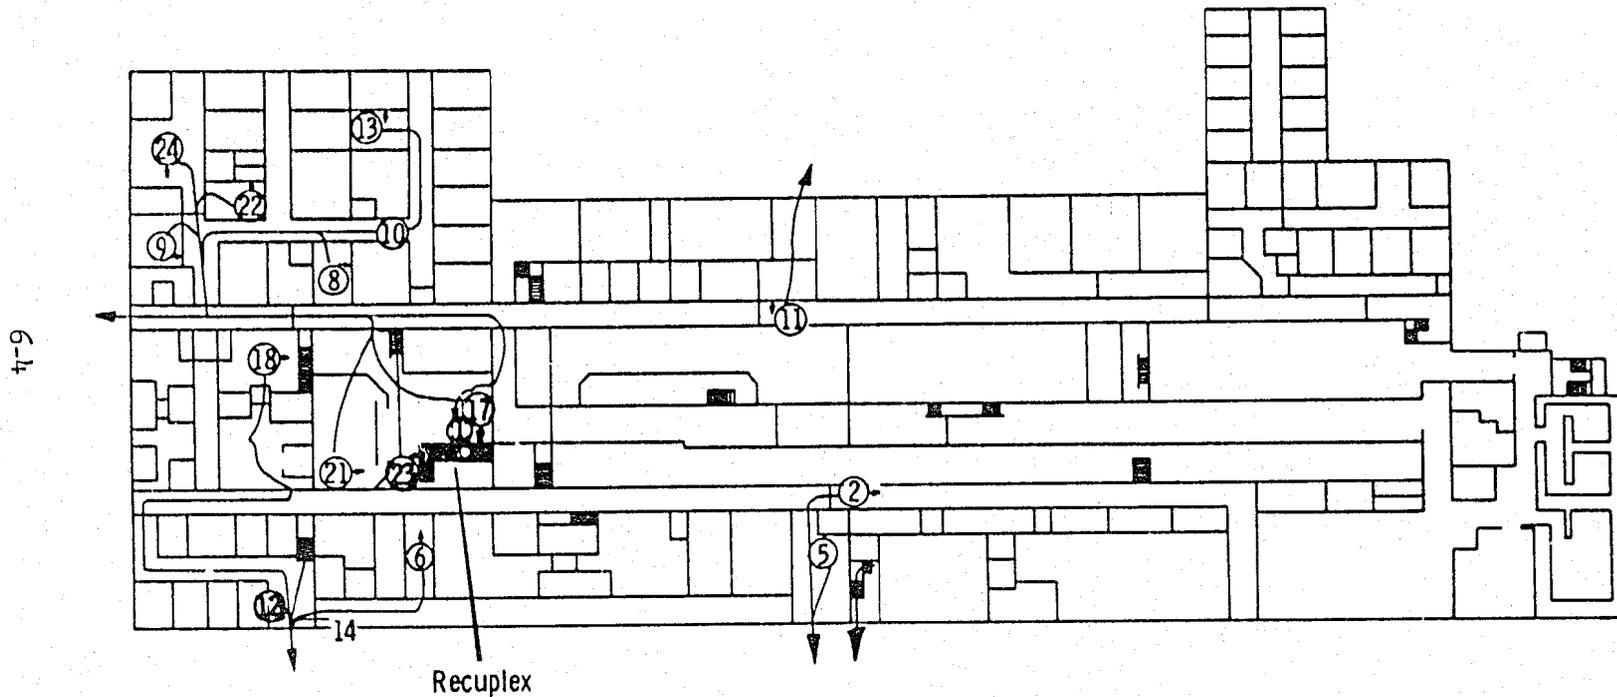
First Floor Plan
234-5 Building

Information was obtained immediately from each employee to establish where he had been when the criticality alarm sounded and how he left the building. Detailed personal interviews were made during the following week. All but five people in the 234-5 Building evacuated immediately upon hearing the siren; all but one had left within about two minutes; the last man was out within four minutes. The routes each one followed in leaving the building are shown in Figures 1 and 2.

Routes Followed by Employees Evacuating the 234-5 Building
(First floor)

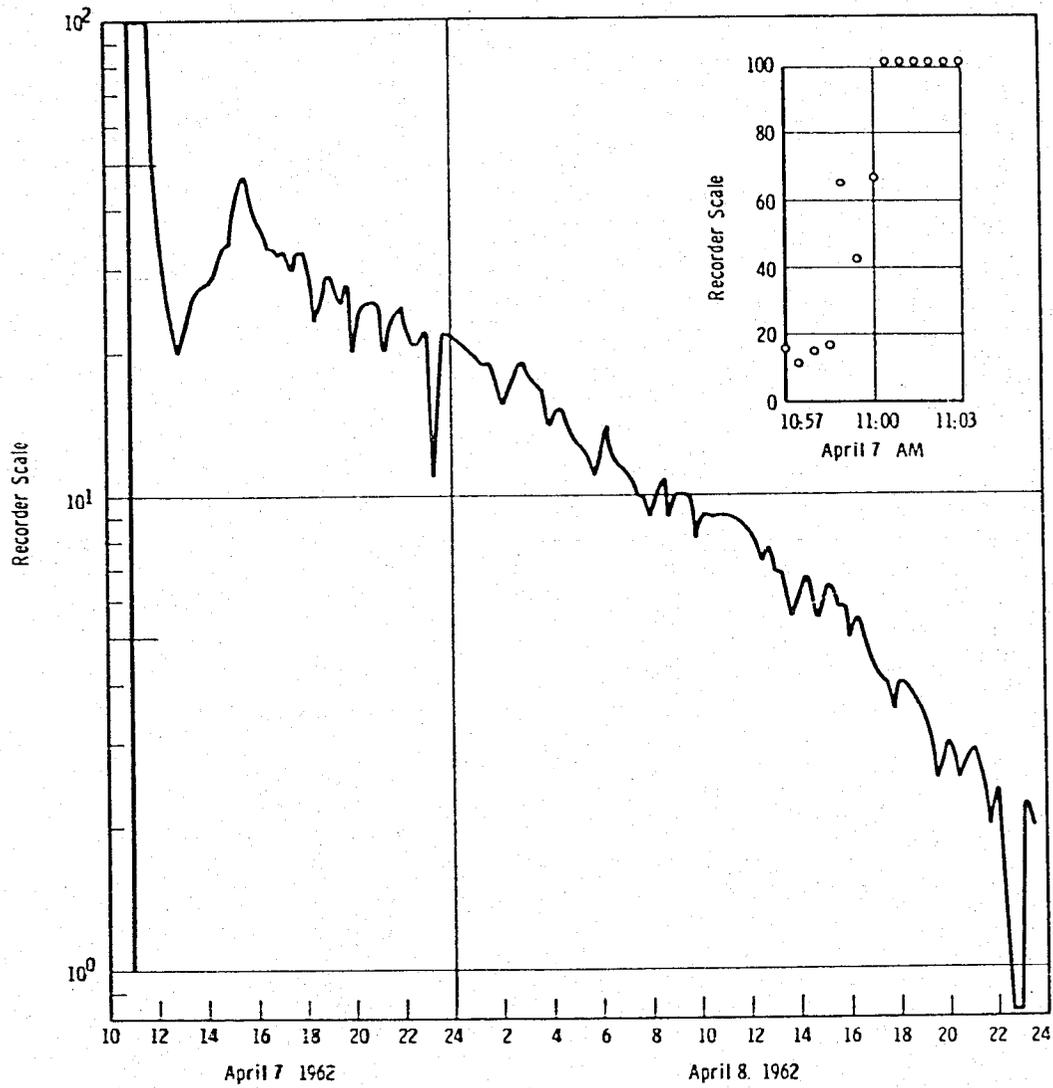
FIGURE 4

Before considering the measurements made for each individual, information of general interest can be obtained from instruments that were near the scene of the accident. Two recording BF_3 counters (one for high levels, one for low) were operating at the time of the accident in an incinerator room in the 234-5 Building. The data from the chart recorders are plotted in Figure 4. They indicate an initial excursion the exact magnitude of which cannot be determined because the flux level is recorded only every 30 seconds and it may be expected to vary by orders of magnitude within such a time period. Following this initial pulse which presumably activated the criticality alarm there was a continuing nuclear reaction of a magnitude sufficient to keep the recorder off-scale for a period of about 30 minutes. After the recorder returned to on-scale readings the fissioning continued at a generally reduced rate till 36 hours after the incident began. It appears that those in a position to be most seriously exposed to the critical vessel evacuated in time to limit their exposure to only a part of the initial excursion.

Data from a Recording BF₃ Counter Operating in the 234-5 Building at the Time of the Accident.

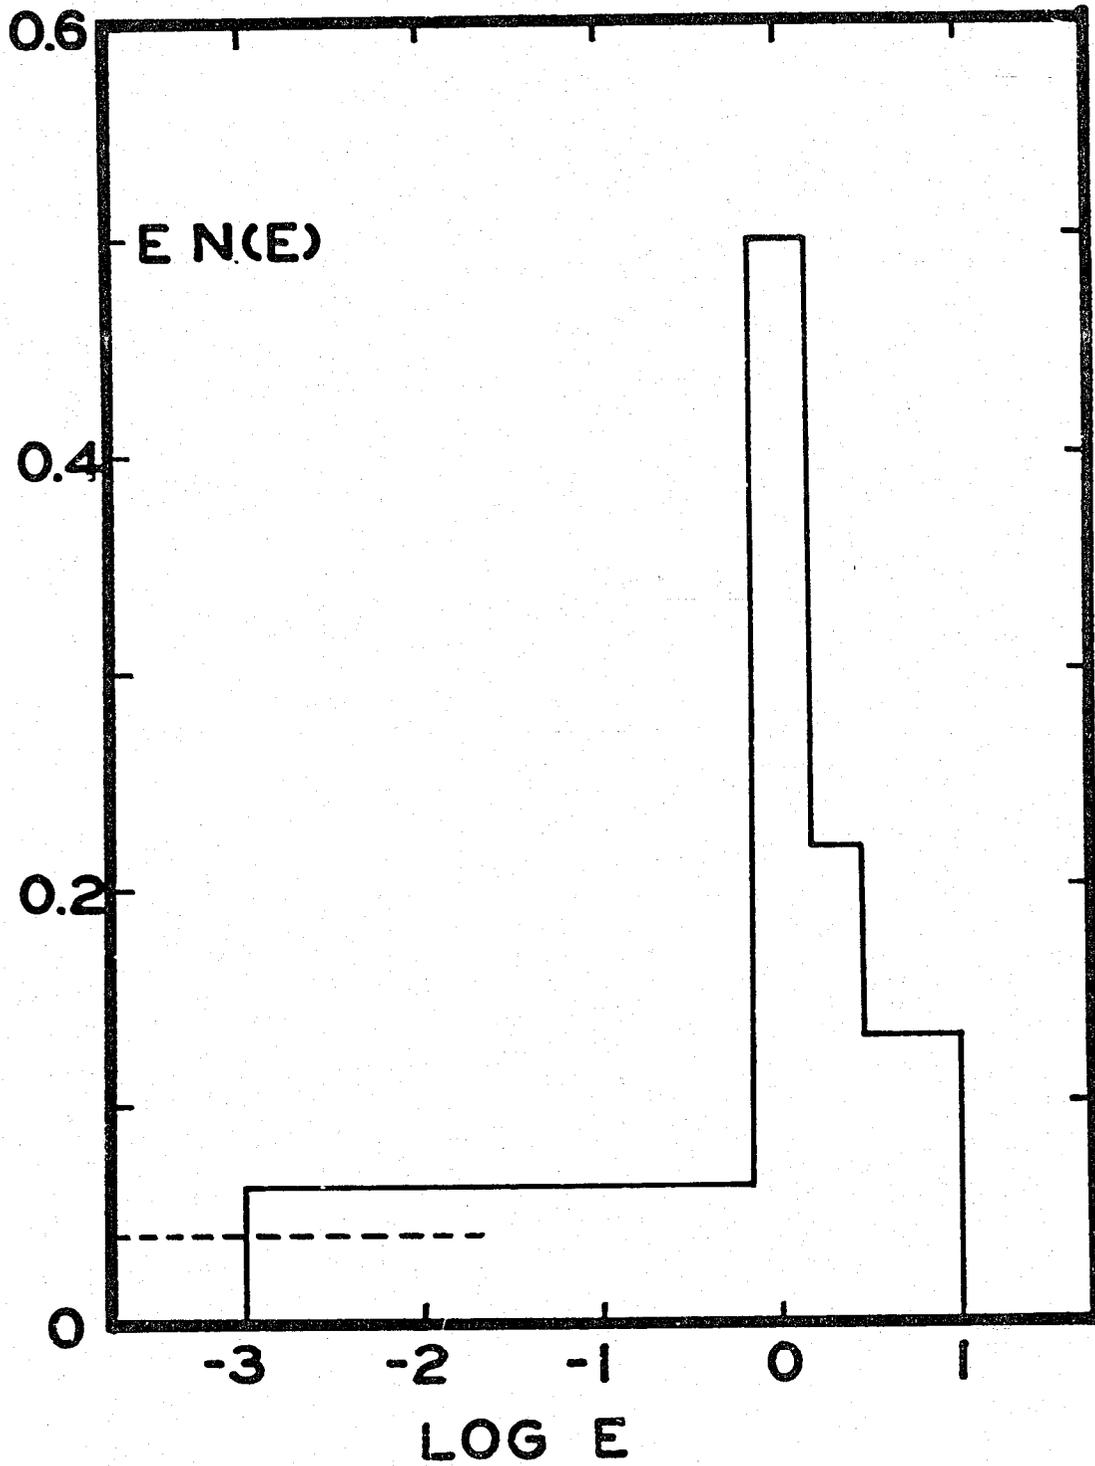
The number spectrum is presented in Figure 5. For comparison several other spectra obtained with threshold detectors³⁾⁴⁾⁵⁾ and normalized in the same way are shown in Figure 6. Figure 7 shows histograms prepared from calculated spectra⁶⁾; since information is lost in going from the calculated spectra to

Spectrum Measured with Threshold Detector During Recuplex Accident.

where the integral is over the activation cross section of gold. Measured foil activities of 1.6 and 1.0×10^5 disintegrations/min, Hughes⁸⁾ values of the cross sections, and flux ratios from Table I give $k = 0.042$. This is shown as a dashed line in Figure 5 and is in good agreement with the spectrum determined with the threshold foils.

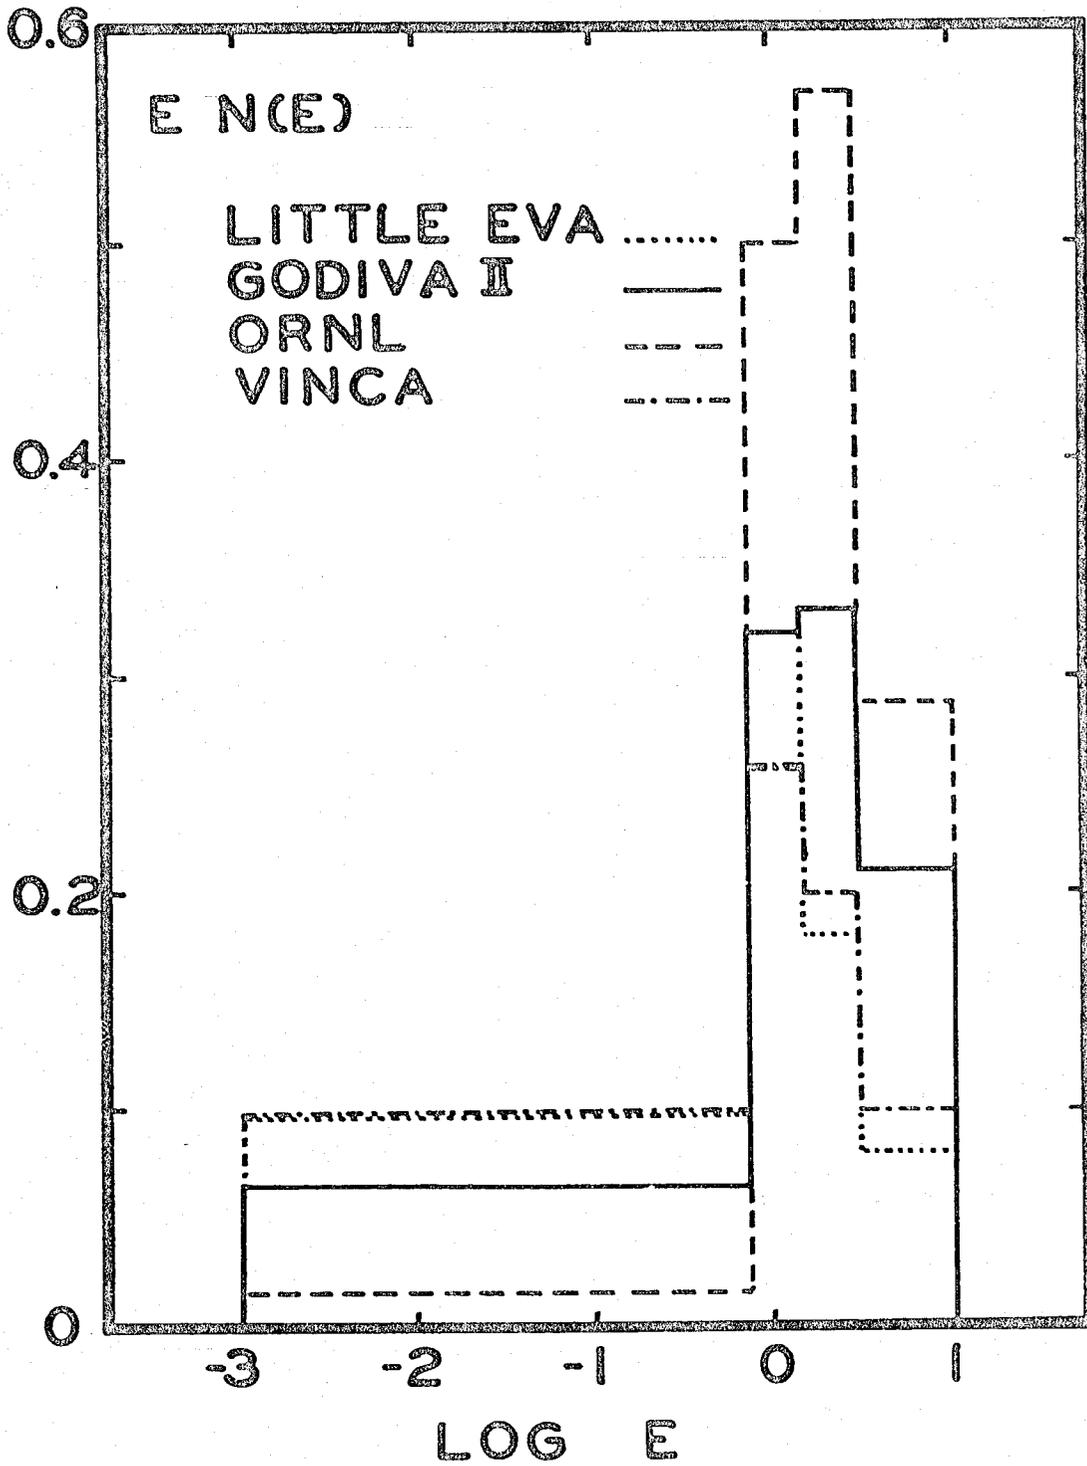
FIGURE 6

Experimental Spectra Measured with Threshold Detectors.

the histograms, the original normalized spectra are given in Figure 8. There is not close agreement between the present spectrum and any of the others, but the general features are the same and the differences are of the sort to be expected if the present results include the effects of a significant number of scattered, and hence lower energy, neutrons. Table I also contains the dose spectrum normalized to unit dose for the neutrons above 1 Kev.

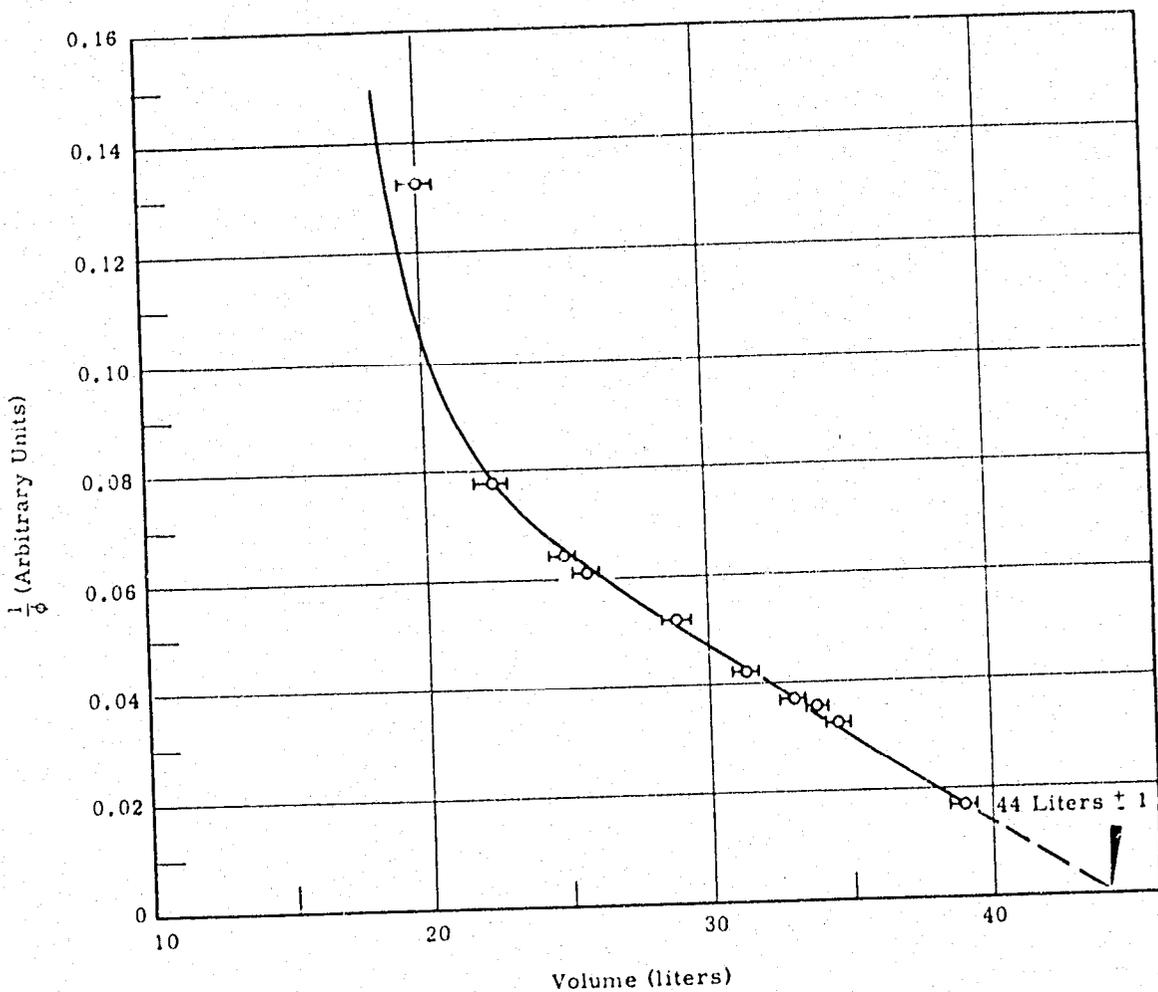
Exhibit 8-D

Estimate of Criticality in Vessel K-9
(35 grams Pu/liter, 120 grams NO₃/liter)

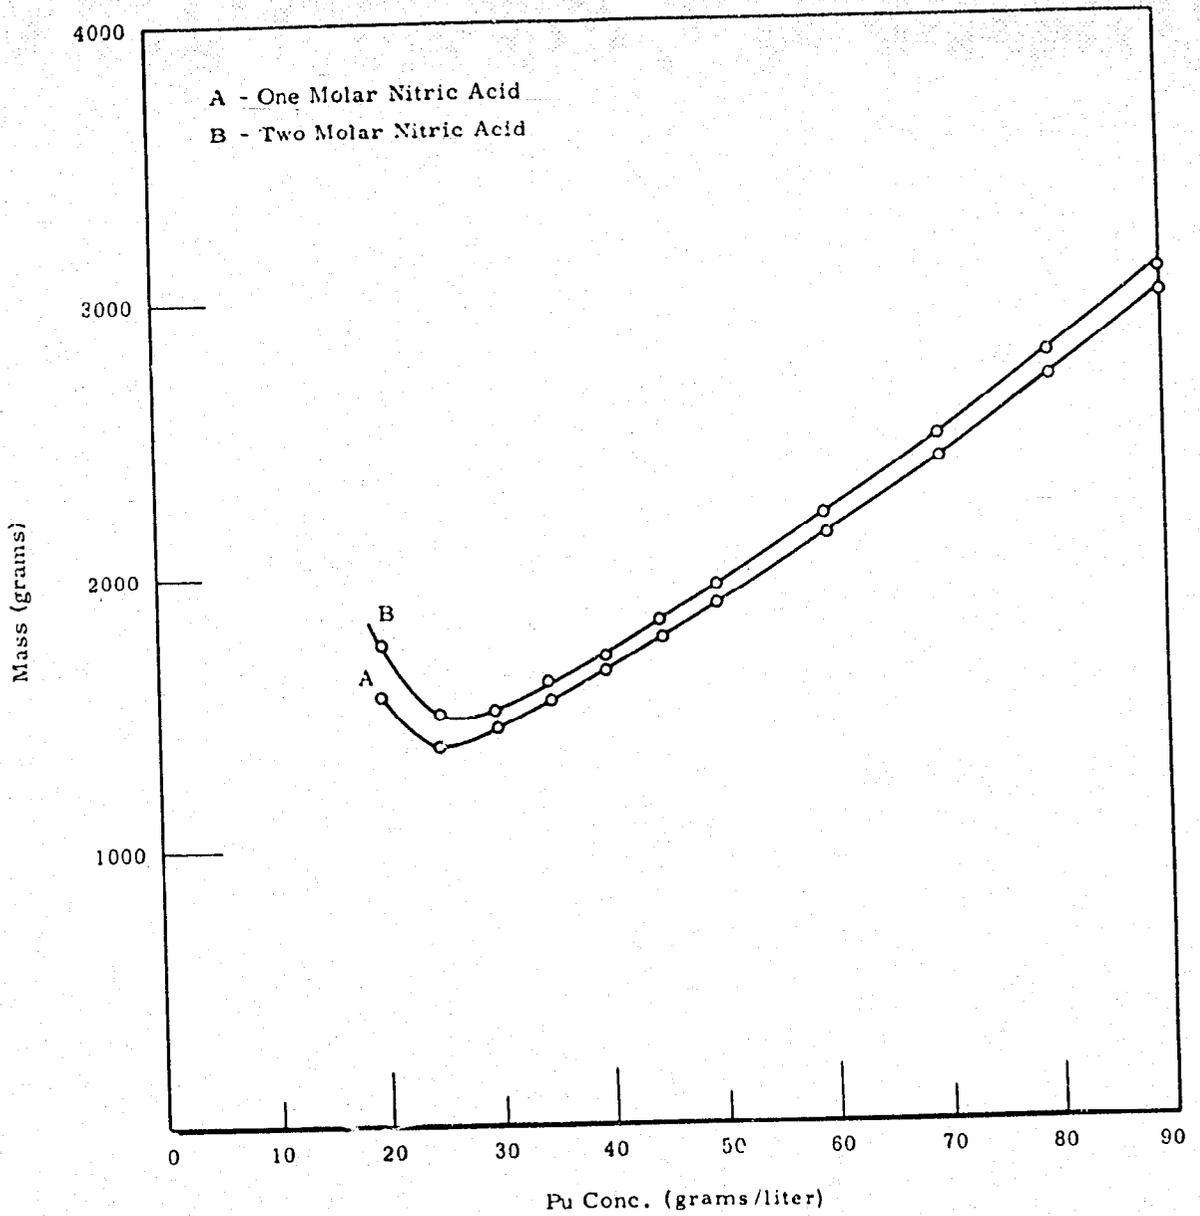
FIGURE 8-E-(1)

Calculated Critical Mass vs. Pu Concentration in Vessel K-9
