## ICPP Criticality Event of October 17, 1978

By Nuclear Safety Staff

## IDAHO CHEMICAL PROCESSING PLANT

October 17, 1978

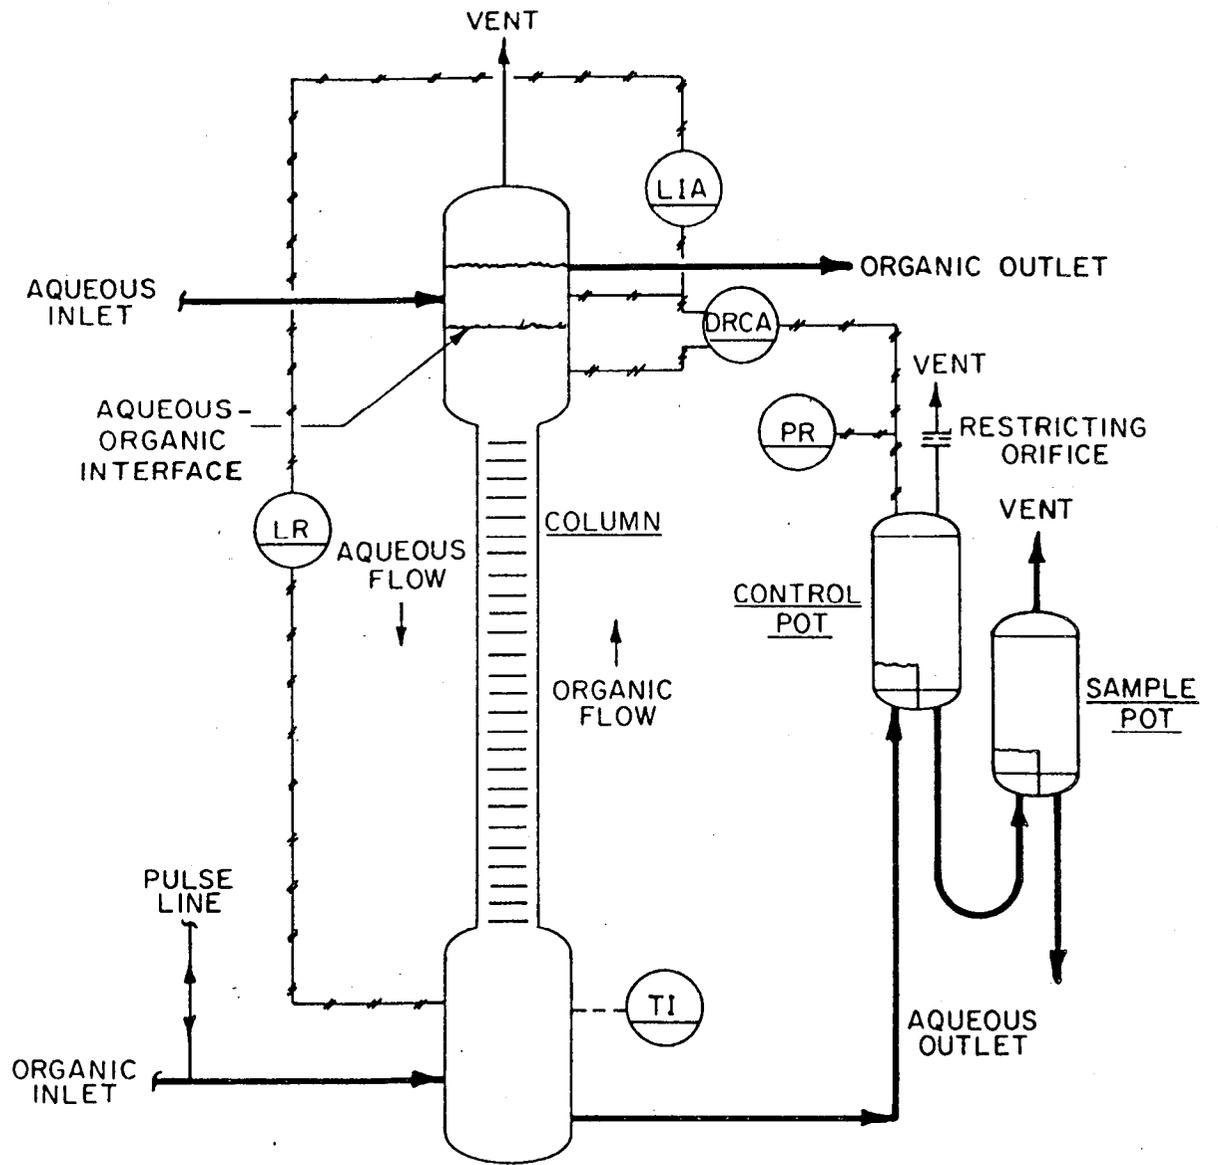
Fig. 2 Typical column.

of 1B, was buffered with aluminum nitrate to a concentration of .75 M to prevent significant transfer of uranium from the organic to the aqueous. In normal operation some uranium would be taken up by the aqueous, to a concentration of about 0.15 g/L, so the aqueous output of 1B was fed back and blended with the dissolver product going into 1A. The organic product stream from 1B, normally about 0.9 g uranium per liter, went on to 1C where the uranium was stripped from the organic by .005 M nitric acid. The output of the stripper column went to mixer settlers where additional purification took place.

The out-of-specification aqueous feed to the scrubber column caused it to operate as a stripper rather than as a scrubber. <sup>Some?</sup> Much of the enriched uranium was removed from the 1B organic and recycled into the input of 1A. This partially closed loop resulted in a steady increase in the uranium inventory in these two columns.

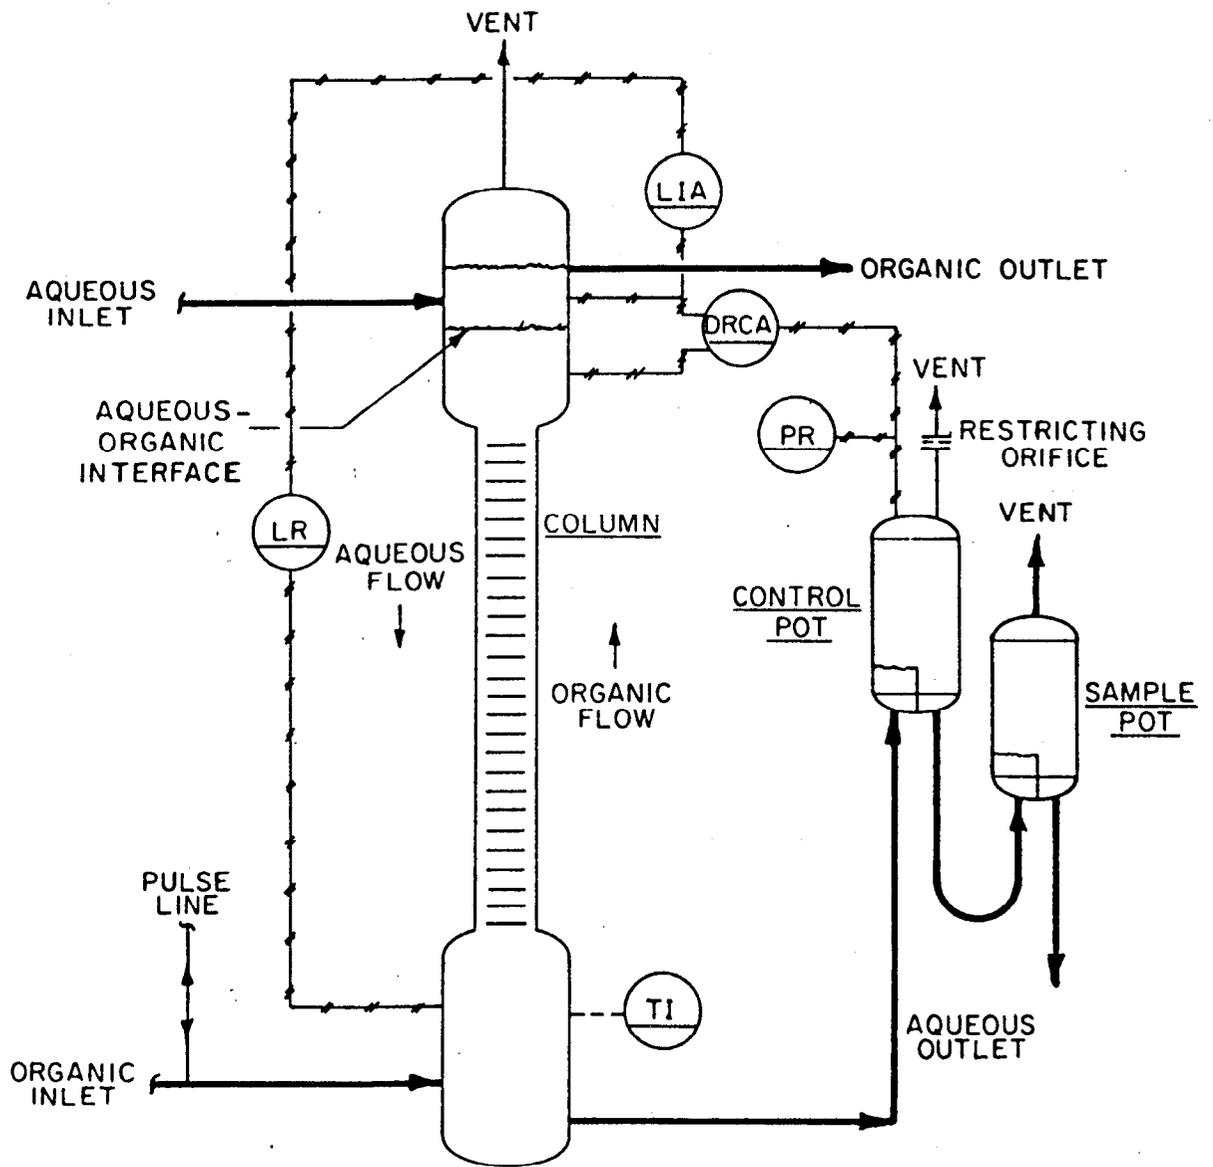
Fig. 2 Typical column.

of 1B, was buffered with aluminum nitrate to a concentration of .75 M to prevent significant transfer of uranium from the organic to the aqueous. In normal operation some uranium would be taken up by the aqueous, to a concentration of about 0.15 g/L, so the aqueous output of 1B was fed back and blended with the dissolver product going into 1A. The organic product stream from 1B, normally about 0.9 g uranium per liter, went on to 1C where the uranium was stripped from the organic by .005 M nitric acid. The output of the stripper column went to mixer settlers where additional purification took place.

The out-of-specification aqueous feed to the scrubber column caused it to operate as a stripper rather than as a scrubber. Much of the enriched uranium was removed from the 1B organic and recycled into the input of 1A. This partially closed loop resulted in a steady increase in the uranium inventory in these two columns.
