TID-5360

**A SUMMARY OF ACCIDENTS AND INCIDENTS  
INVOLVING RADIATION IN ATOMIC ENERGY  
ACTIVITIES, JUNE 1945 THROUGH  
DECEMBER 1955**

By  
Daniel F. Hayes

August 1956

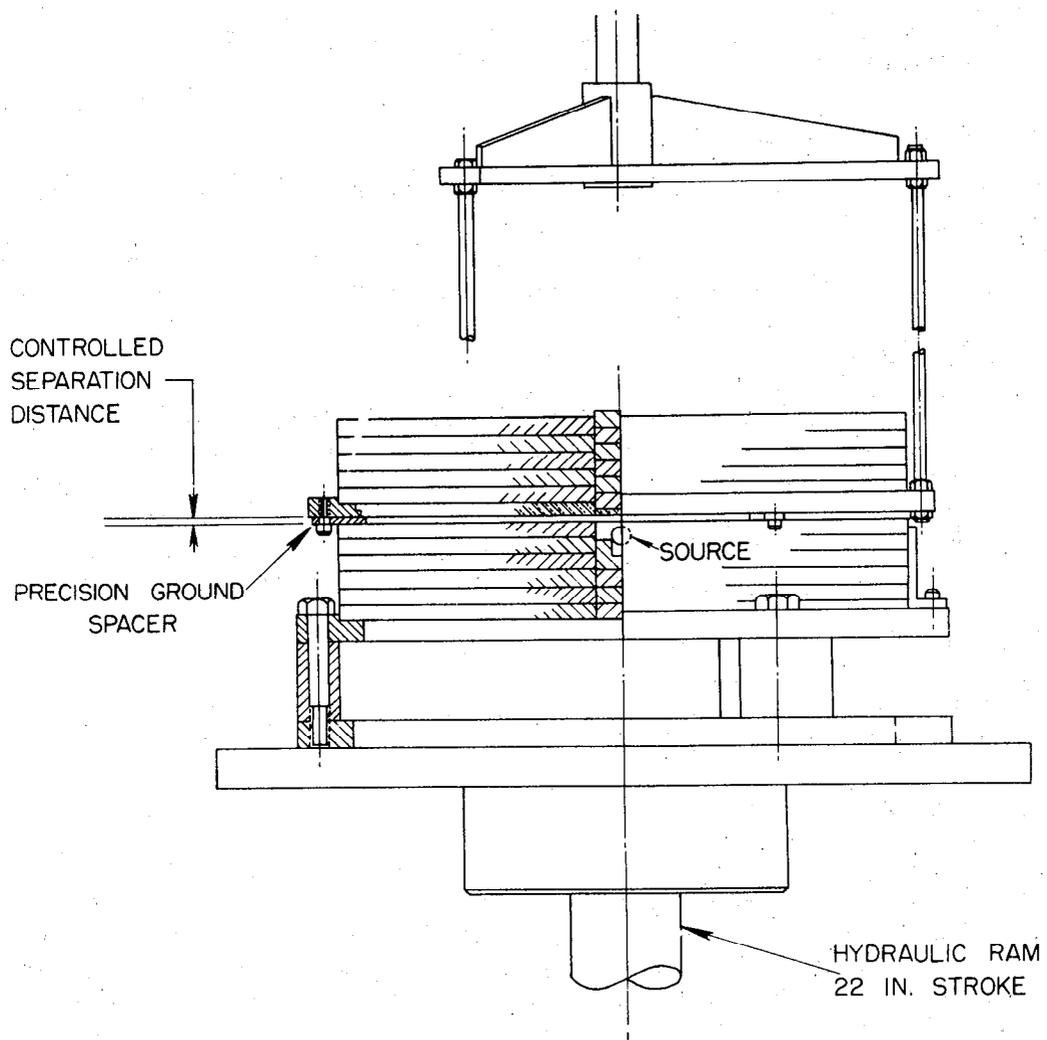
A criticality test assembly.

The incident occurred in the course of an extensive study of the properties of supercritical radiation bursts produced by an assembly of fissionable metal. This study involved operations of a type that the normal regulations are designed to prevent, so was covered by a specific procedure. A reference check of critical conditions preceded each supercritical burst.\*

To attain rapidly sufficient power for a delayed critical check, it was customary to set control rods at the position of minimum reactivity and insert a reactivity booster in the form of a fissionable metal slug. This time, when the booster was inserted, radiation indicators and the assembly temperature recorder went off scale (to return in a few minutes), and scrams were actuated. The resulting shock separated parts of the assembly and damaged steel supporting members.

There was no injury. The property loss was an expenditure of \$600 for repair of the assembly.
