CROSSROADS TECHNICAL INSTRUMENTATION REPORT

Timing Signals (TV-12)

Crossroads Technical Instrumentation Report Tests A and B

From: Los Alamos Field Group 013H
To; Technical Director, JTF-1
Project No.: IV - 12

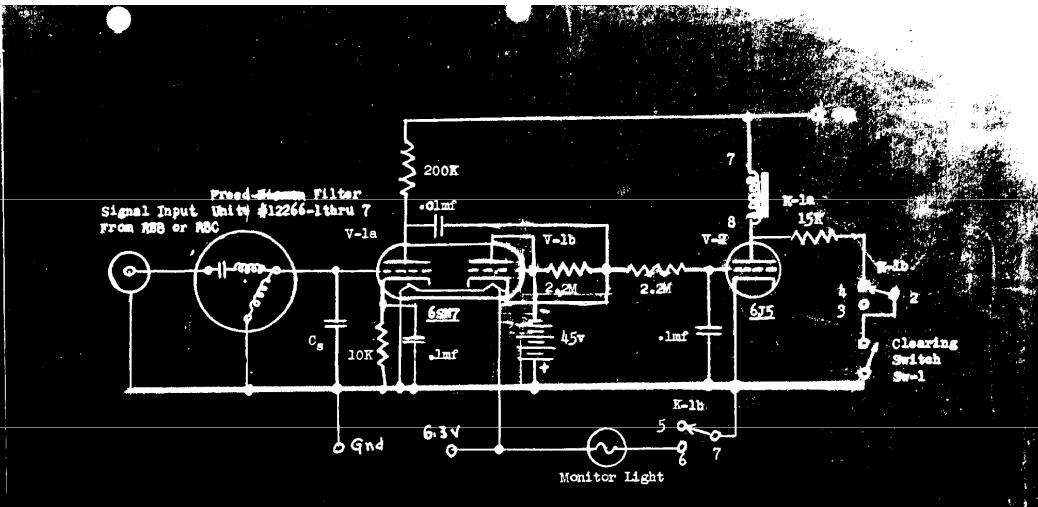
Each transmitter was provided with a monitor consisting of a receiver tuned to the carrier frequency, whose audio output was applied to a multi-channel filter unit. Figure 3 is the circuit diagram of a typical channel. When the transmitter is modulated at the filter frequency, the audio output signal from the receiver will pass through the filter and be amplified by the triode V-ls. The output of this amplifier is applied to the cathode of the diode-connected triode, V-lb, causing it to develop a positive voltage. The relay-tube, V-2, is normally biased far beyond the cut-off point by a 45-volt battery, but when the voltage from the rectifier is applied to its grid, it conducts, and the plate-current, passing through the relay windings causes it to operate. One set of relay contacts, K-lb holds the relationed after the

C_s - Selected to match Filter Unit

K-1 - Advance Plug-in Relay; Octal Base. Pin numbers shown.

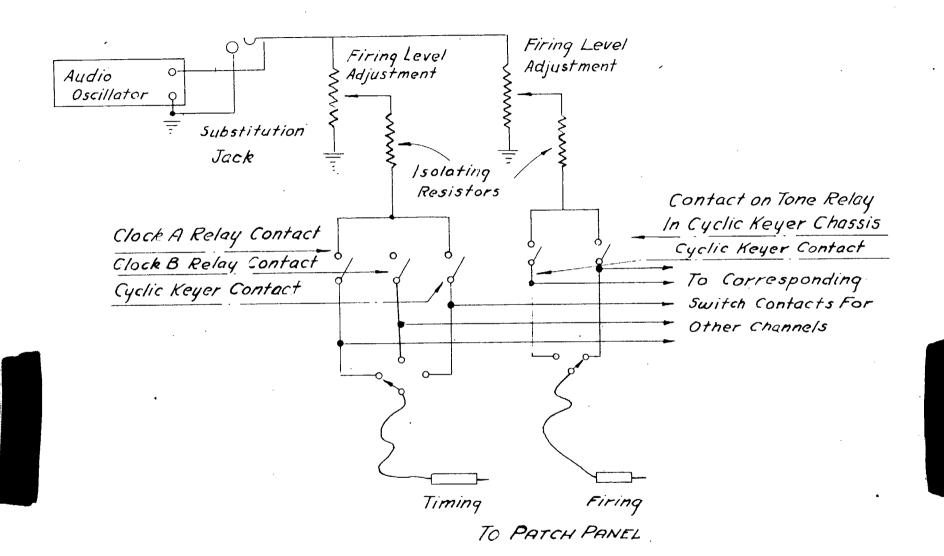
F1G. 7

CIRCUIT OF TYPICAL AUDIO CHANNEL

Figure 7 shows the complete circuit from oscillator to modulator for a typical timing tone. It will be noted that there are two basic methods of keying the tones into the modulators. In the first method, there are 11 relays, for each of the timing and firing tones. Closure of one of these relays, whose energizing circuits will be considered later, puts the corresponding signal into the modulators. In the second method, there are pairs of cam-operated switches for each tone; these are closed automatically in sequence by a motor-driven can that completes its cycle once a minute. This cyclic keyer is used for the preliminary testing. It can be seen that either type of keying can be selected for either group of transmitters independently. As will be shown later, where a single frequency is used for both timing and firing, the coils of the two relays are connected in parallel, so that the operation of a single switch modulates all transmitters simultaneously.

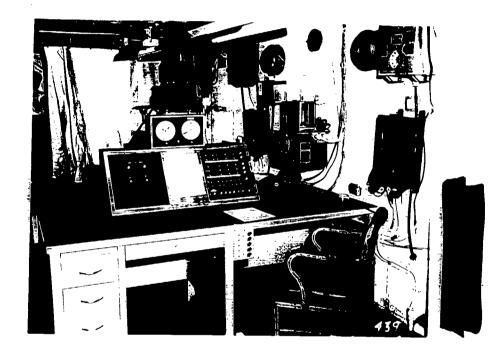
Figure 10. Waster Control Console

The Gamma-Timing Equipment is located behind the curtain in the left background.

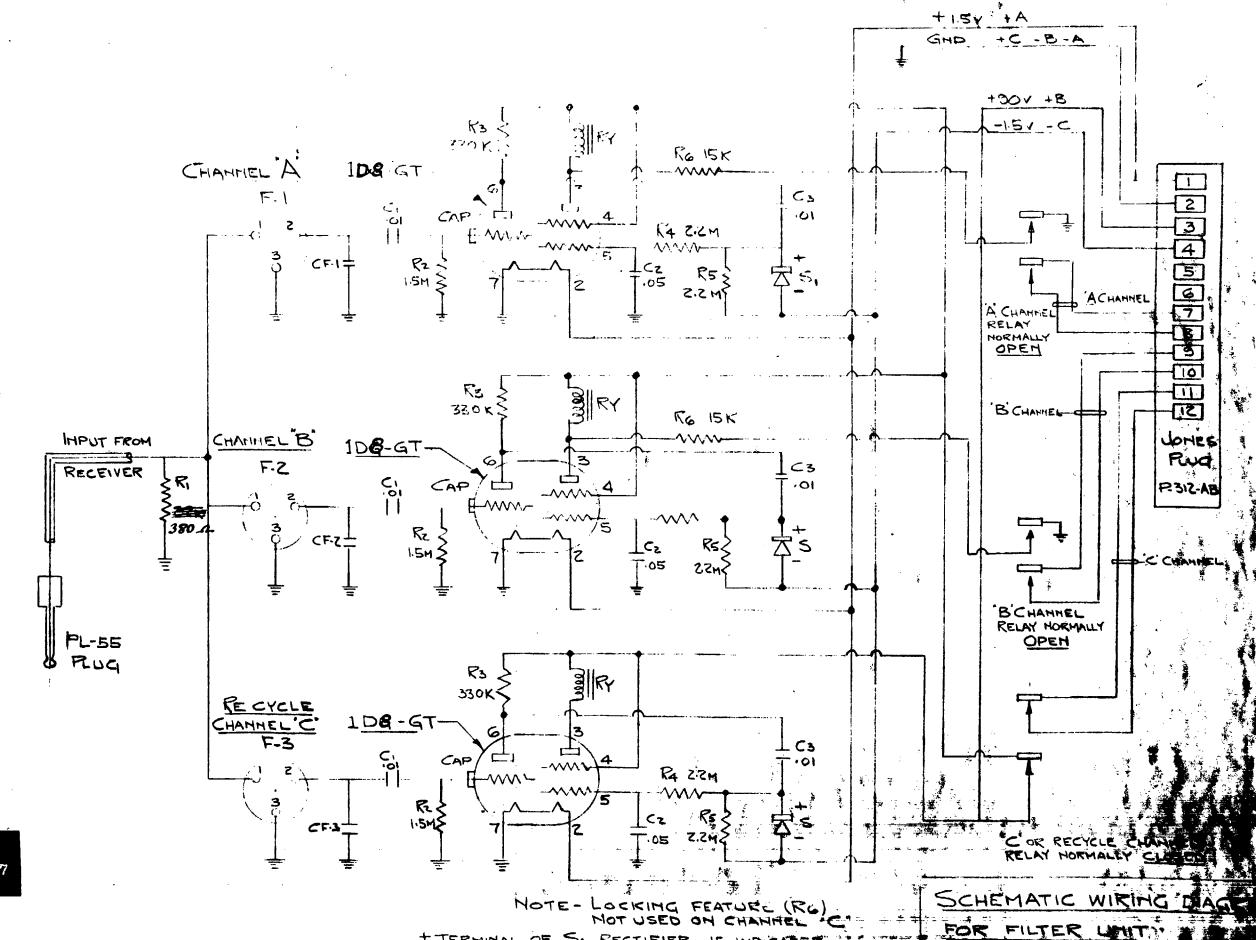
Fig. 17

+ TERMINAL OF SI RECTIFIER IS INDI BY A SMALL RED DOT ON LEAD N APPROVED FOR PUBLIC RELEASE

A search was made for a filter-relay unit that could be operated with low drain from portable type dry batteries. It was found that no such device was available from Government sources or on the commercial market. Therefore, it became necessary to design and produce the filter-relay units to be used in the Timing Boxes. The circuit used in the Filter-Relay Unit is a straight forward arrangement of a band-pass filter, an audio amplifier, a detector, and a D.C. ampedifier controlling a relay. (See Figures 17 and 18).
