LA-9042-PR

# Space Nuclear Safety and Fuels Program

May 1981

### I. GENERAL-PURPOSE HEAT SOURCE

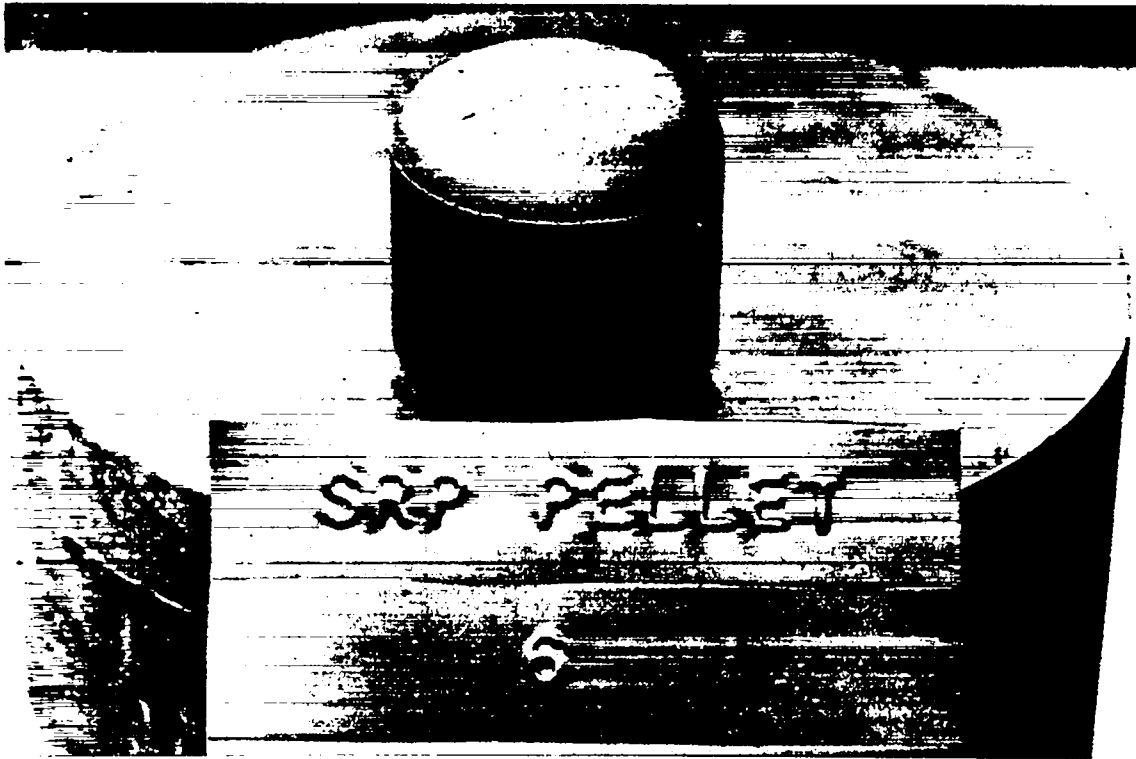
Fig. 1. The ends of fuel pellet SRP-6 cracked in a crow's-foot pattern, and there was a defect at the lower knife-edge location. (1.5X)

All six pellets were cracked, but integral, as shown in Figs. 1-6. Their dimensions, weights, calculated densities, and neutron emission rates are given in Table I. Two pellets were judged suitable only for emergency use:

SRP-28, because of the spot visible on its upper face in Fig. 4, and SRP-62, because of its significantly smaller dimensions and higher density.

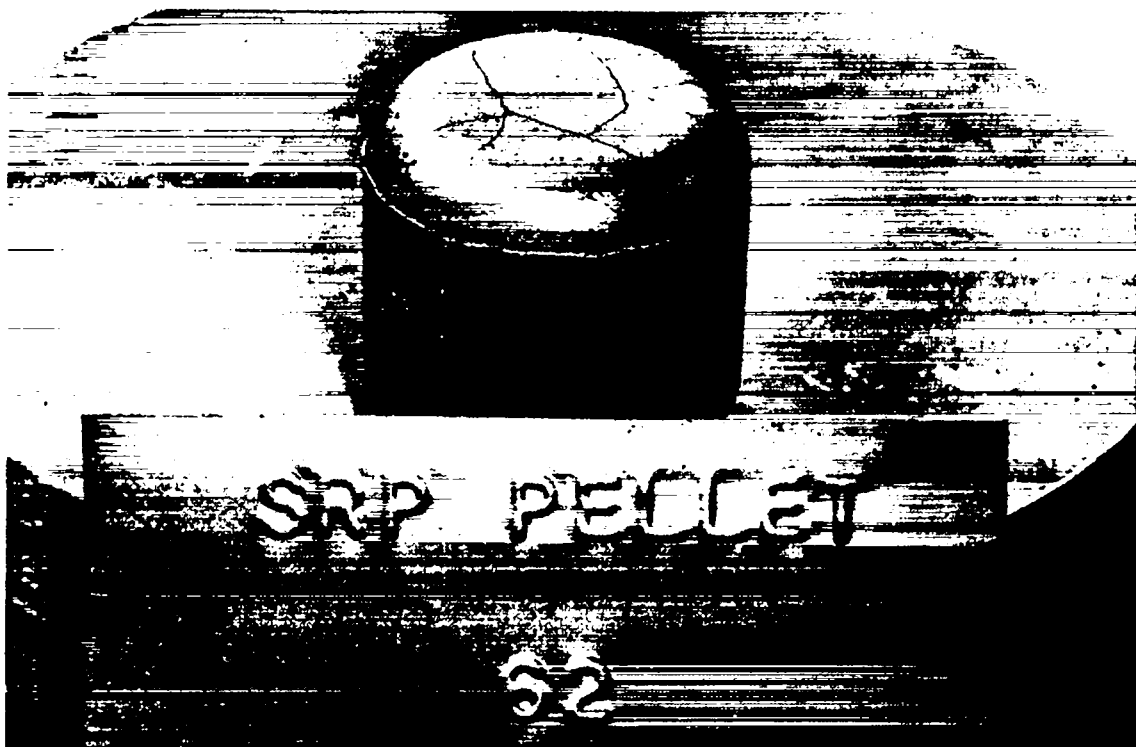
Fig. 6. The ends of fuel pellet SRP-62 contained many cracks and the knife-edge regions were moderately defective. (1.5X)

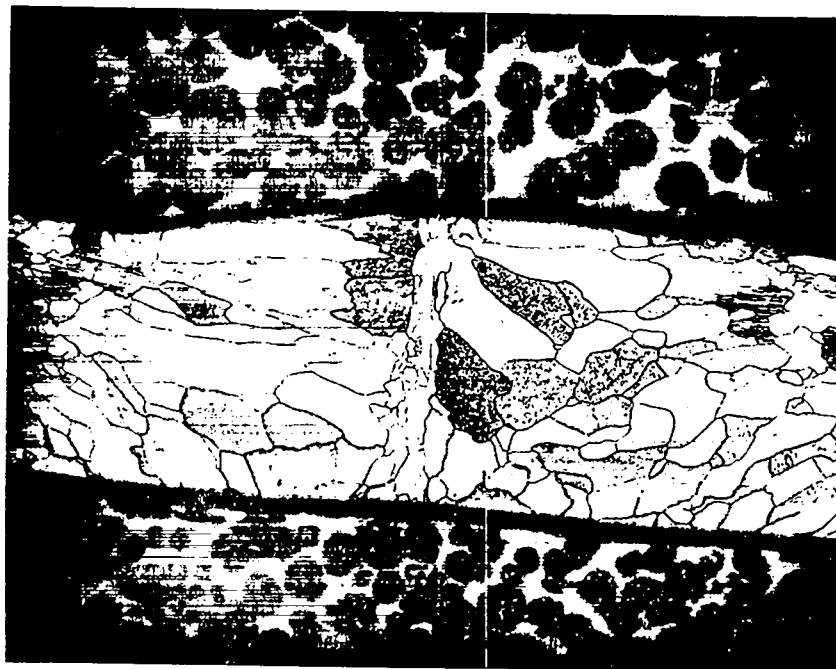
Fig. 8. The welds of capsules IRG-105 (a) and IRG-90 (b) had very similar microstructures. (50X)

A cross section of the weld on example-weld capsule IRG-105 is shown in Fig. 8 along with a similar section of capsule IRG-90. The welds are very similar, as required.

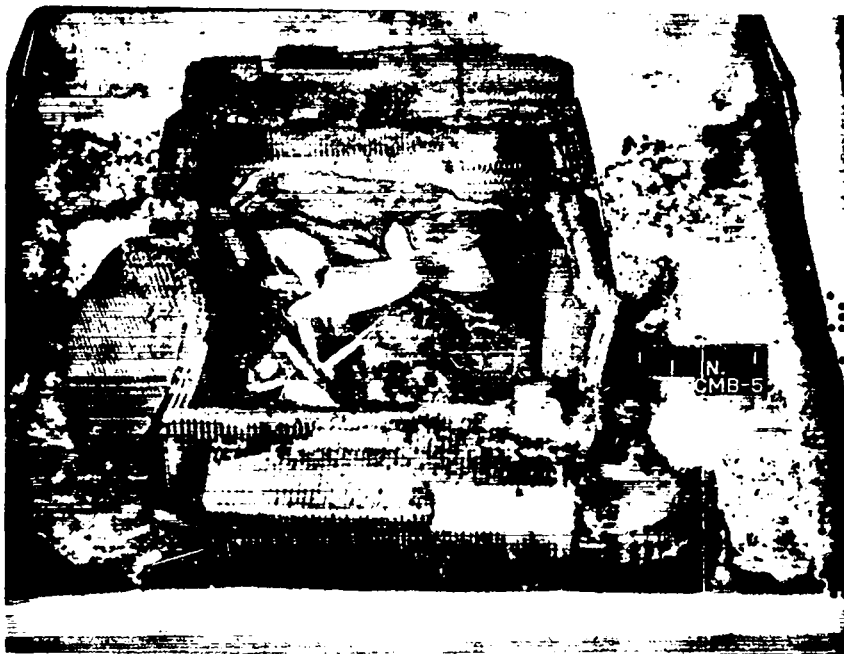
Fig. 10. The aeroshell and insulators were broken by the impact. The separation of the fragments occurred when the impact shells were removed.

The remains of the aeroshell and insulators are shown in Fig. 10. Before removal of the impact shells, the impact face of the aeroshell was broken into uneven slabs 6-12 mm wide and 24-50 mm long. The aeroshell had cracked on the sides parallel to the impact shell axes, and its threaded closure had come out.

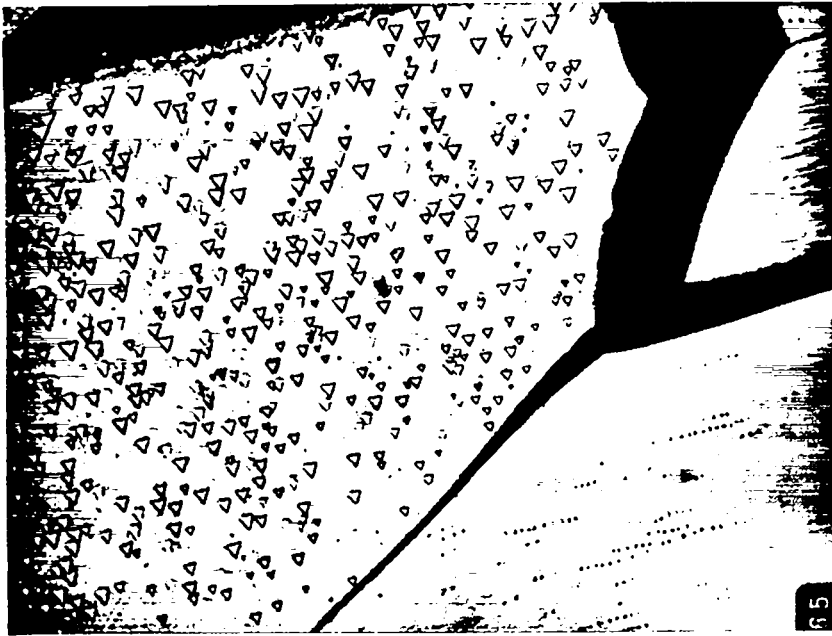
Fig. 16. The NaCl-saturated NaOH etchant produced etch pits on a {111} grain in SR-28-D. (250X)
