# THE CRITICALITY ACCIDENT IN SAROV

On 17 June 1997 a physicist working as a senior technician at the Nuclear Centre, Sarov, in the Russian Federation, was severely exposed as a result of a criticality accident with an assembly of high enriched uranium. The exposure, which caused a high neutron radiation dose, led to death within three days despite prompt medical attention.

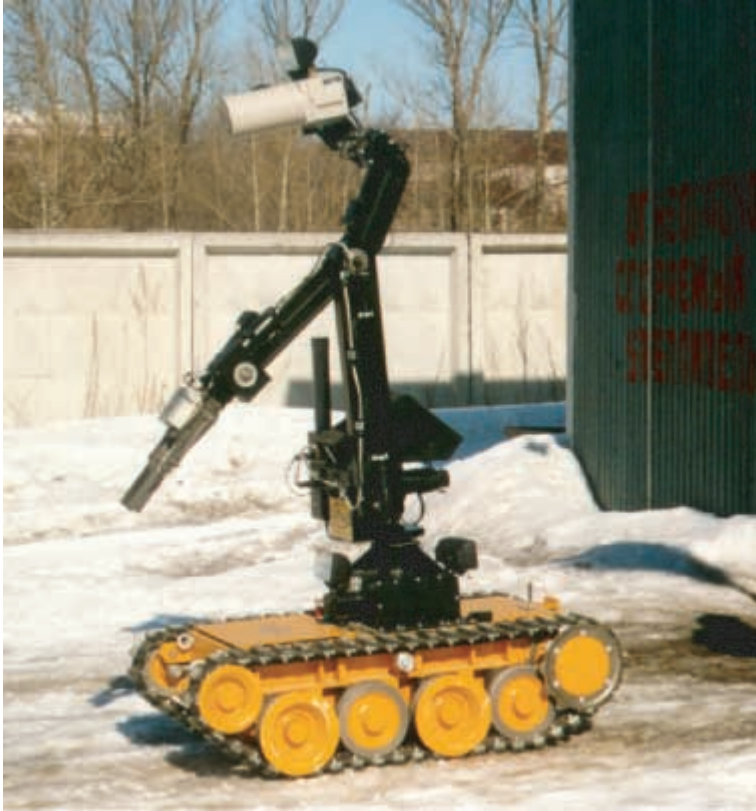
*FIG. 6. Robot manipulator (type MF-4).*

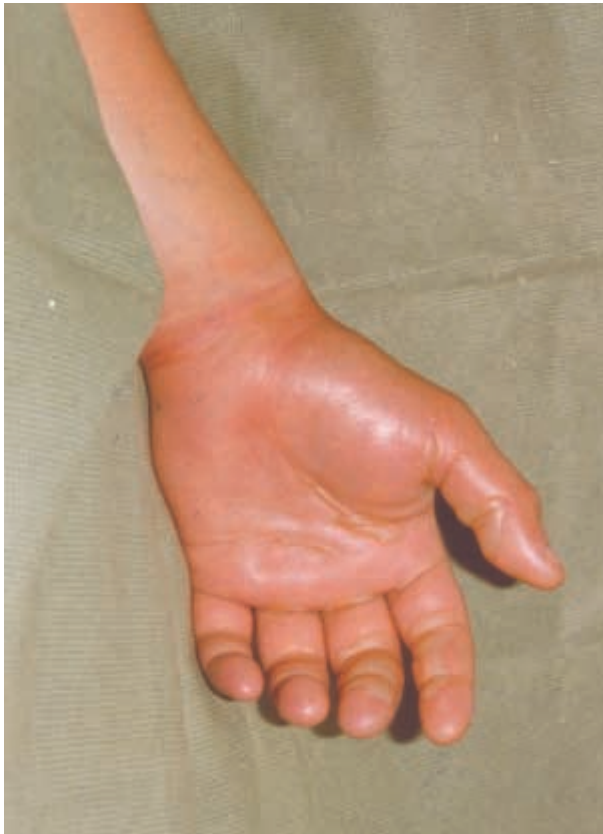
*FIG. 11. Left palm of the victim 50 h after exposure.*

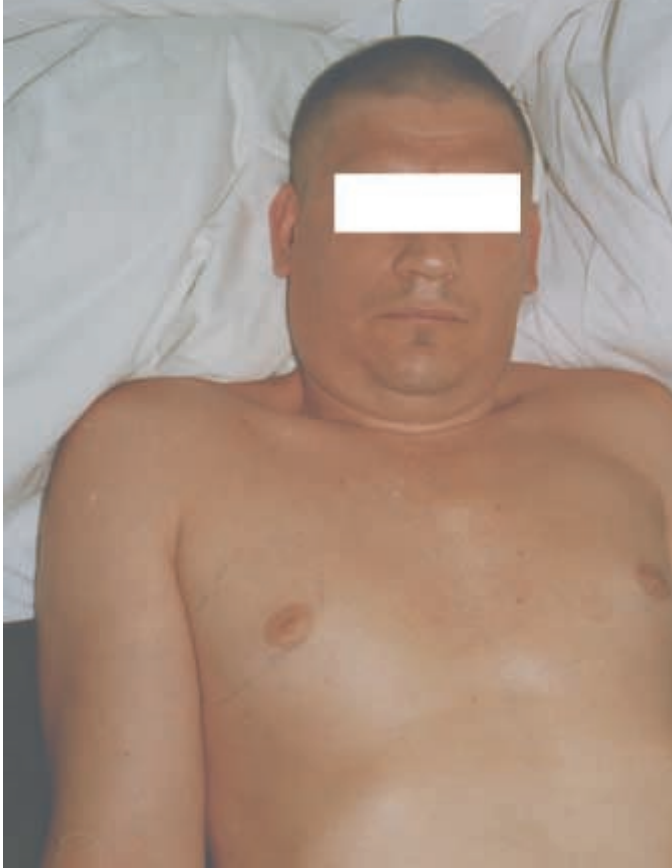
*FIG. 12. Edematous face and thorax of the victim 50 h after exposure.*
